## ARBORICULTURAL REPORT

### TREE INSPECTION & RISK ASSESSMENT

**SITE ADDRESS:** 88 TERRACE RD, GUILDFORD, 6055. WA

**REPORT DATE:** 09.03.2026.

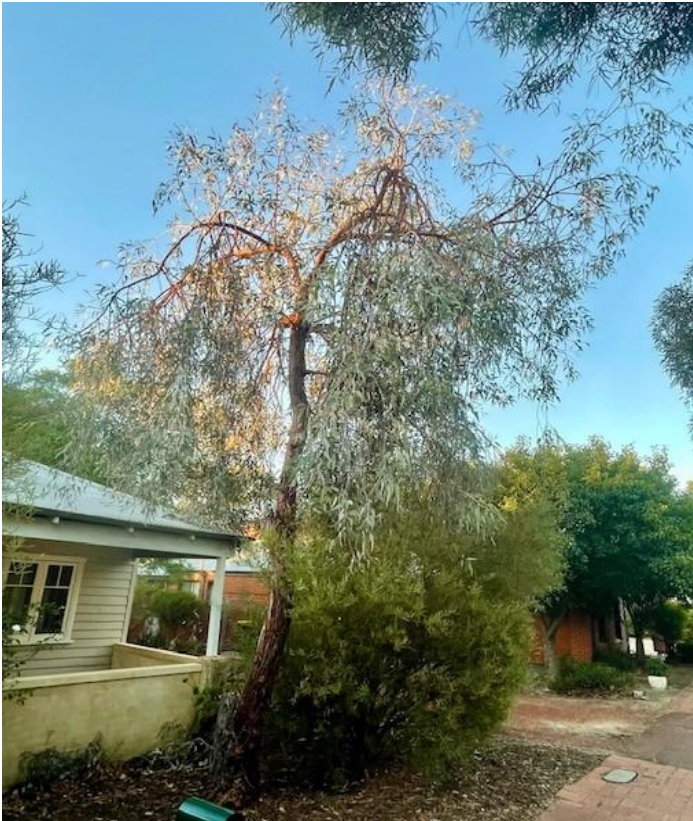
| Image of subject tree: | |

| Health: | Good: Exhibiting good foliage density & appearance, with no evidence of detrimental levels of pathogenic activity observed. |
| Structure: | Satisfactory: Single stem to approx. 3 metres, subsequent stem/limb unions appear sound, with some limb over extension developing.<br>Recent 80mm limb failure.<br>Satisfactory basal flare with no established lignotuber. |
| Additional observations: | Good specimen, suited to its location. |
| QTRA Risk rating - part tree (PT)/ whole tree (WT) failure within following 12-month period: | PT - T 4, S 4, PoF 6 = RoH: <1/1M Broadly acceptable<br>WT- T 3, S 0, PoF 6 = RoH: <1/1M Broadly acceptable |

**5.3** Subject tree # 1 (Silver Princess) confers moderate visual amenity to the subject property and local streetscape and exhibits good health, structure and useful life expectancy with recent failure of a moderately sized limb, and requires minor maintenance pruning.

| Maintenance recommendations: | Minor maintenance pruning recommended. |

**7.1** Subject tree # 1: Maintenance pruning overextended lateral limbs.

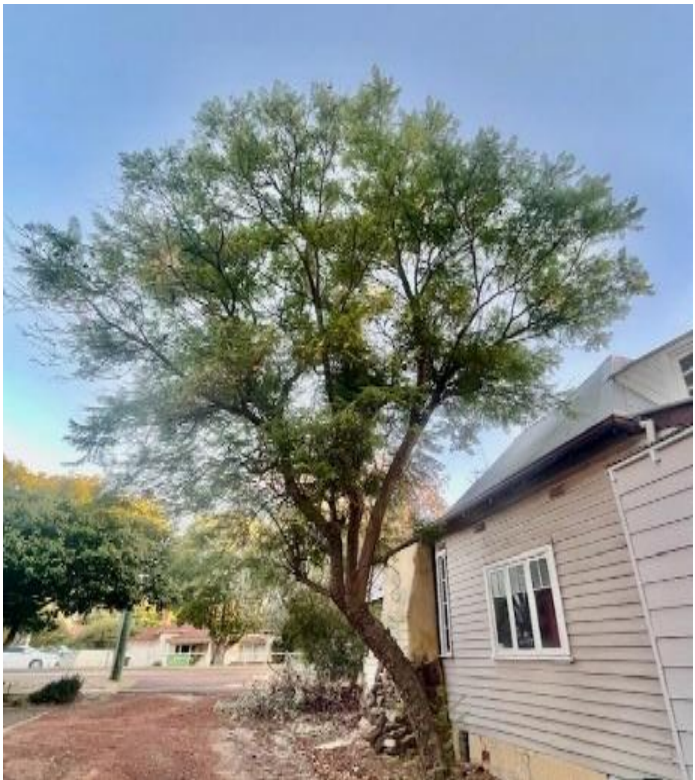
| Image of subject tree: | |

| Health: | Good: Exhibiting good foliage density & appearance, with no evidence of detrimental levels of pathogenic activity observed. Minor deadwood and epicormic shoot development throughout canopy – typical of species. |
| Structure: | Good: Single stem to 2m, moderate basal flare, stem/limb unions appear sound throughout canopy. Moderate lean to east from phototropic growth development . |
| Additional observations: | Subject tree situated 1.14m from subject property., with surface root directly adjacent to crack in wall. |
| QTRA Risk rating - part tree (PT)/ whole tree (WT) failure within following 12-month period: | PT - T 4, S 0, PoF 6= RoH: <1/1M Broadly acceptable<br>WT- T5, S 2, PoF 6 = RoH: 1/<1M Broadly acceptable |

| Maintenance recommendations: | Consider removal prior to structural remediation works. |

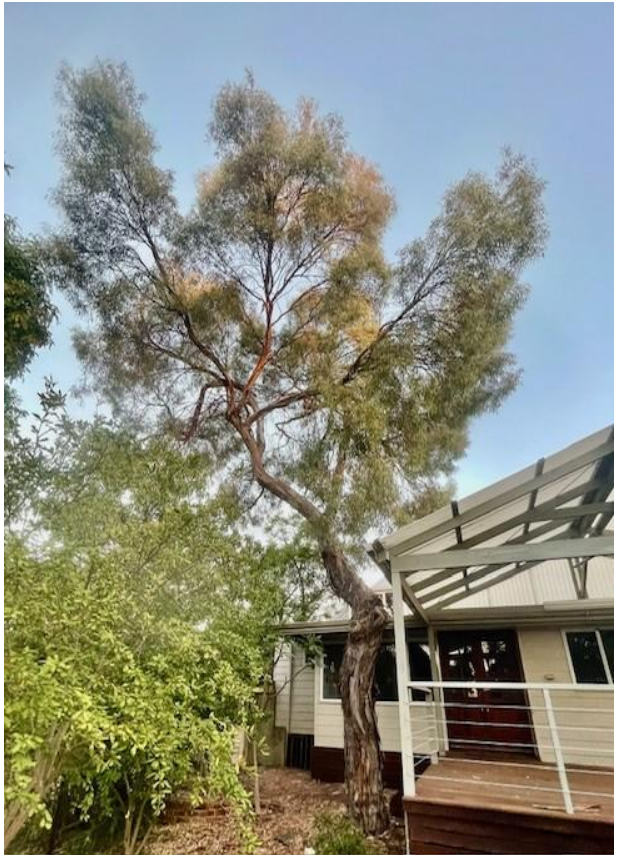
| Image of subject tree: | |

| QTRA Risk rating - part tree (PT)/ whole tree (WT) failure within following 12-month period: | PT - T 3, S 0, PoF 6 = RoH: <1/1M Broadly acceptable<br>WT- T 2, S 0, PoF 6 = RoH: <1/1M Broadly acceptable |

**5.5** Subject tree # 3 (SA Yellow Gum) appear to be in good health with good structure, with a ULE of > 15 years, however the overextension of lateral limbs may increase the risk of part tree failure over time if not maintained. 2.

| Maintenance recommendations: | Consider lateral limb reduction/maintenance pruning. |

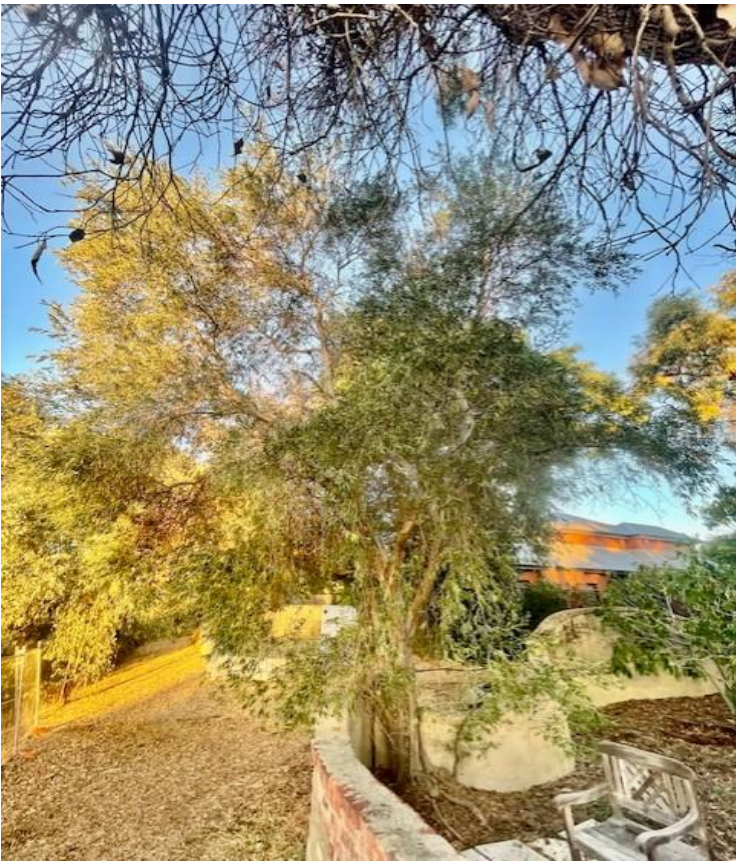
| Image of subject tree: | |

| QTRA Risk rating - part tree (PT)/ whole tree (WT) failure within following 12-month period: | PT - T 4, S 4, PoF 6 = RoH: <1/1M Broadly acceptable<br>WT- T 4, S 3, PoF 7 = RoH: <1/1M Broadly acceptable |

| Maintenance recommendations: | No maintenance works required, Consider reticulation review. |

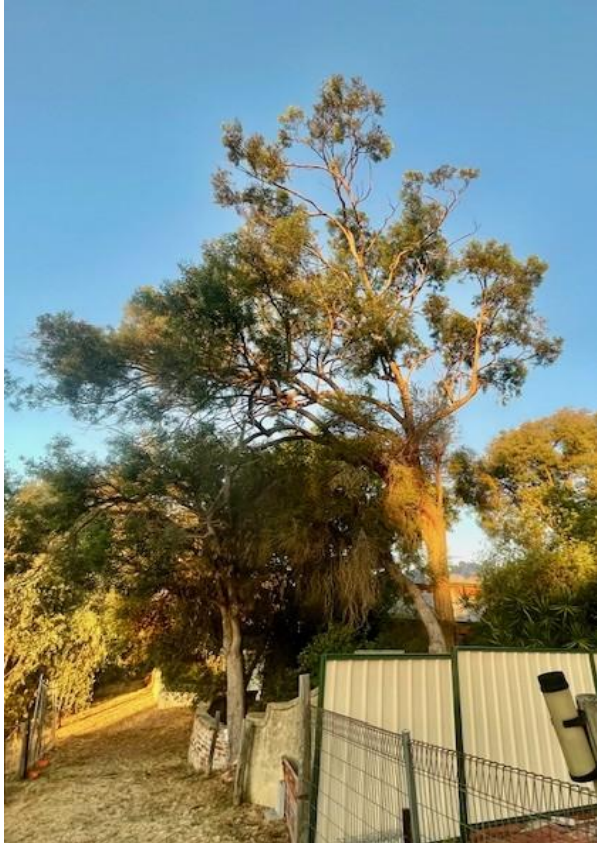
| Image of subject tree: | |

| Health: | Satisfactory: Keno exudation from lesions on lower stem, satisfactory foliage density & appearance. Moderate level of deadwood present in canopy. |
| QTRA Risk rating - part tree (PT)/ whole tree (WT) failure within following 12-month period: | PT - T 4, S 3, PoF 5 = RoH: <1/1M Broadly acceptable<br>WT- T 4, S 2, PoF 7 = RoH: <1/1M Broadly acceptable |

| Maintenance recommendations: | Maintenance prune, consider removal of lower structural limb. |

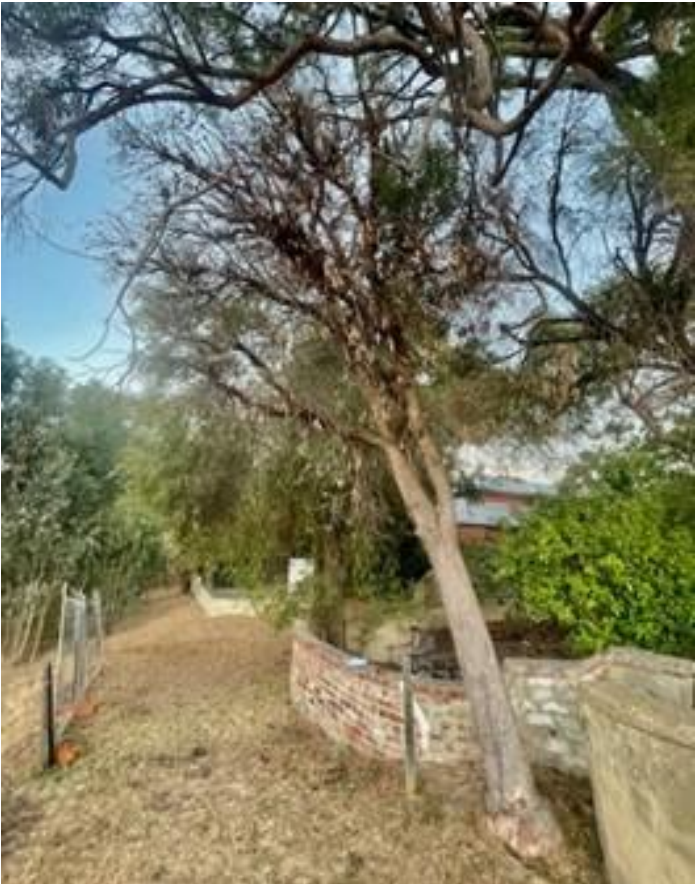
| Image of subject tree: | |

| Structure: | Satisfactory – Good lignotuber development – typical of species, stem and structural limbs appear sound, with no evidence of decay. Asymmetrical canopy and stem lean due to suppression from adjacent tree. |
| QTRA Risk rating - part tree (PT)/ whole tree (WT) failure within following 12-month period: | PT - T 4, S 3, PoF 5 = RoH: <1/1M Broadly acceptable<br>WT- T 4, S 2, PoF 6 = RoH: <1/M Broadly acceptable |

| Maintenance recommendations: | Consider whole tree removal or canopy removal and retain as monolith for habitat. |

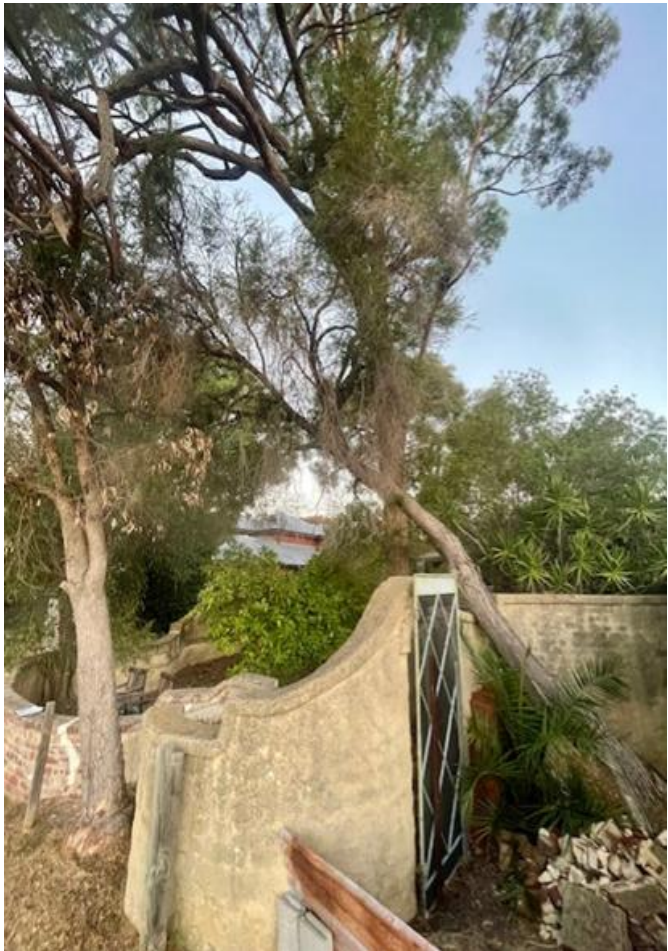
| Image of subject tree: | |

| Structure: | Poor: Tree failed at base, with significant stress fracture in lower stem, held in situ by adjacent low wall and trees. |
| QTRA Risk rating - part tree (PT)/ whole tree (WT) failure within following 12-month period: | PT - T 4, S 3, PoF 5 = RoH: <1/1M Broadly acceptable<br>WT- T 4, S 3, PoF 6 = RoH: <1/1M Broadly acceptable |

**5.9** Subject tree # 7 (Moonah) appears to have failed at the rootplate.

| Maintenance recommendations: | Remove. |

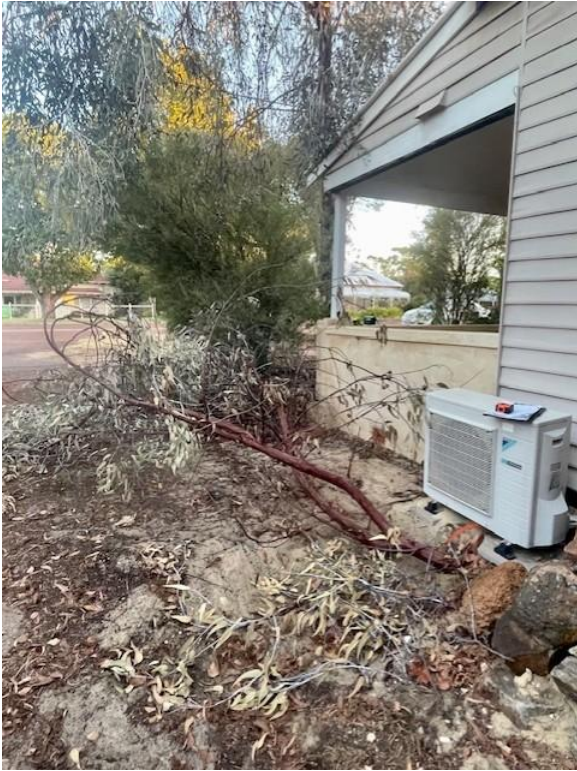
**6.1:** Image showing failed limb from subject tree # 1

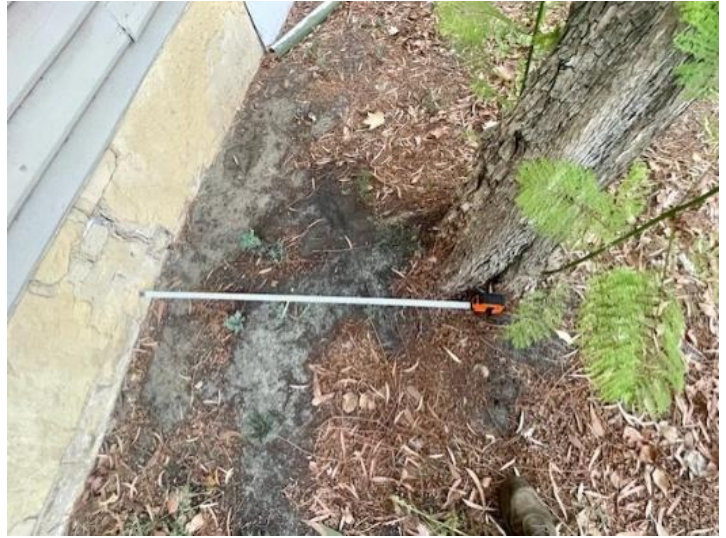
**2.4** As part of the quote request for this arboricultural report from the Client, details from a building survey undertaken in December 2025 were shared suggesting that Subject tree #3 (Jacaranda) is the primary causal agent of structural damage to the east façade of the subject property.

**6.2:** Image showing proximity of subject tree # 2 to; location of structural damage to subject property:

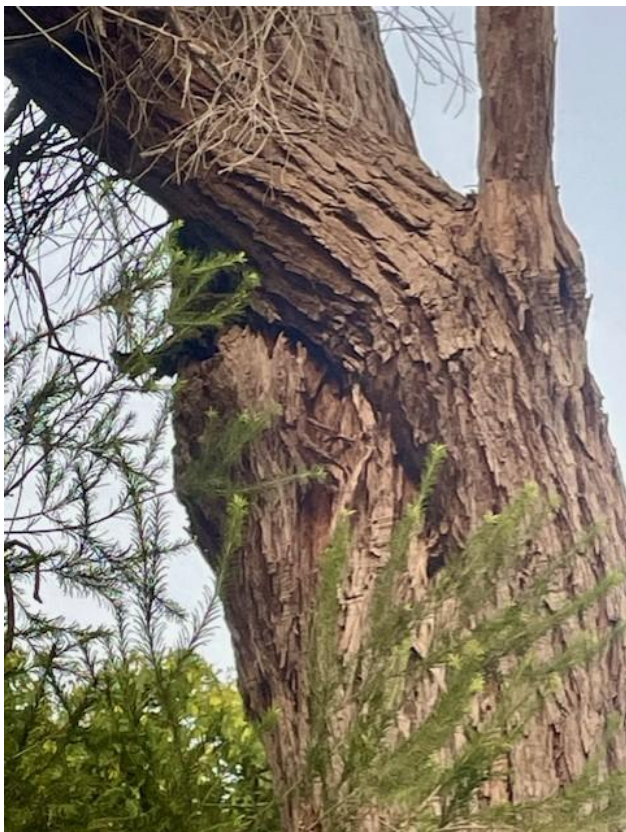
**6.3** Image showing compressed union at canopy base of subject tree # 6:

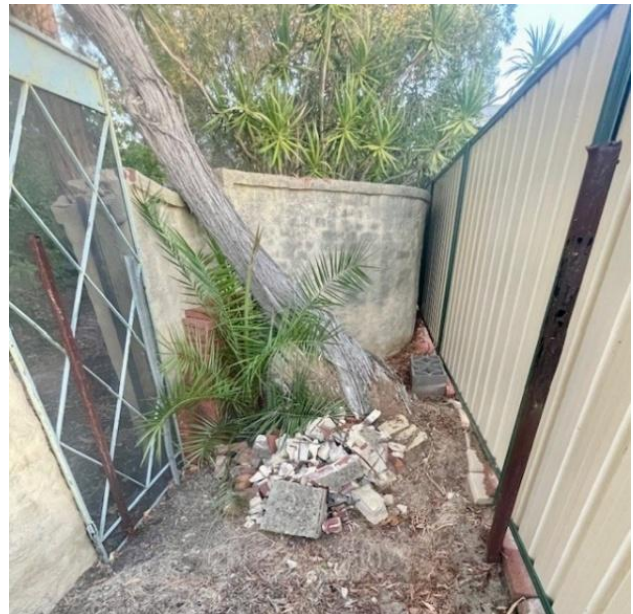
**6.4** Image showing basal failure of subject tree # extent of tree # 7:
