# BUILDING REPORT

88 Terrace Road Guildford

# Building Report

**Property** : 88 Terrace Road Guildford  
**Inspection Date** : 20 th December 2025  
**Occupied** : Vacant  
**Weather Conditions** : Fine  
**Inspector** : Brian Connor Building Practitioner 100541 Mobile 0401866 640

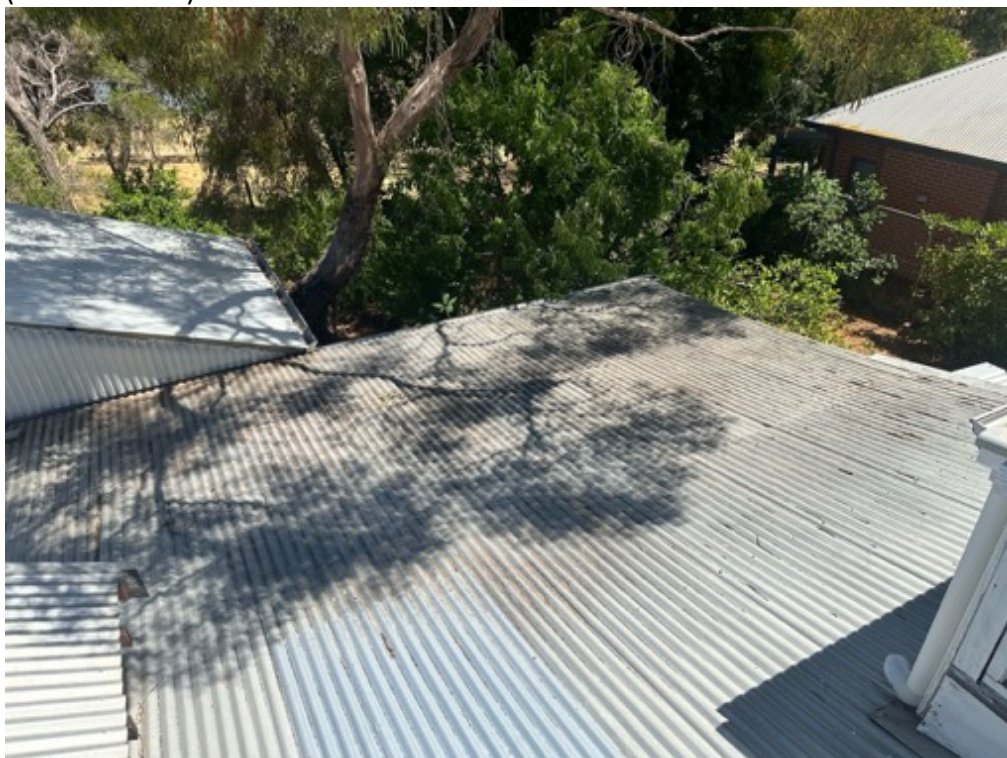
The valley and ends of roof sheets are rusted over the front entry and should be replaced.  
(Maintenance)

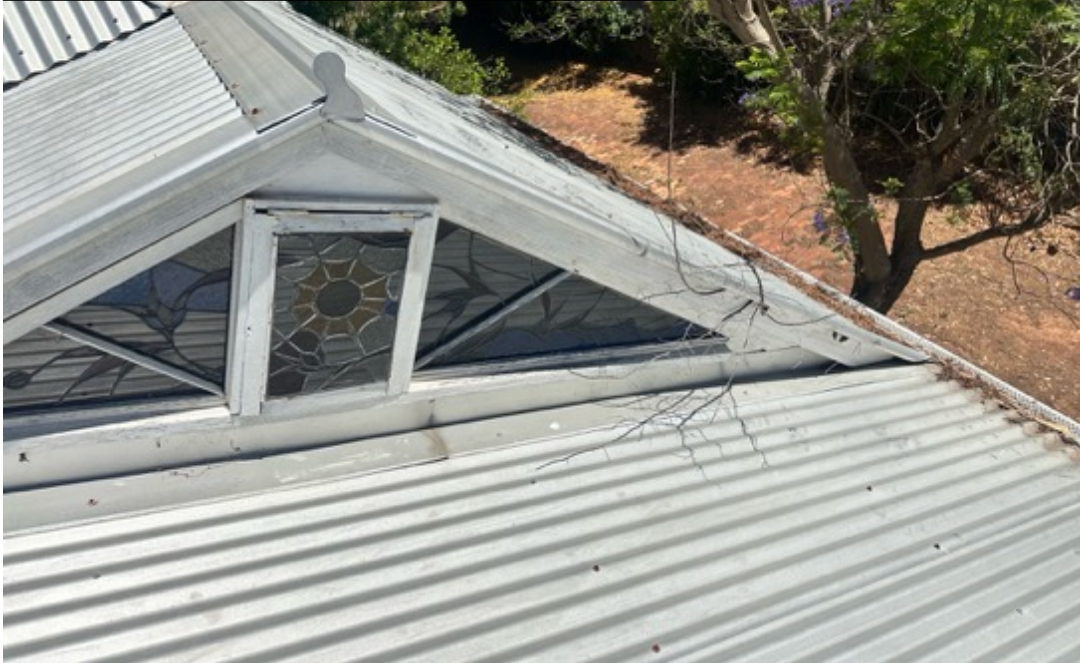
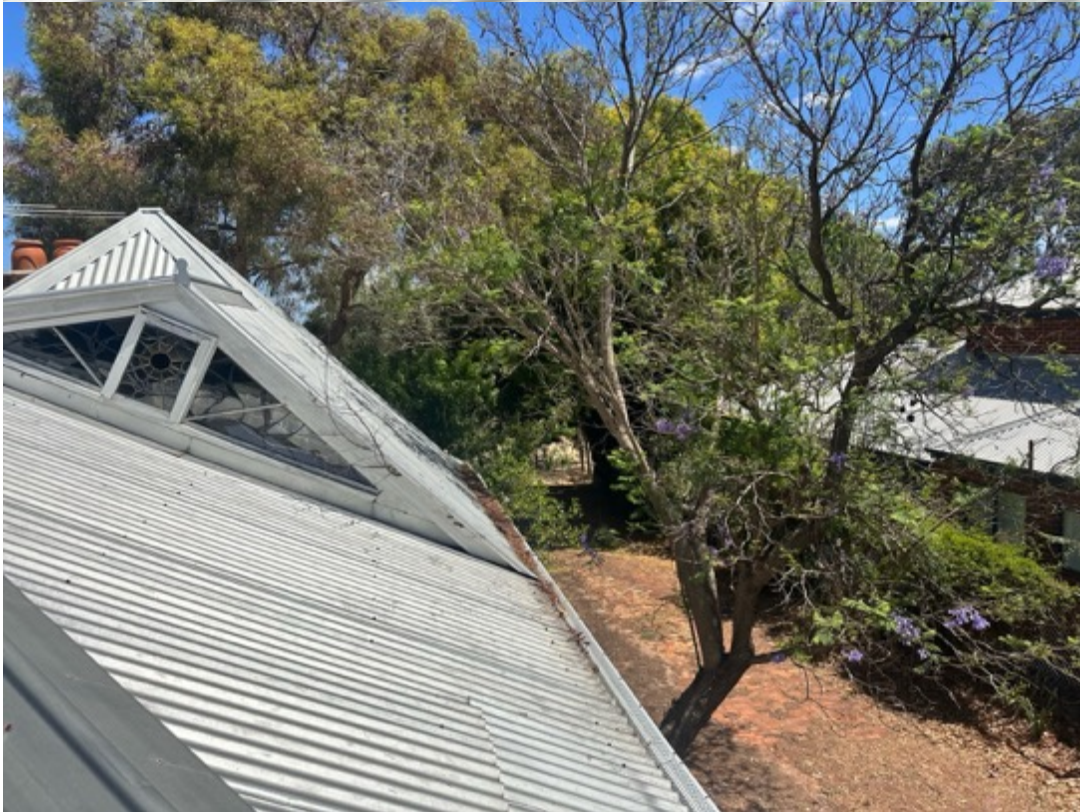
Right side gutter is rusted and requires replacement. Currently full of tree matter causing leaks to the rear bathroom ceiling

The east gutter (right side of the house) is full of tree matter from the Jacaranda and is causing leaking to the rear bathroom ceiling. (Maintenance)

Replace rusted roof  
sheets ad valleys

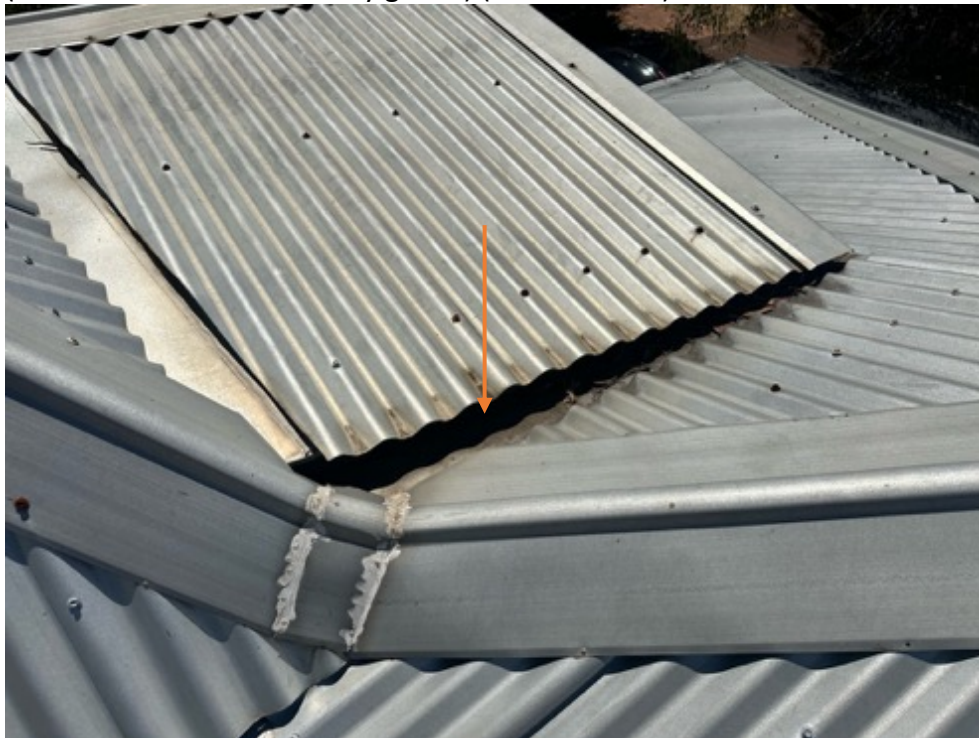
There is a shallow valley gutter to the attic roof and water entry in heavy rains is possible (insufficient fall on the valley gutter) (Maintenance)

Flat valley gutter will be prone to water ingress , inadequate valley gutter fall

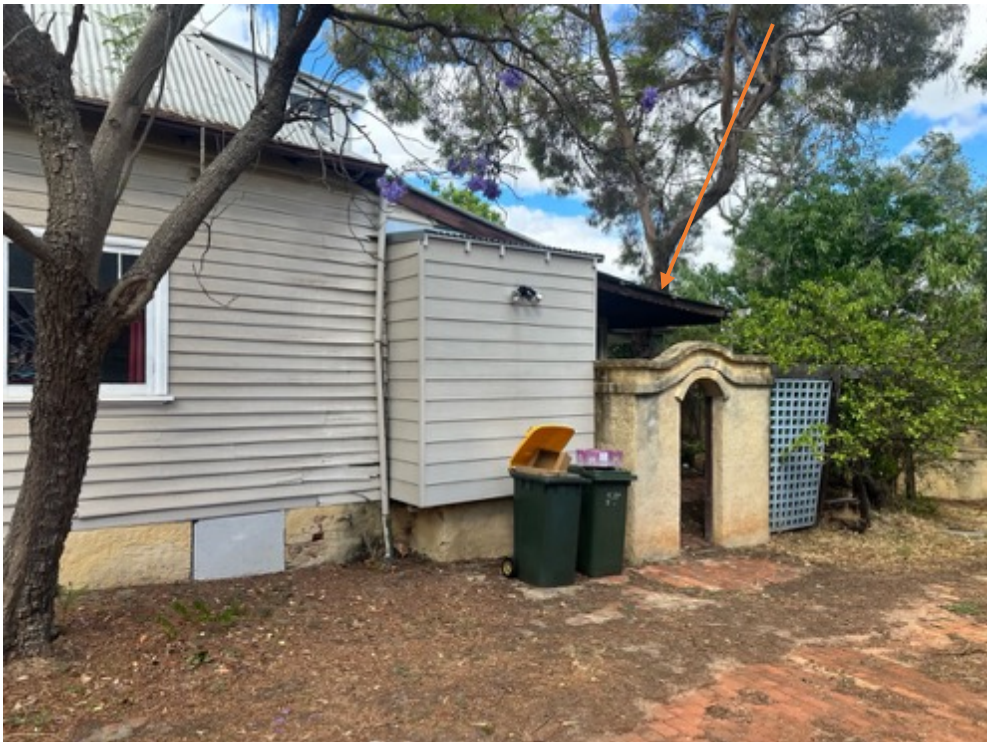
The rear east side veranda entry rafters are bowed and over span and require a load bearing fascia installed to rectify. This roof may be part of the original structure.

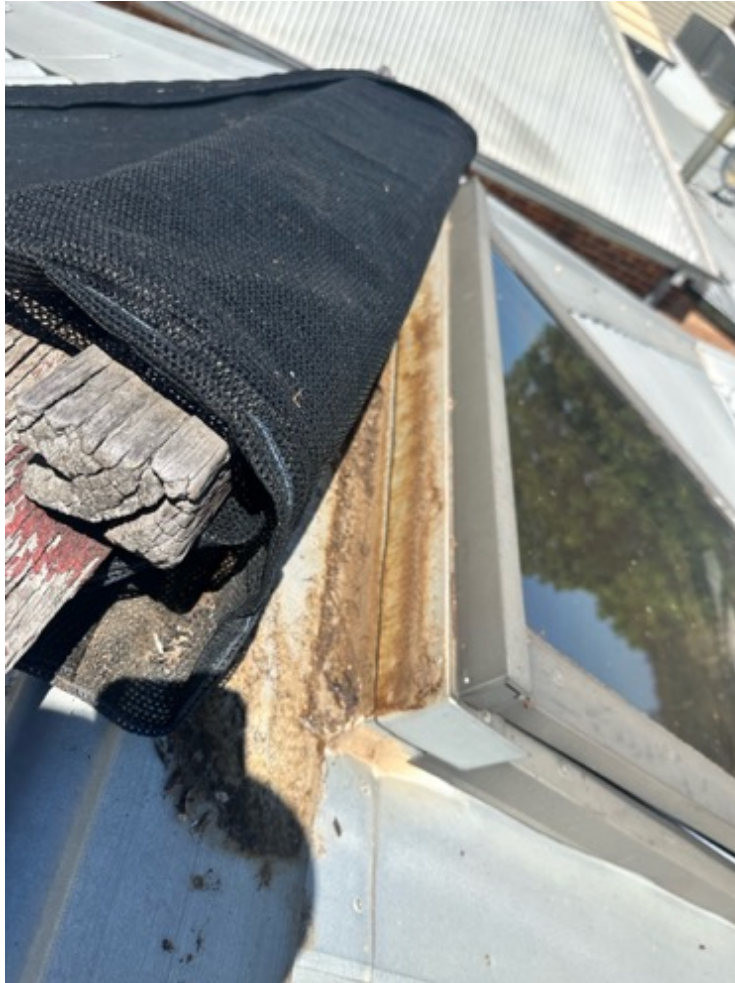
There is a skylight to. the attic which has some temporary flashing and requires new flashings, some leakage expected from the skylight (Maintenance)

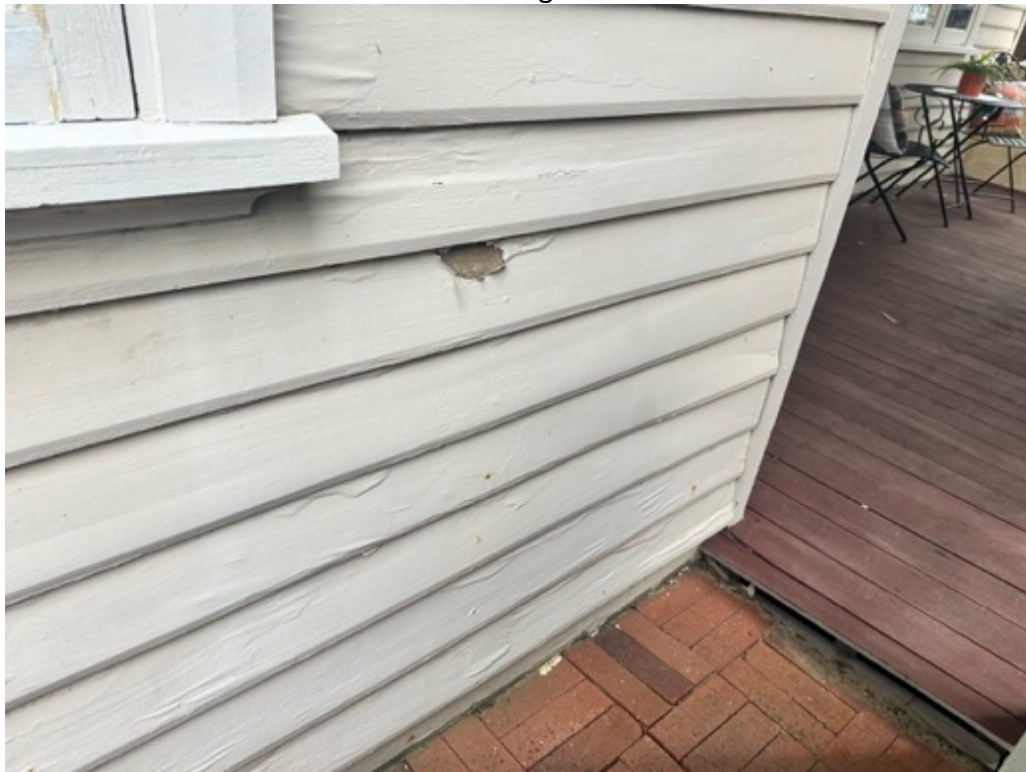
Front elevation

Base weatherboards rotted to 900 mm high to front elevation.

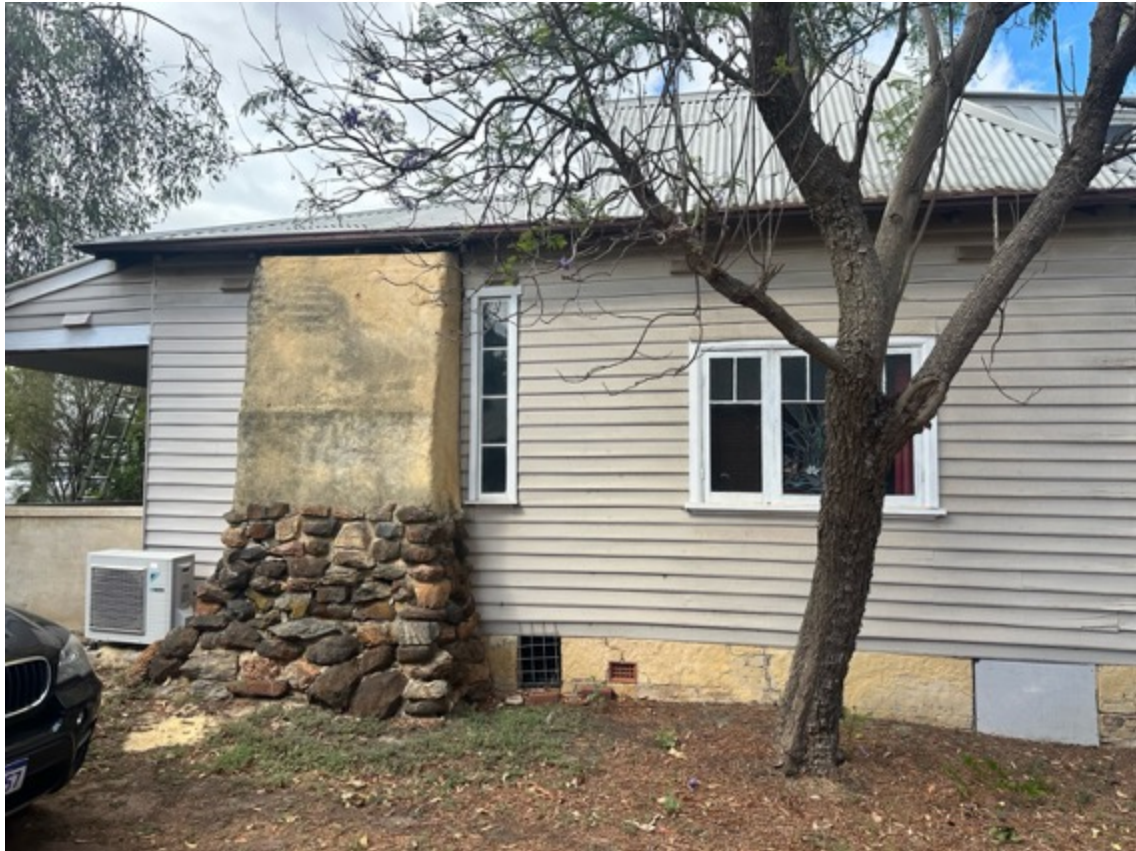
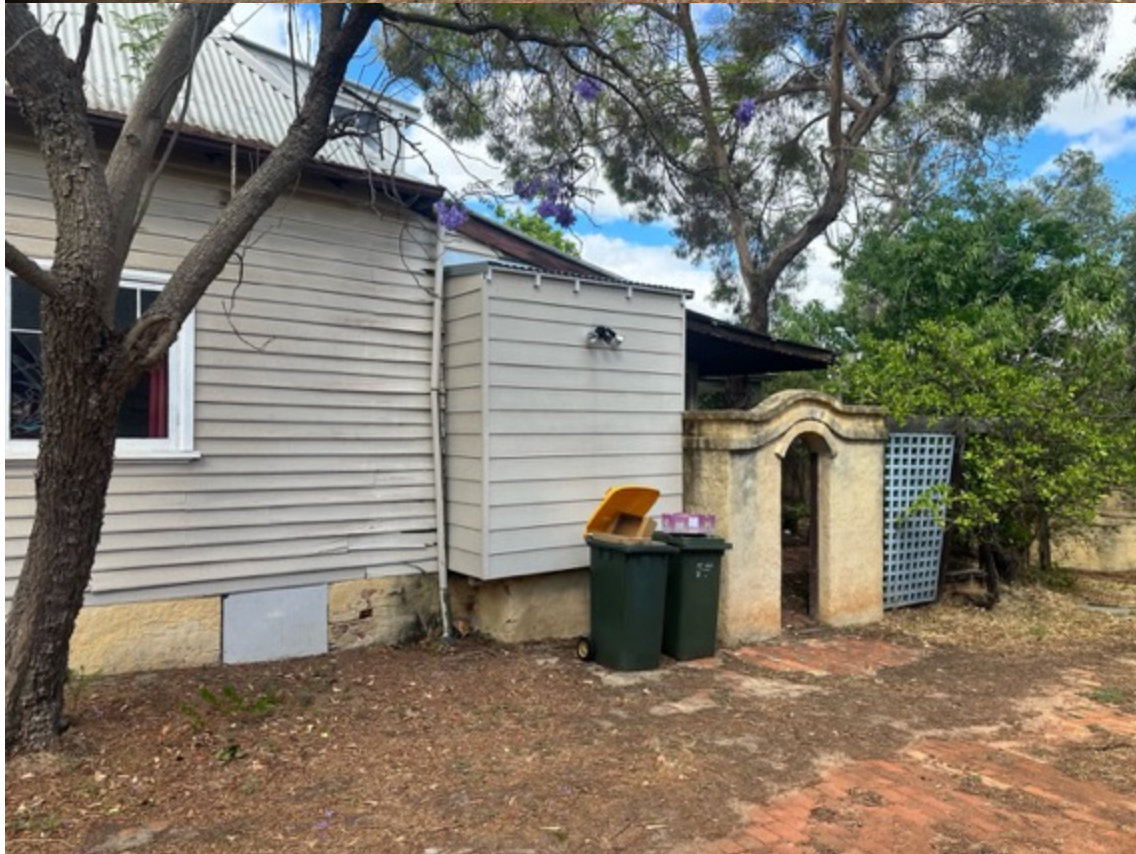
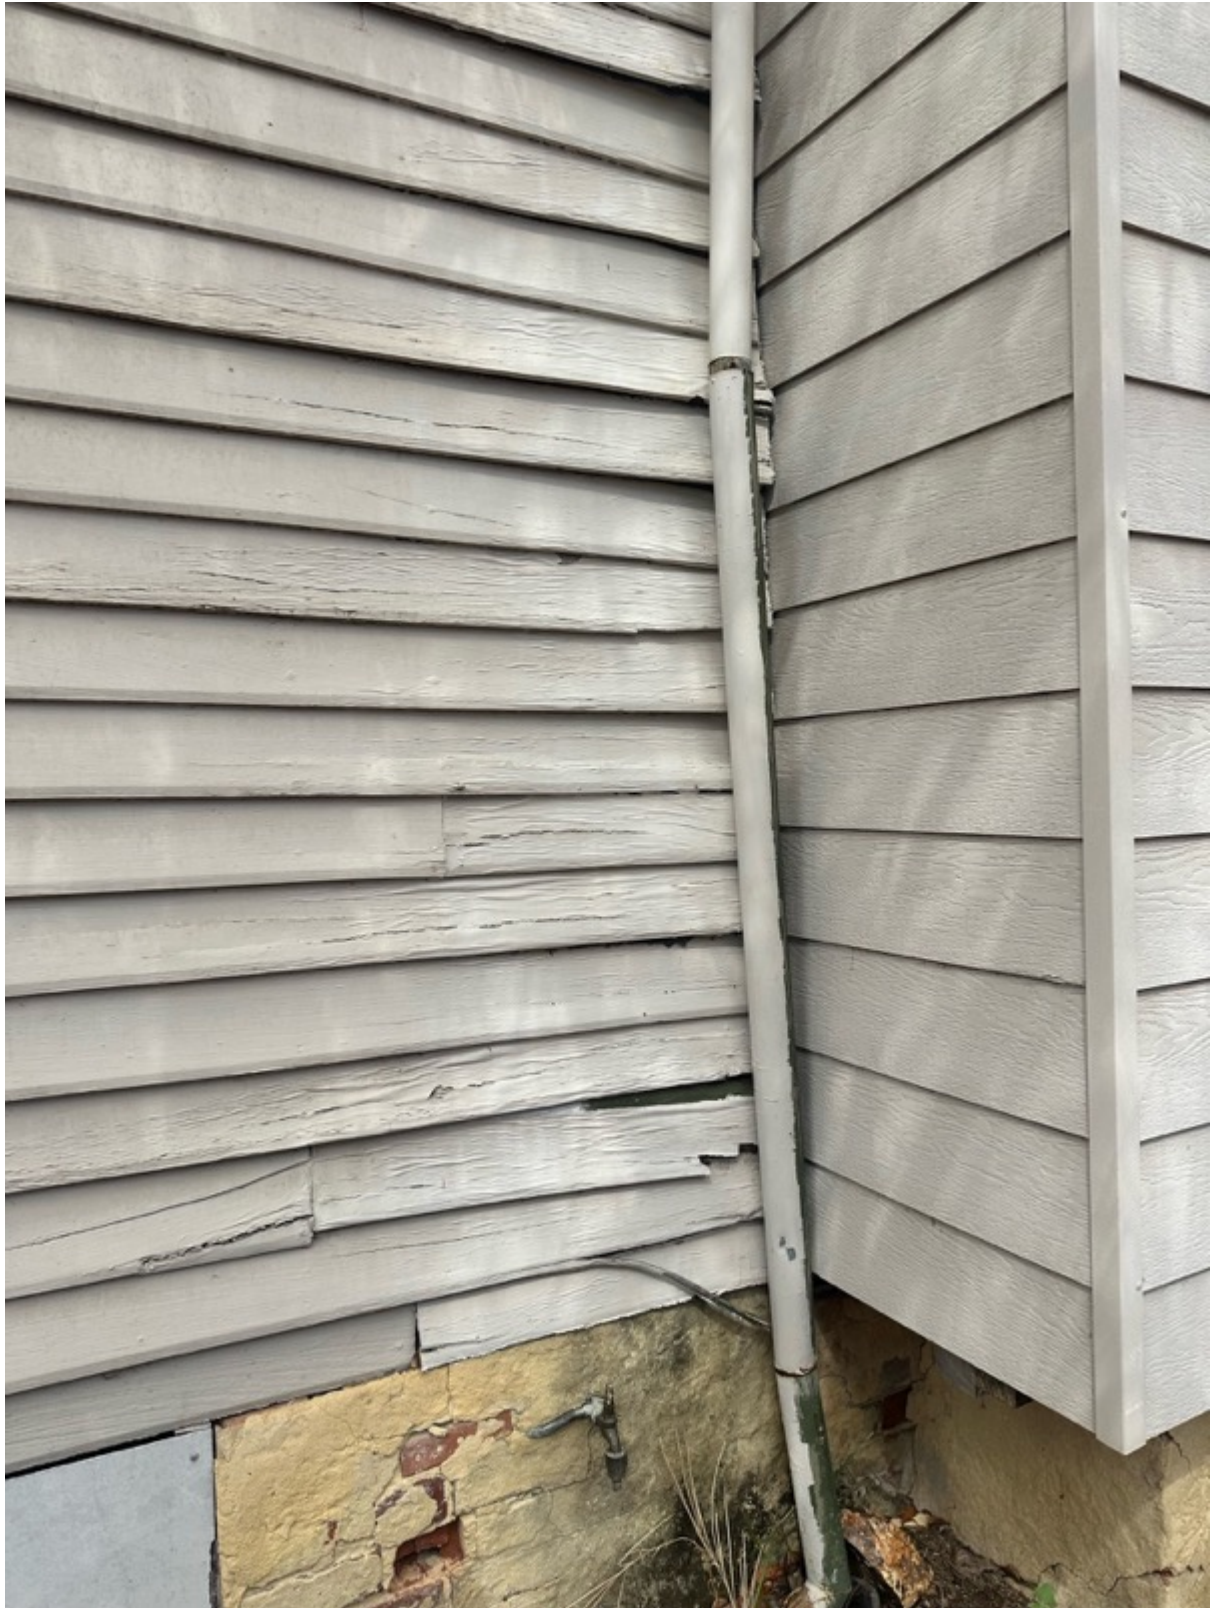
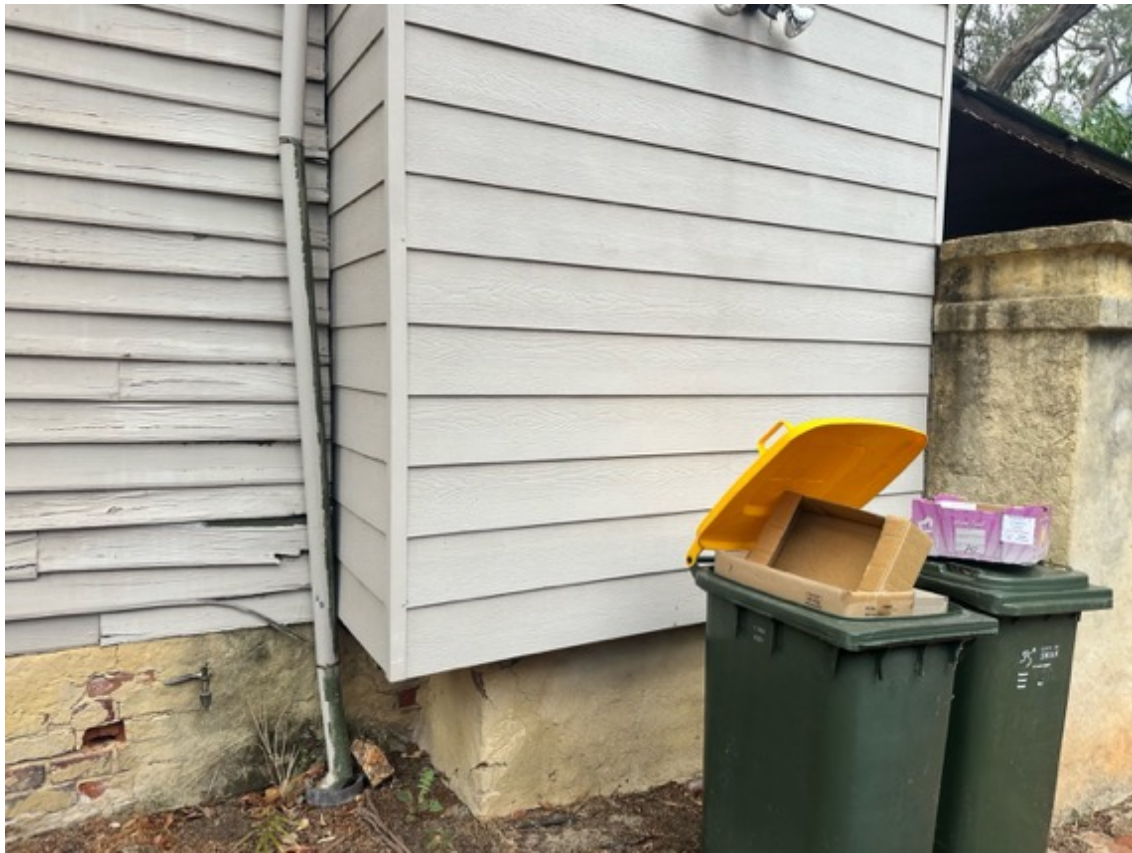
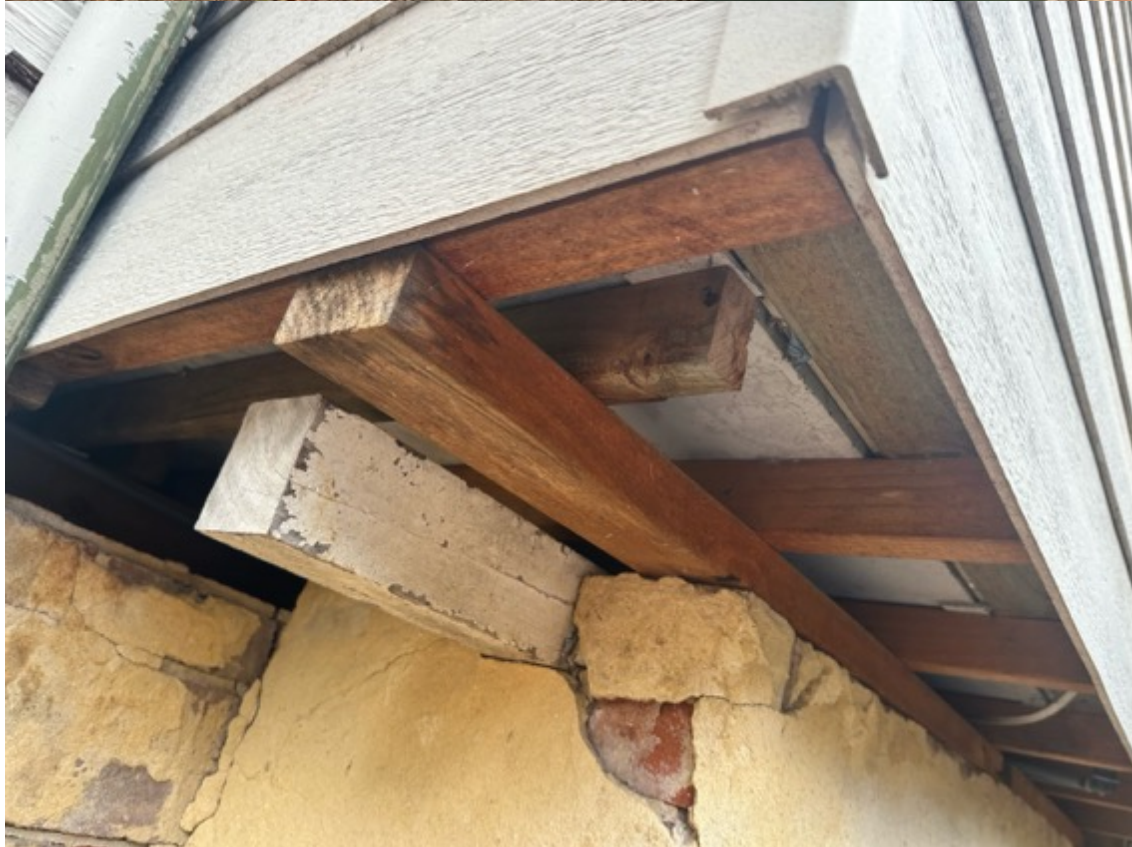
## East elevation

Chimney stone cladding huge gaps and cracks 30 mm to stone and brickwork cracked and leaning greater than 100 mm chimney unstable not safe and needs to be demolished.

Jacaranda roots gave cracked the footing and vase brickwork tree needs to be removed and wall rebuilt.

Rotted weatherboards requiring replacement.

800 mm outdented area floor framing is undersized not compliant with Australian standard AS1684.2

No gutter to roof same area

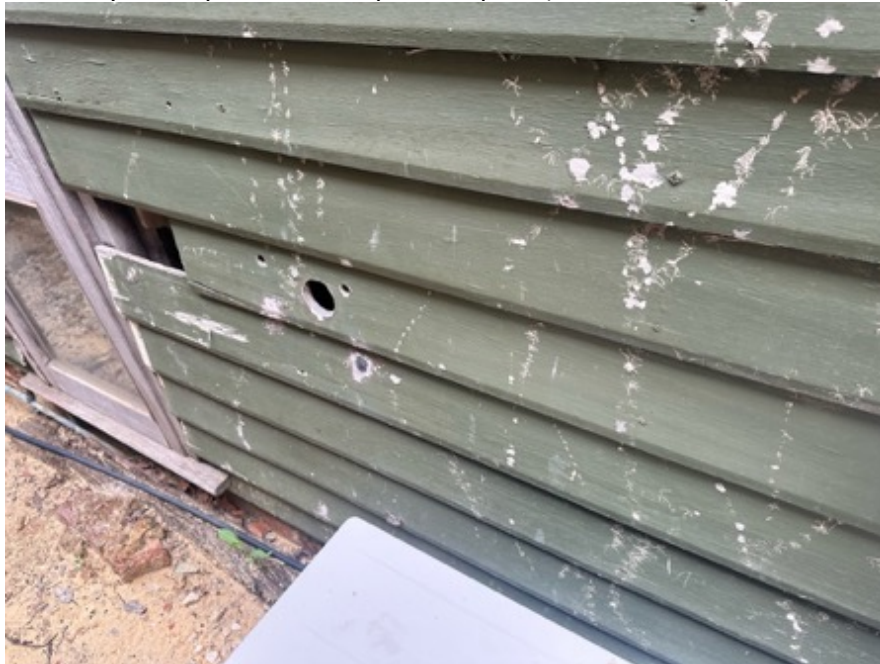
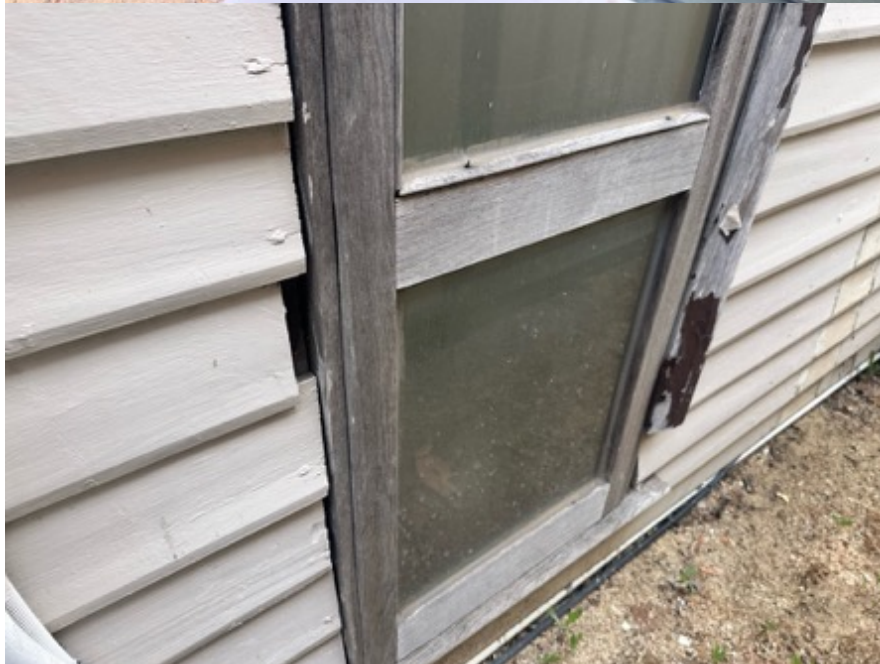
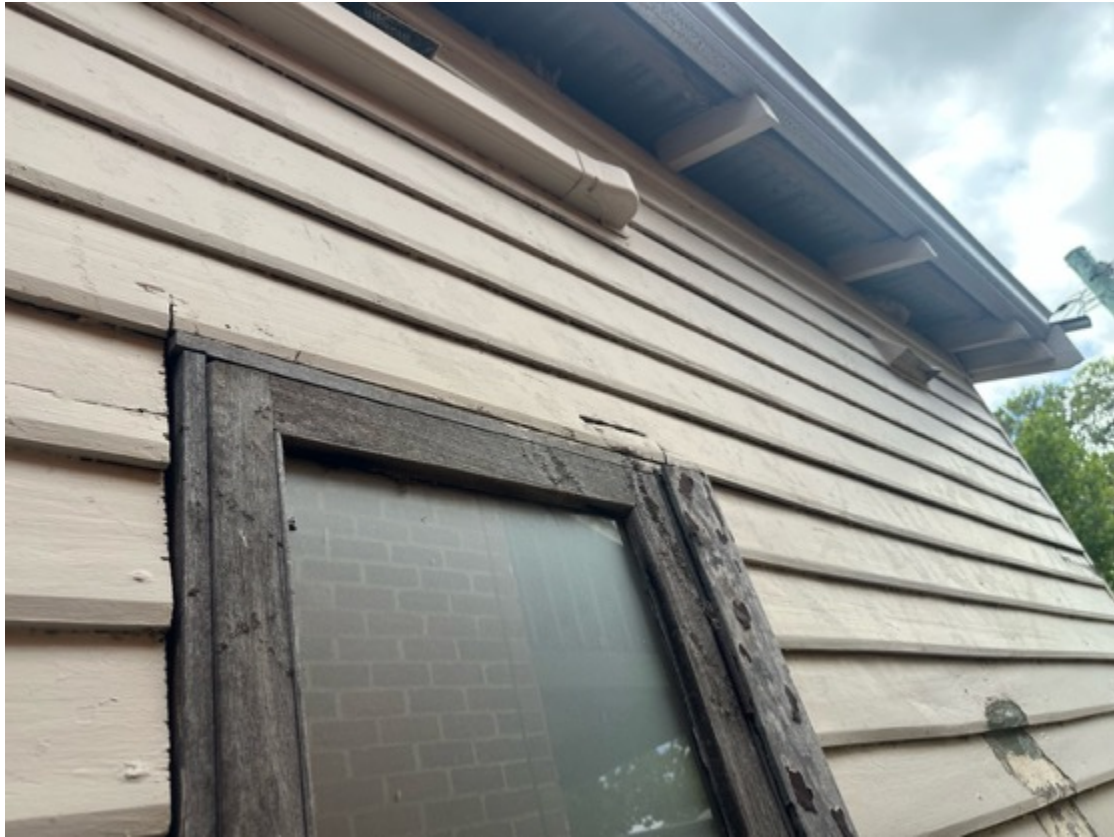
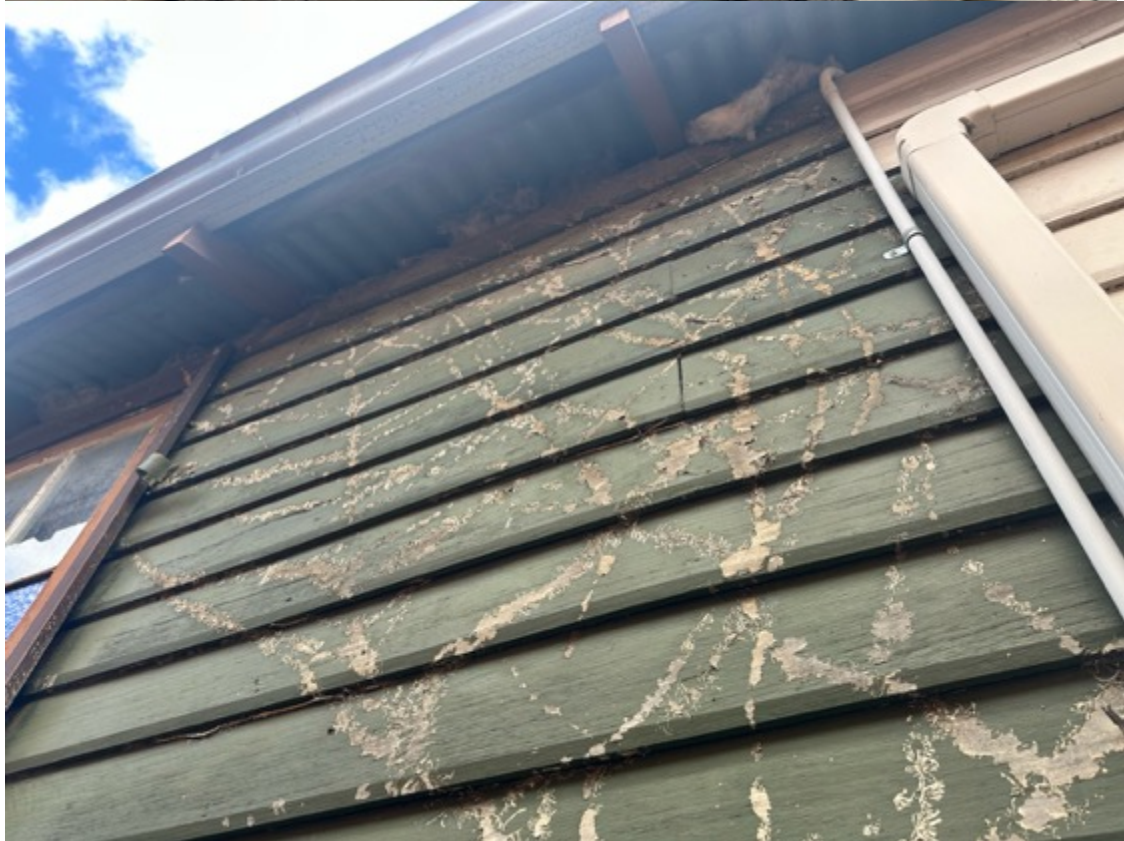
## West Elevation

Many gaps, holes and splits to the weatherboards, and rotted sections.

Windows are badly weathered and require repair / replacement. (Maintenance)

Sewer vent pipe is uncapped and should extend through the roof. (Maintenance)

North end cement sheeting has bulge and shows gap at the plastic sheet joiners and is not currently waterproof and requires repair. (Maintenance)

Require replacement of weatherboards to this entire elevation. (Maintenance)

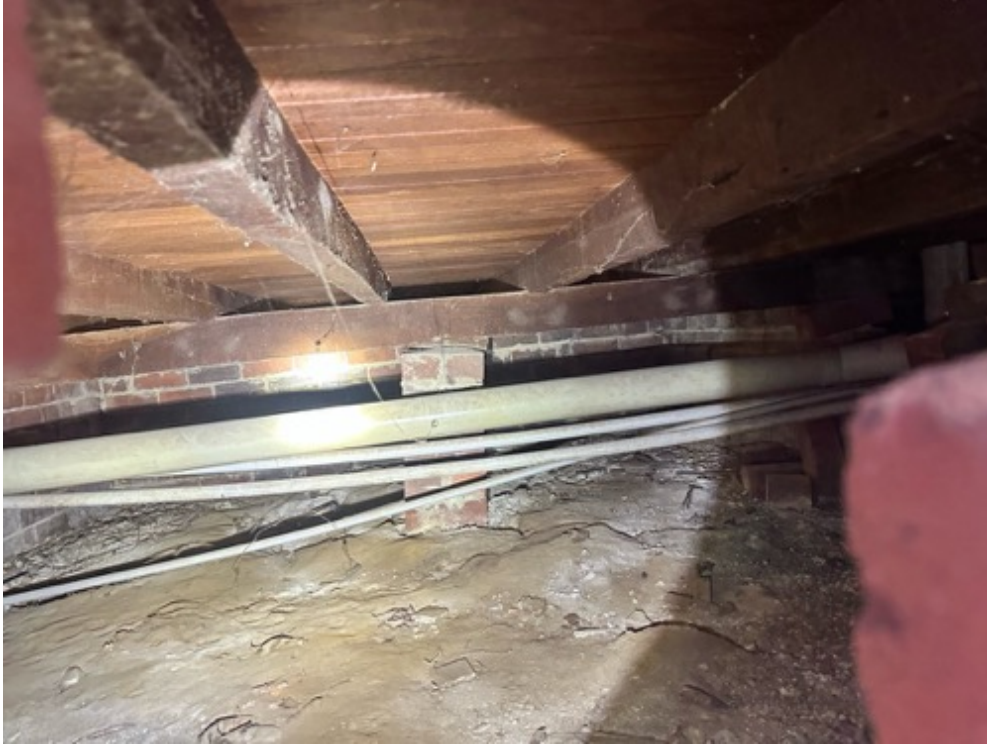
Leaning brick floor support require replacement to Dining room. **Not structurally sound.**

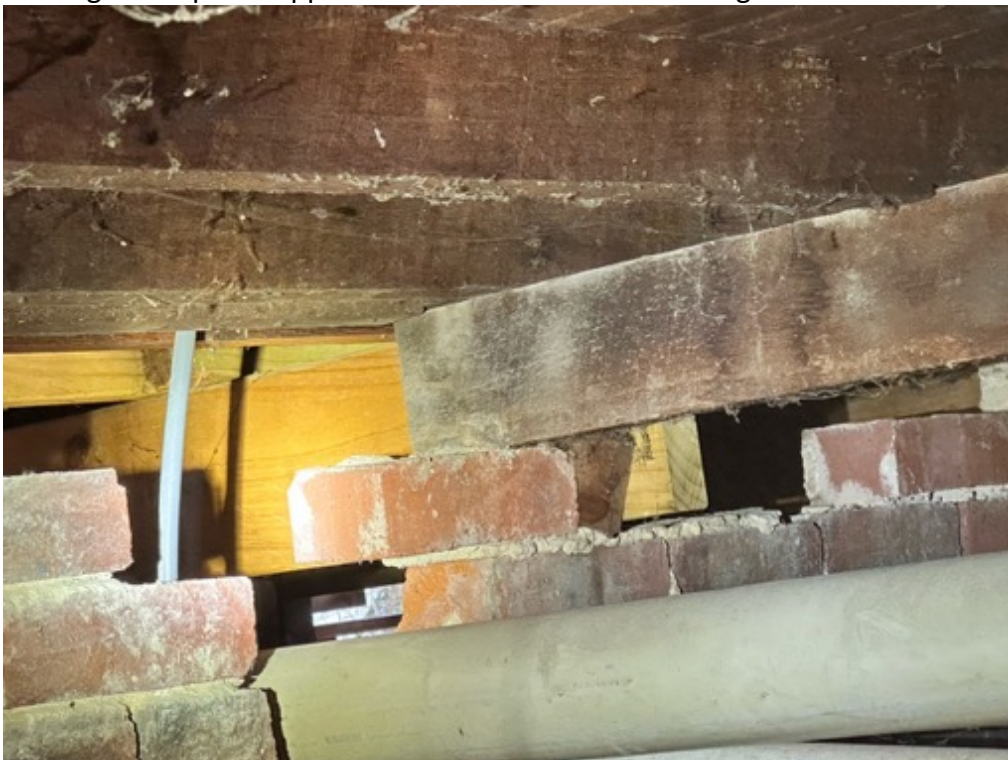
Missing bricks poor support to the west wall of the Dining room

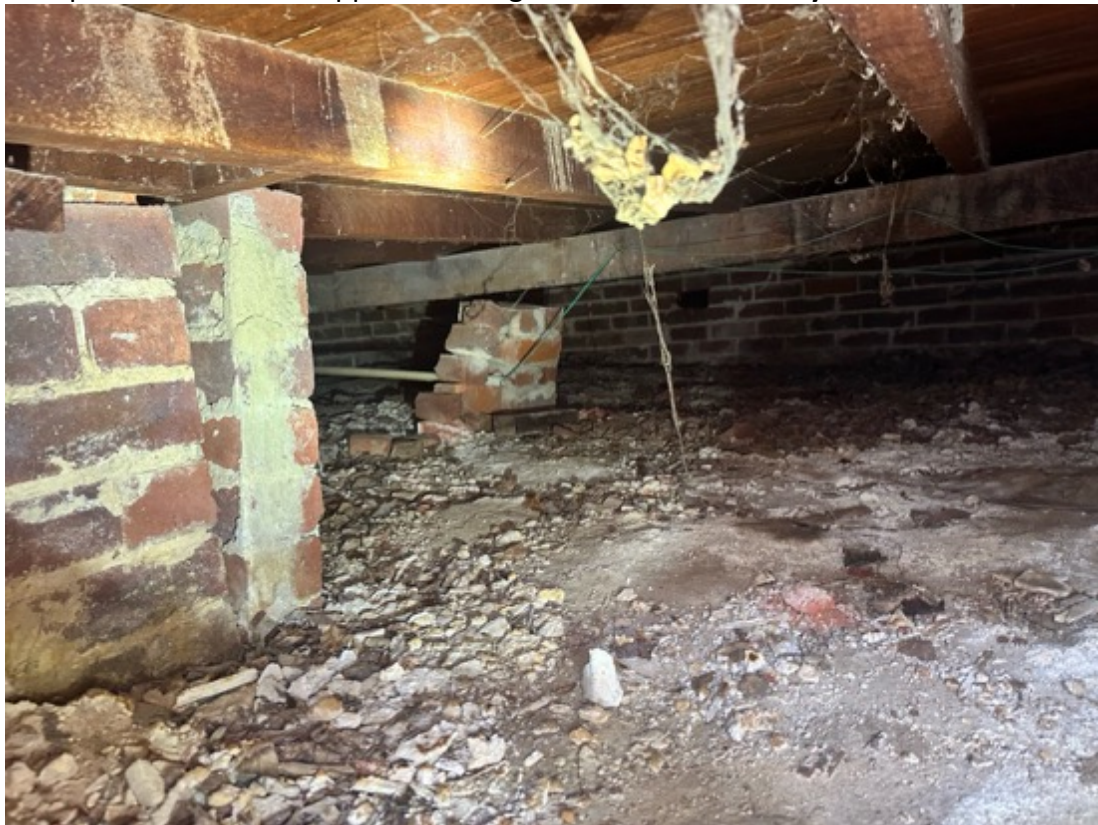
Collapsed central brick support to Living room. **Not structurally sound.**

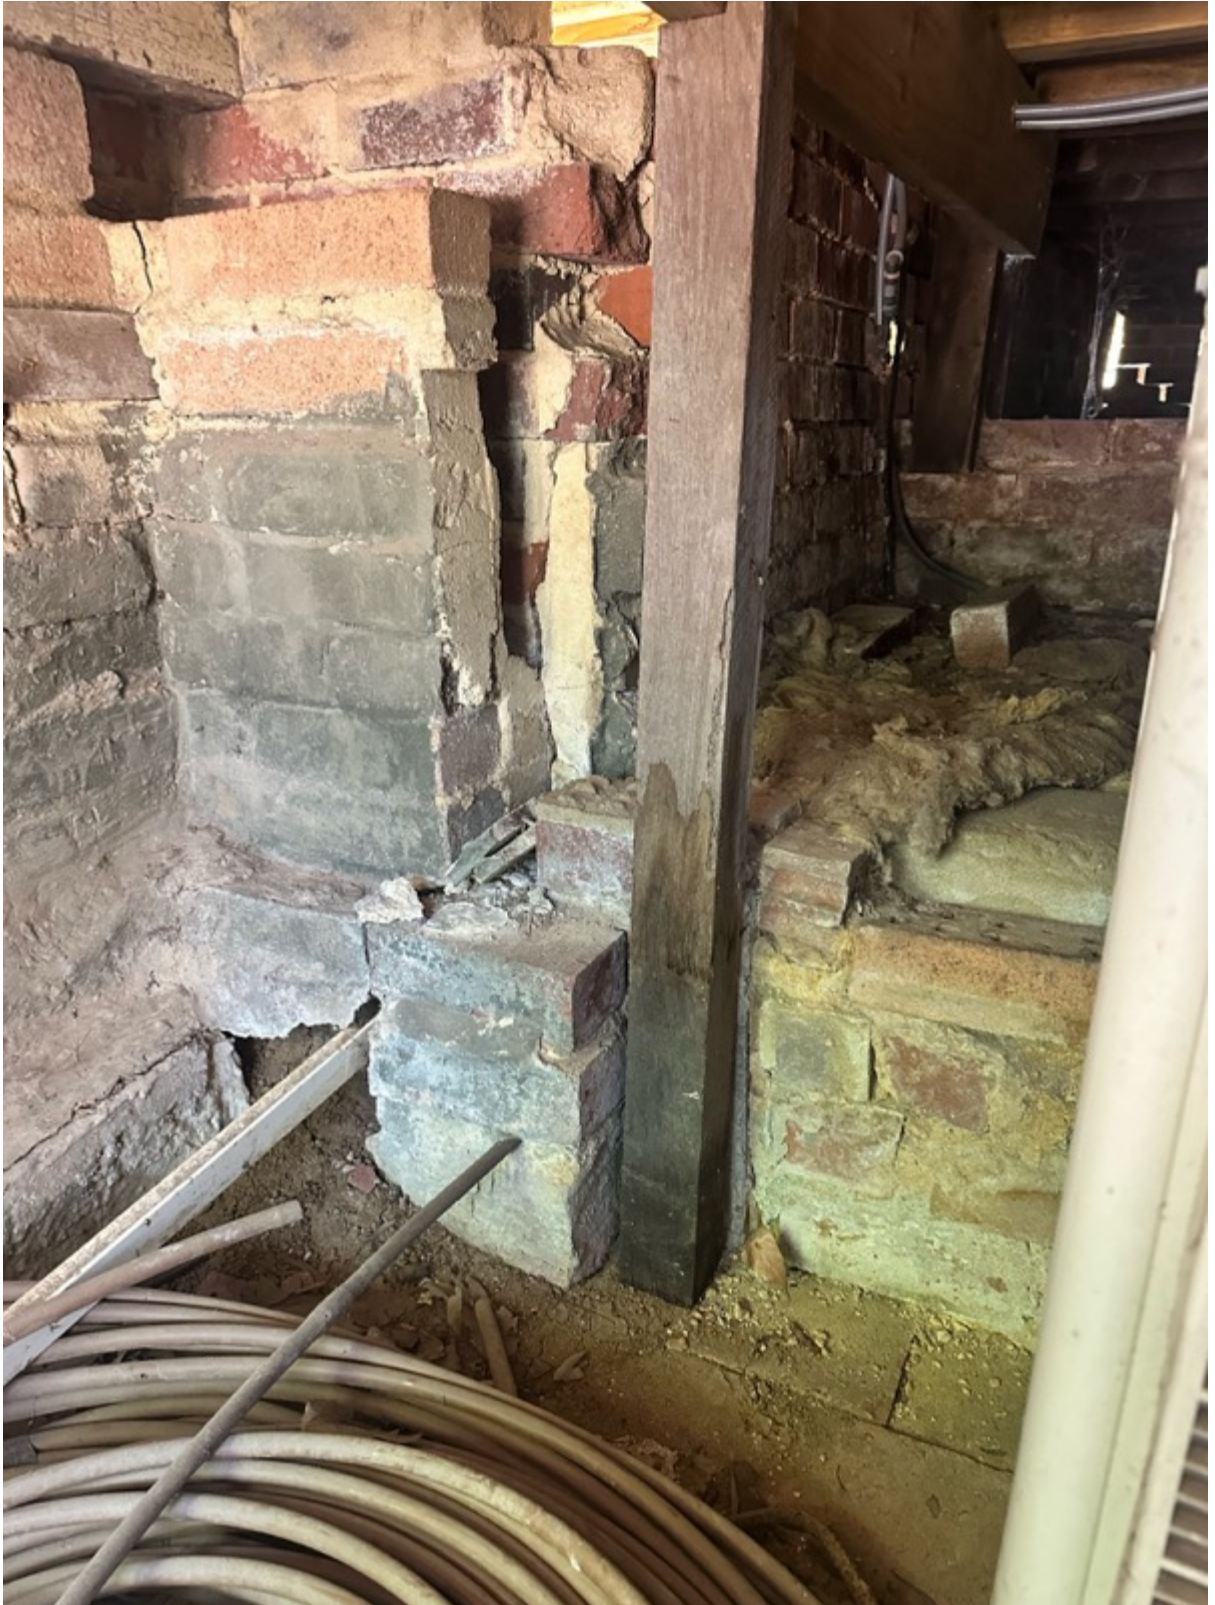
Stump supported on paving. **Not structurally sound.**

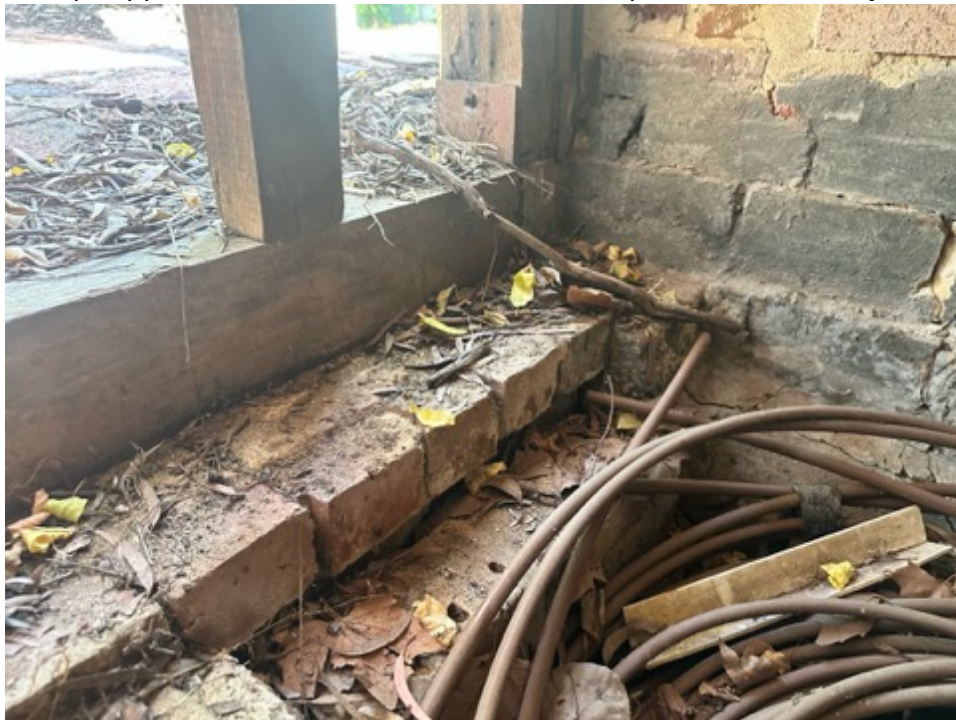
Stump supported on bearer on cracked brick steps. **Not structurally sound**

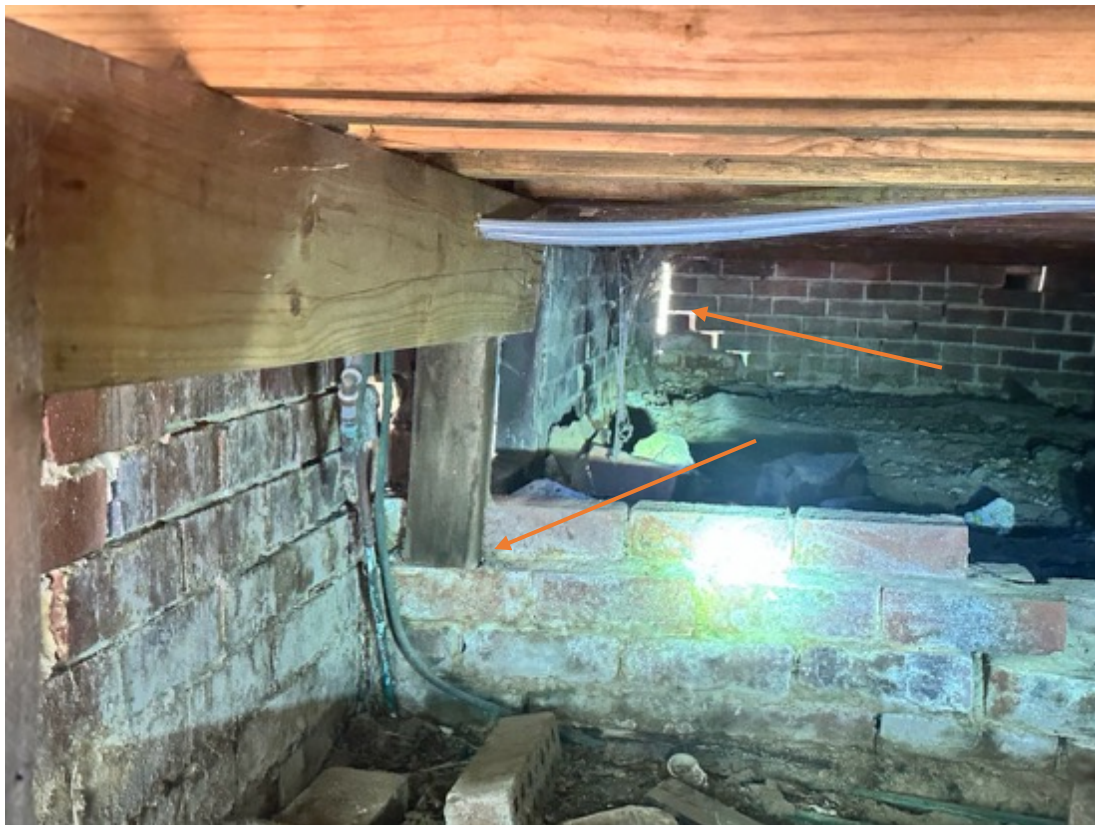
Side base brickwork walls have separated from the brick internal cross walls due to heaving from silty soil causing subsidence. Stump sitting in brick wall not secured. **Not structurally sound**

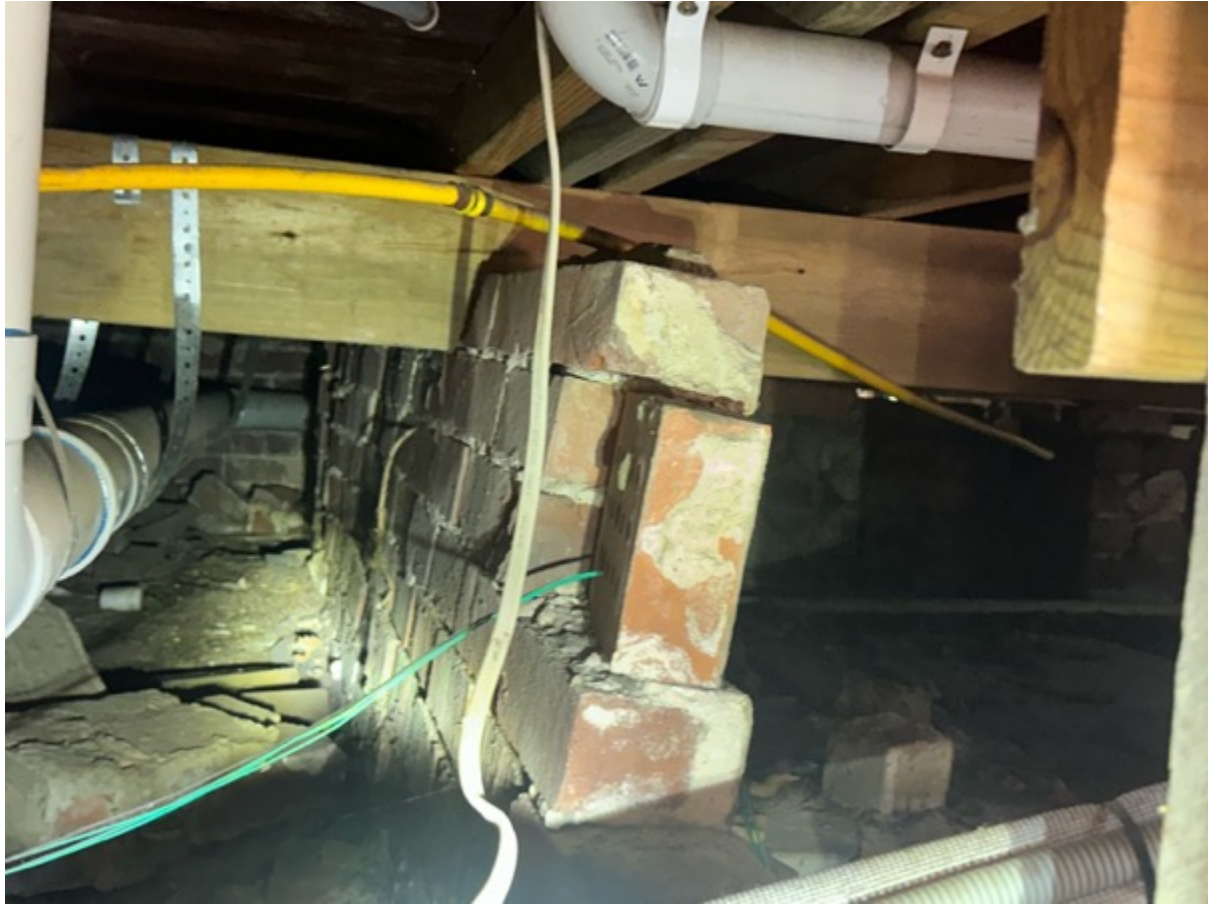
Leaning footing support wall at the north side of the home. **Not structurally sound.**

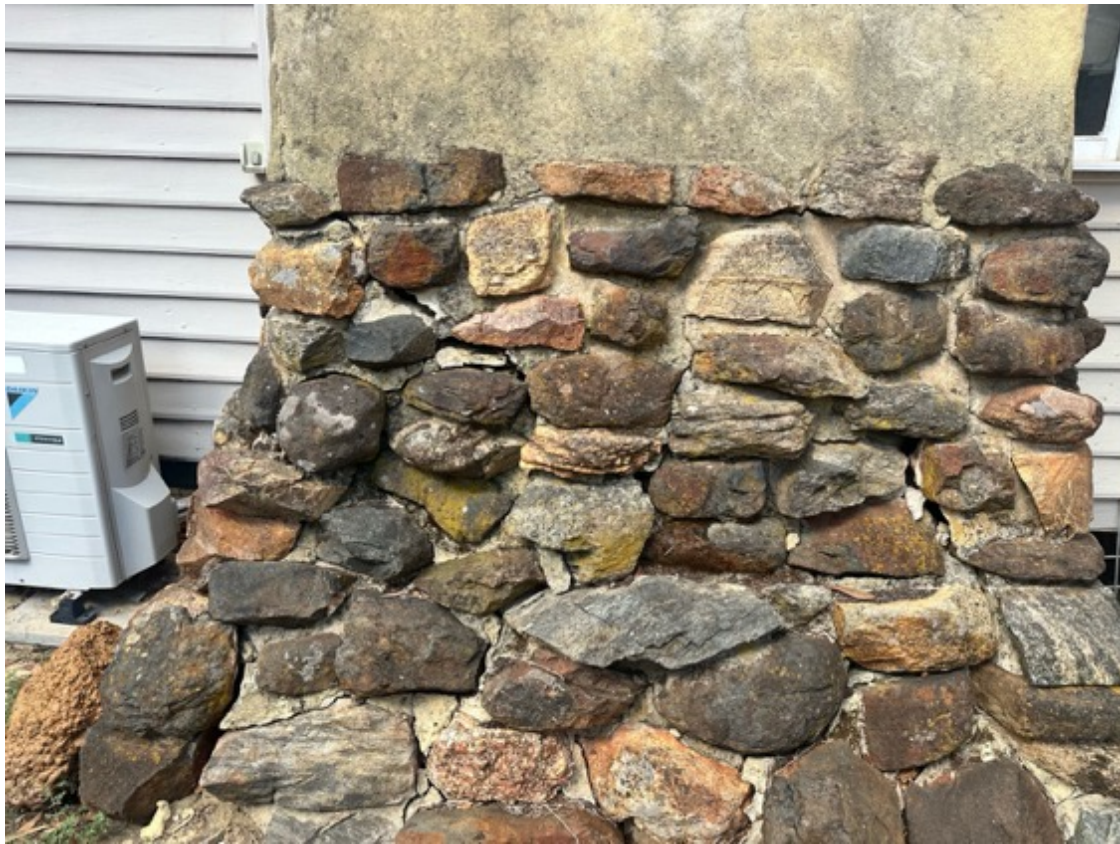
The chimney on the right side of the house is constructed of brick masonry with stone cladding on the brickwork. The brickwork has separated from the wall frame and is leaning approximately 100mm or more. There are gaps and cracking 40mm to the brickwork. It is not possible repairing this chimney without demolition and rebuilding. The current state of the brickwork is considered unstable and a safety risk and should be removed/ demolished to prevent it falling onto someone.

**This item is considered a structural defect and is not structurally sound.**

It is recommended to demolish / remove the east brick chimney which has separated from the house framing and is unstable. It is considered a currently a safety risk. **Safety risk**
