# BUILDING REPORT

88 Terrace Road Guildford

# Building Report

**Property** : 88 Terrace Road Guildford  
**Inspection Date** : 20 th December 2025  
**Occupied** : Vacant  
**Weather Conditions** : Fine  
**Inspector** : Brian Connor Building Practitioner 100541 Mobile 0401866 640

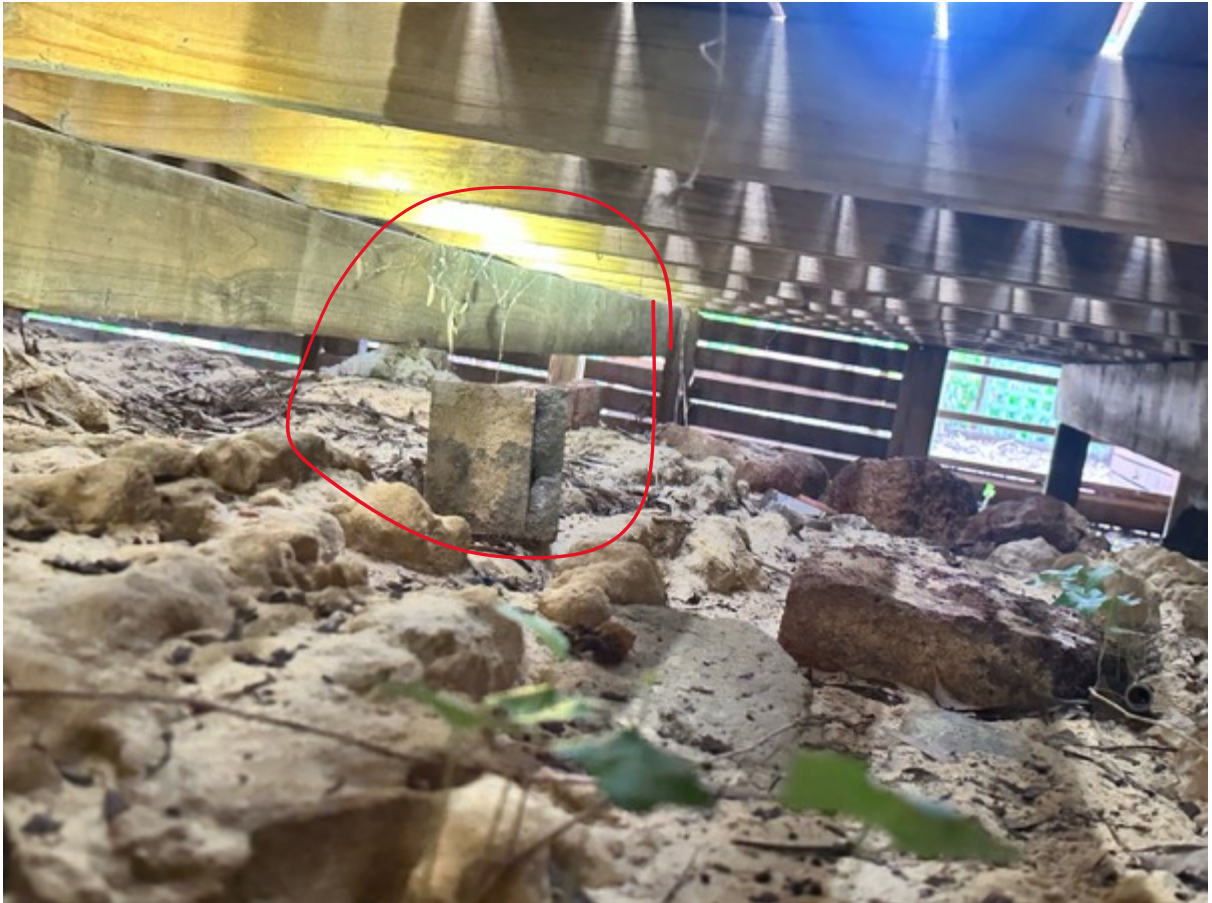
The decking is constructed of a large spanning deep bearer that is currently un-supported (not in contact with the central support post)

**This is a structural defect.**

It requires a new support post or packer to support the bearer to rectify.

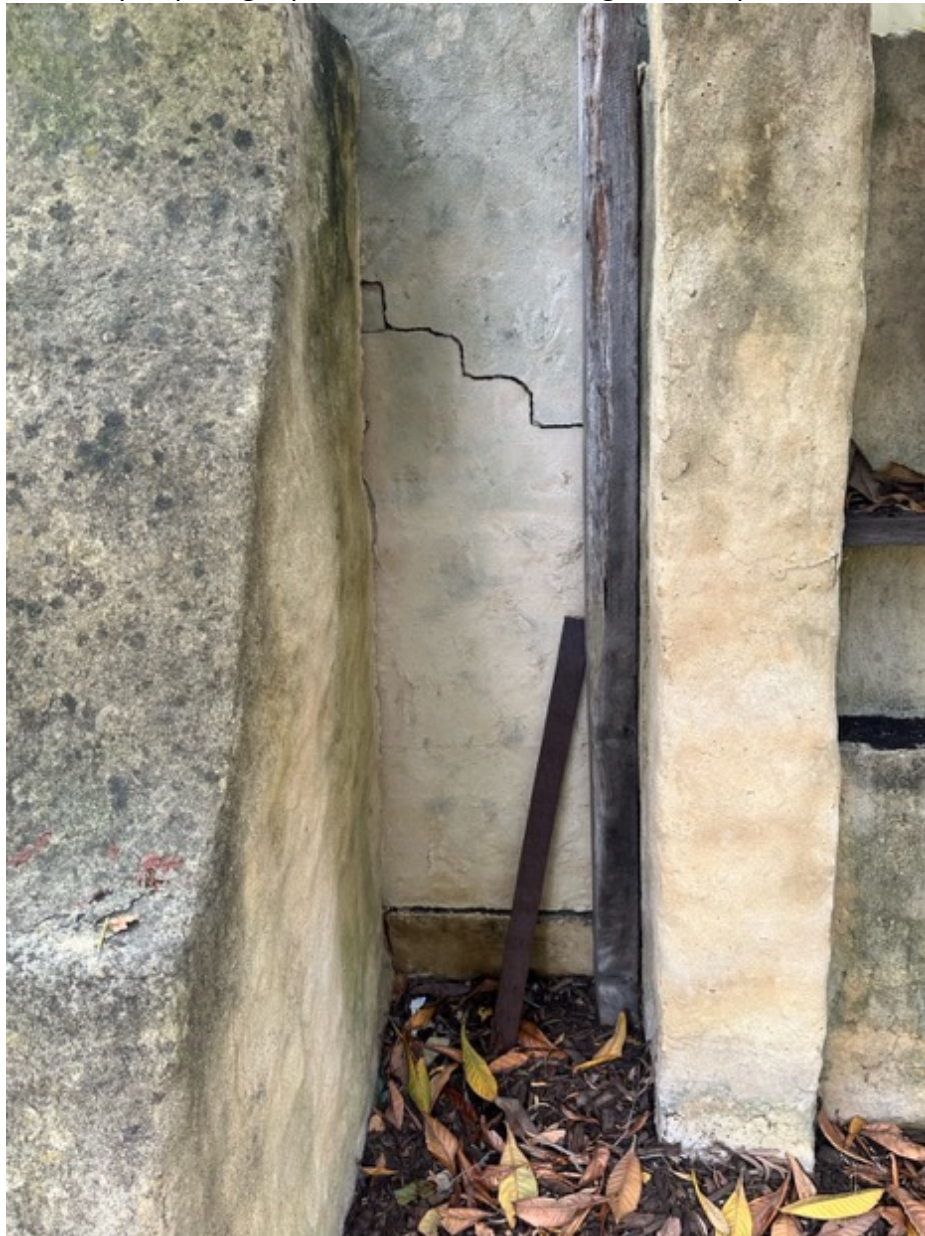
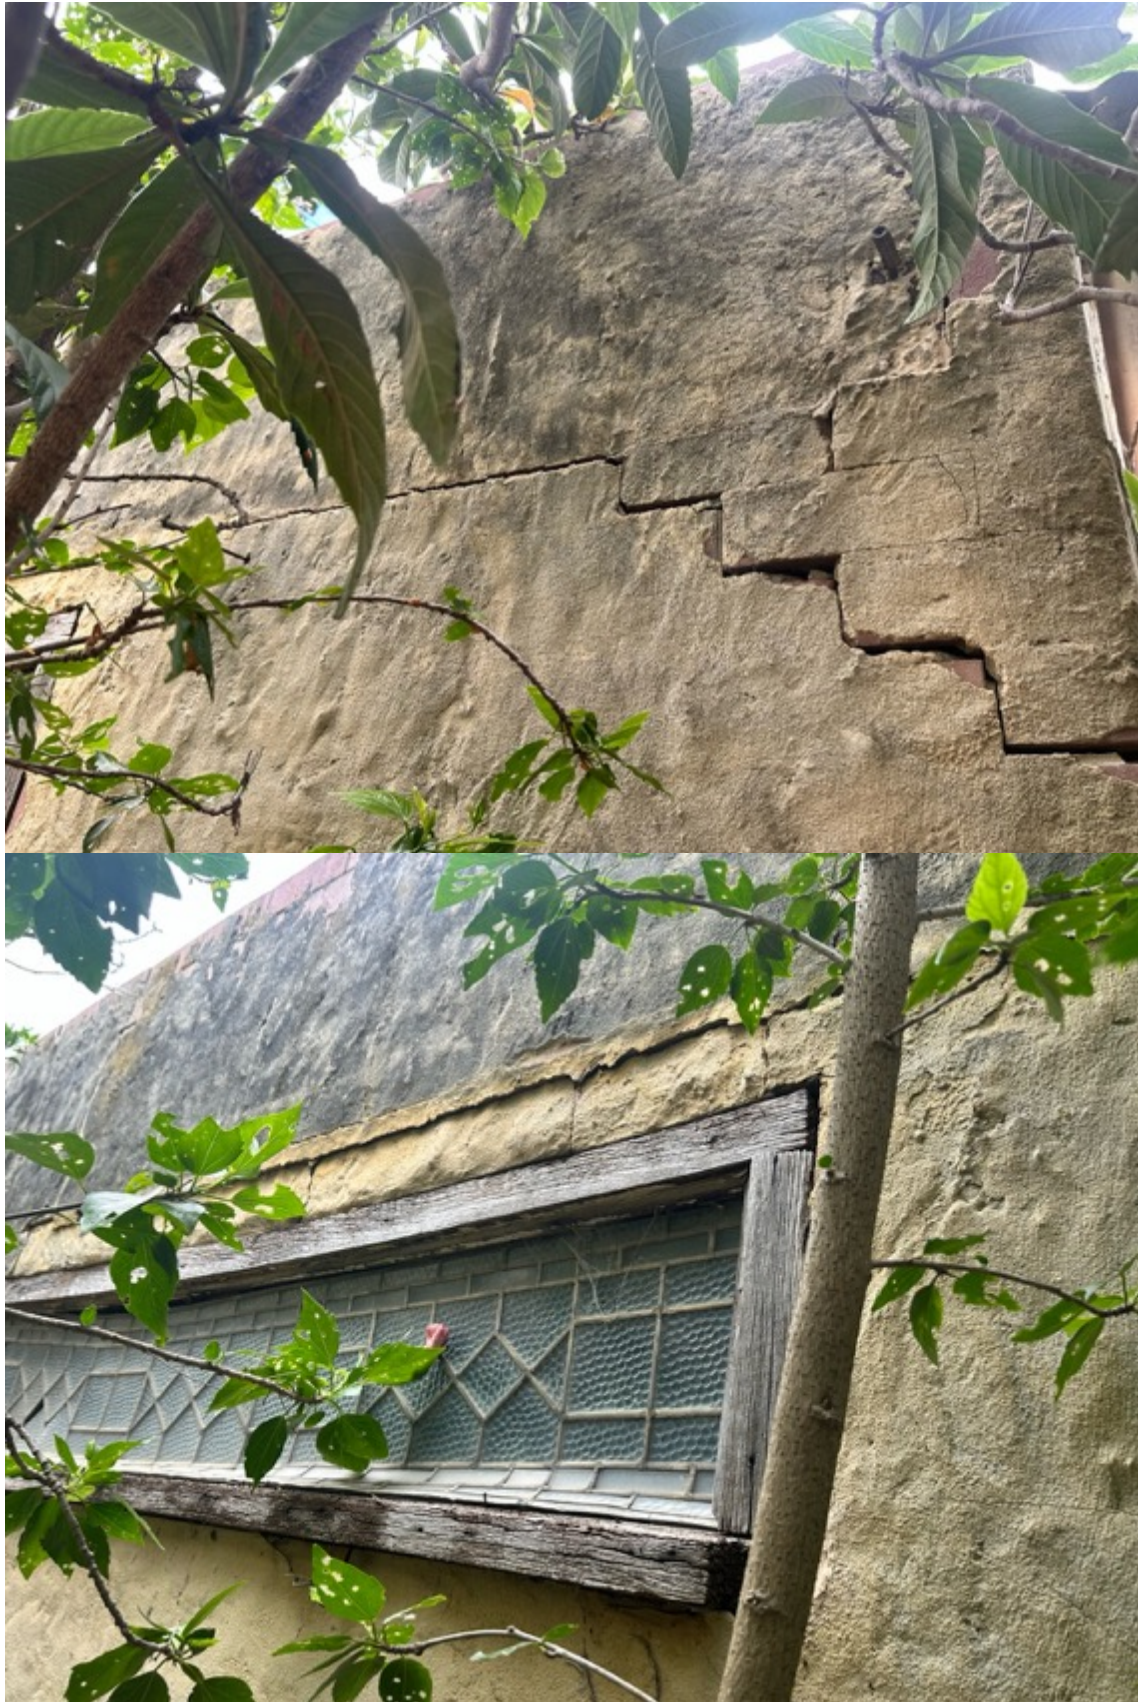
There is cracking of the brickwork to the neighbor's garage which forms part of the west boundary requiring repair, and further cracking to other parts of this west boundary wall

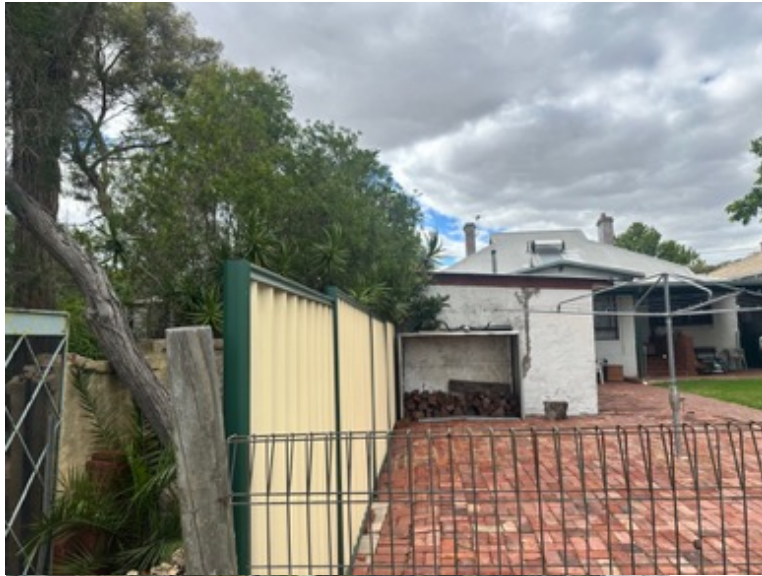
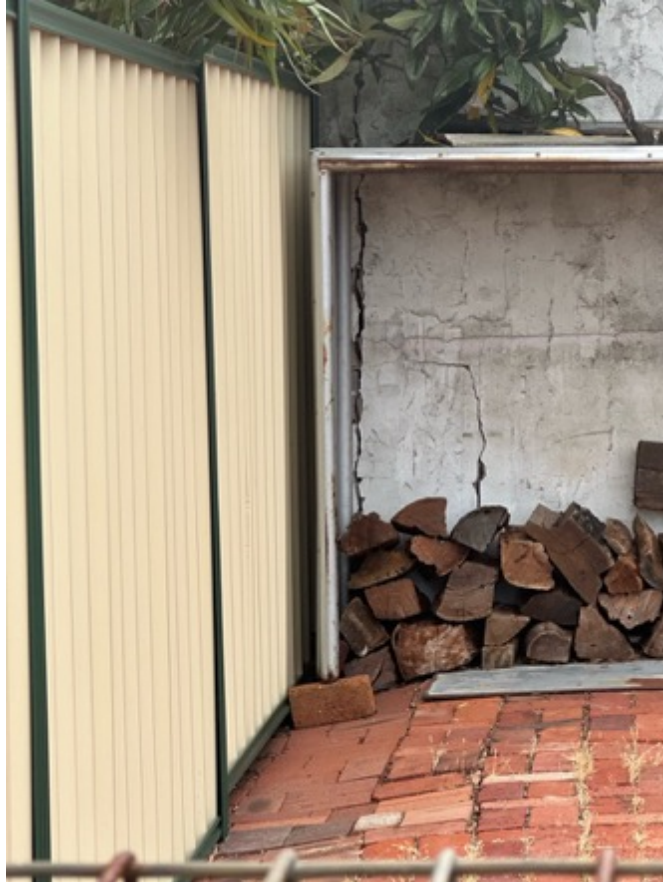
There is a large vertical crack within 200mm of the boundary to the north face of the neighbor's garage wall requiring repair. This wall is poorly attached and may pose a safety risk to the occupants of your property. **This west boundary wall is not structurally sound.** There is cracking of the rear yard masonry walls to the north of the neighbor's garage requiring repair. (Maintenance)

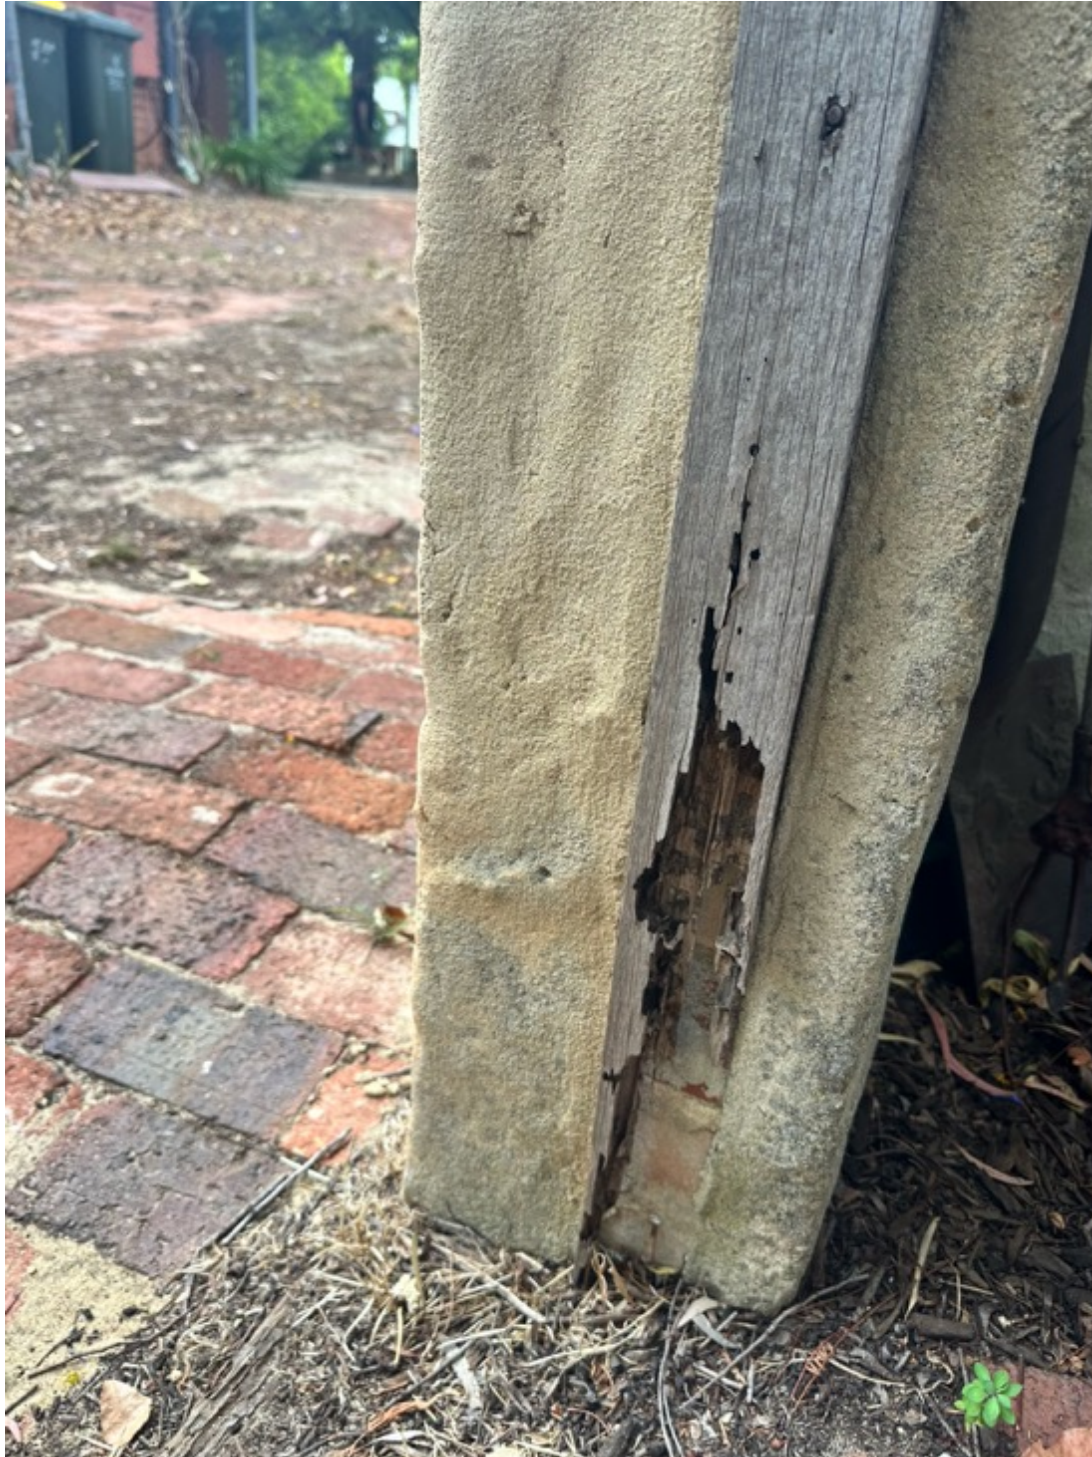
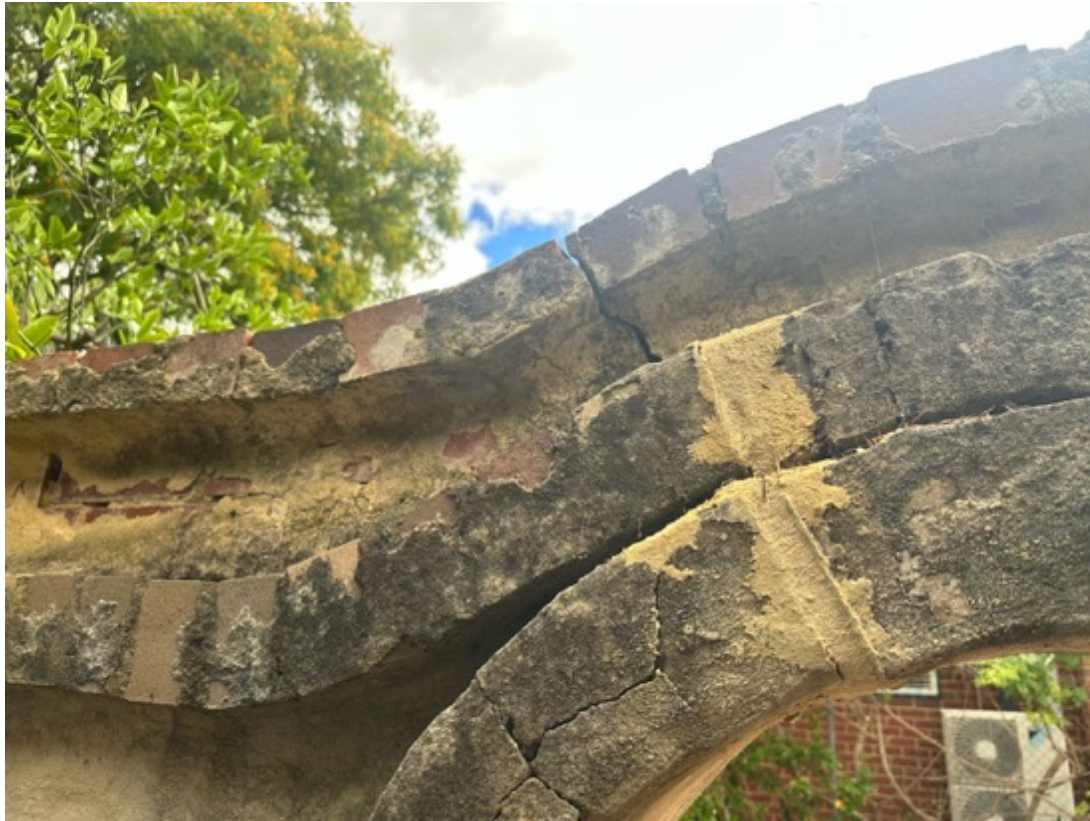
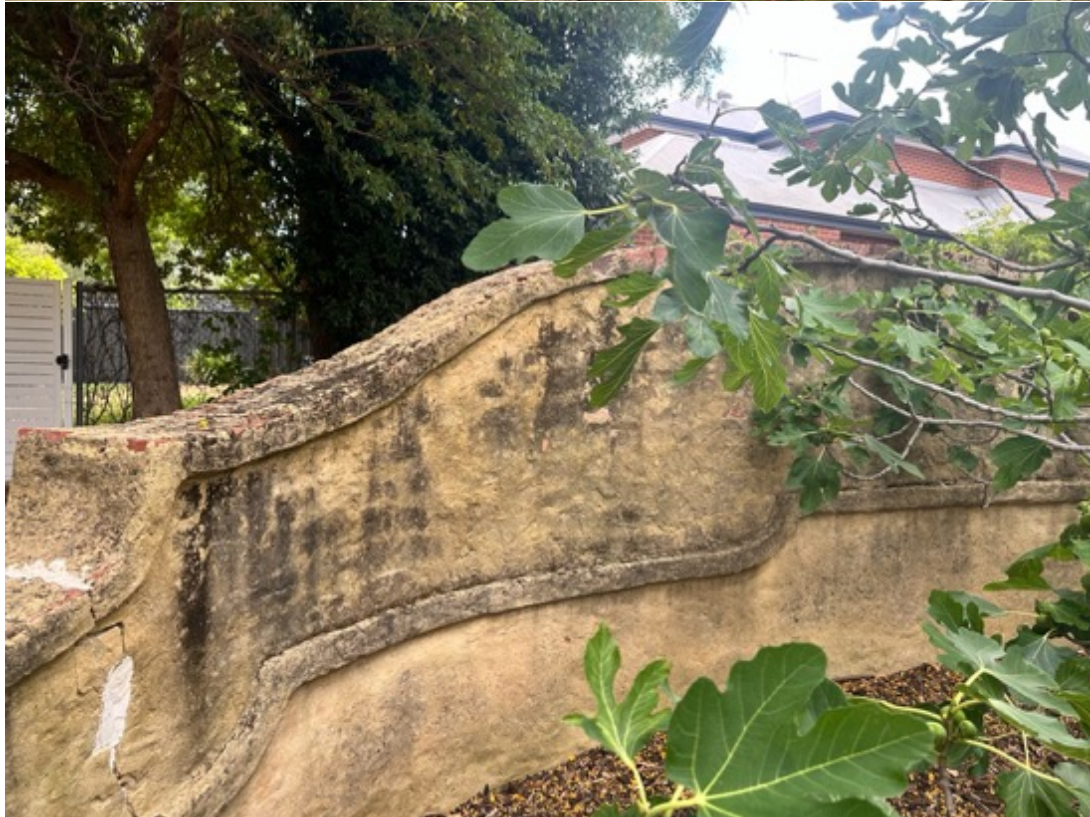
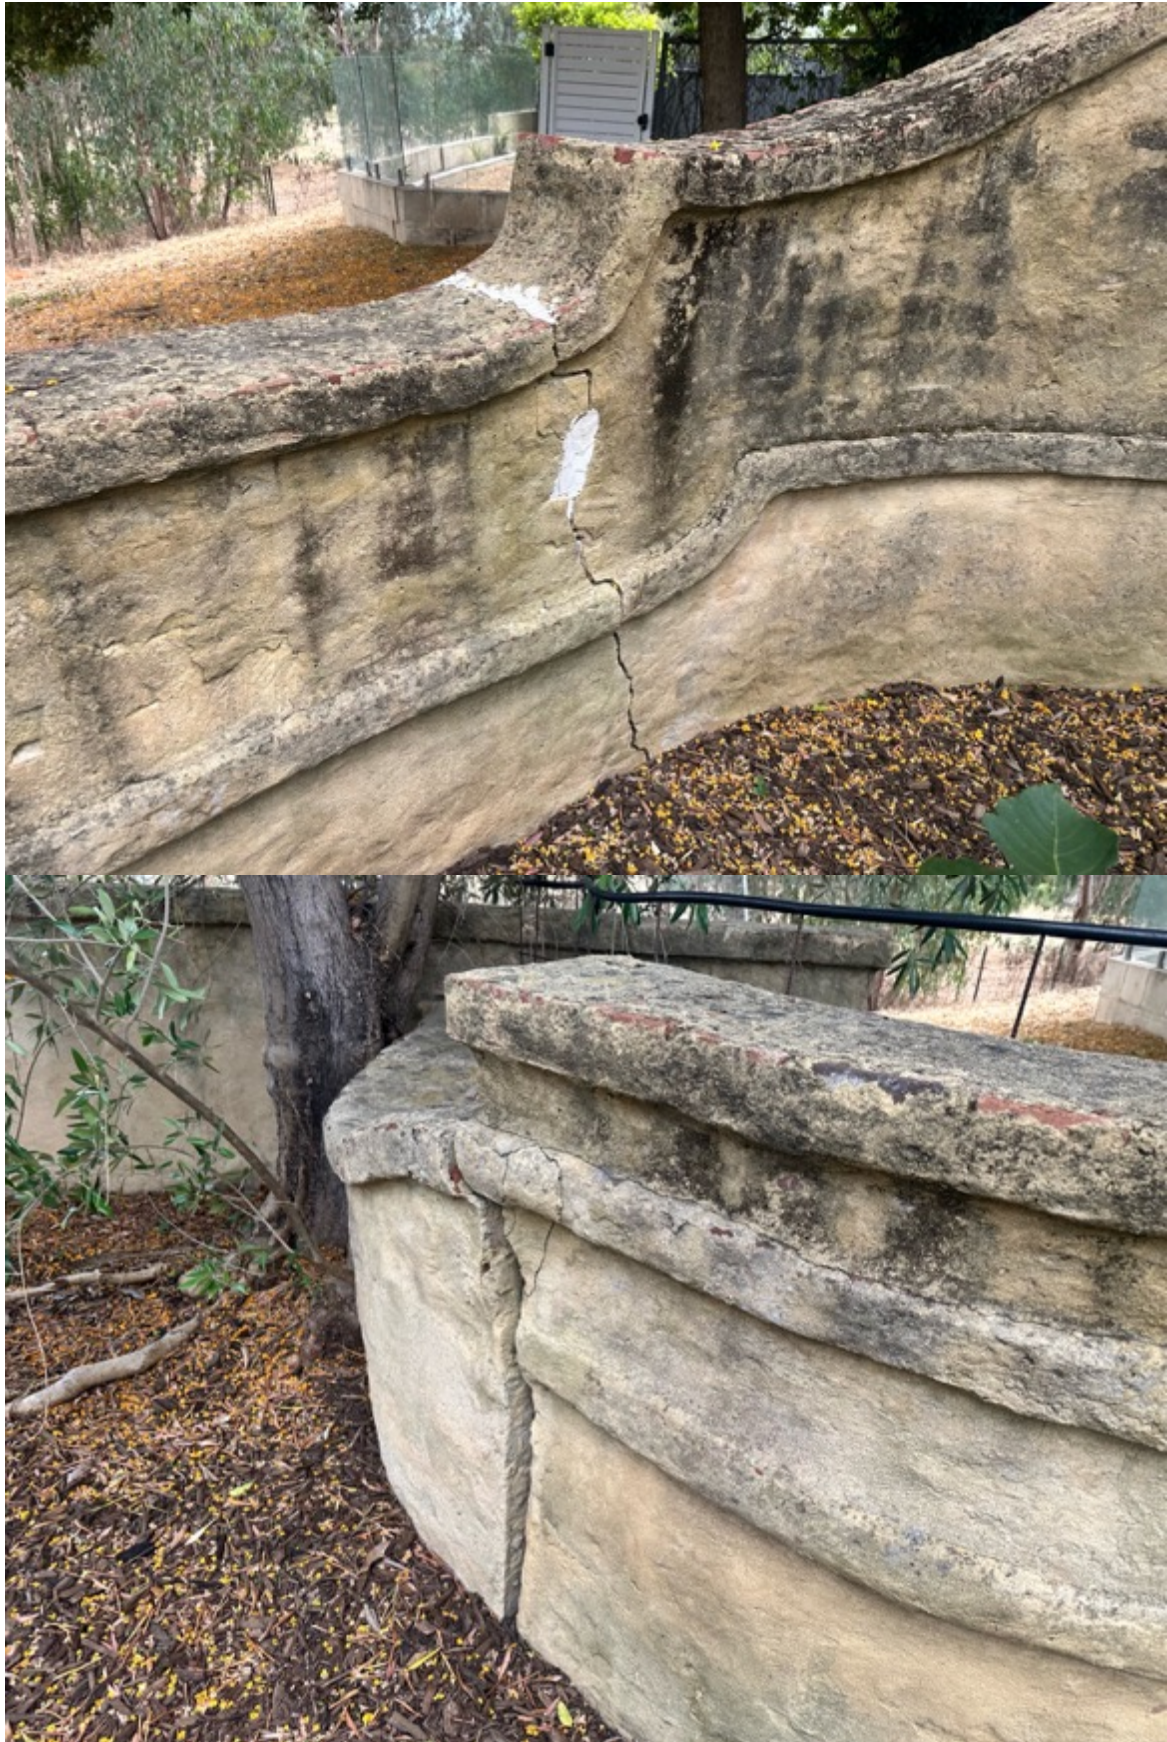
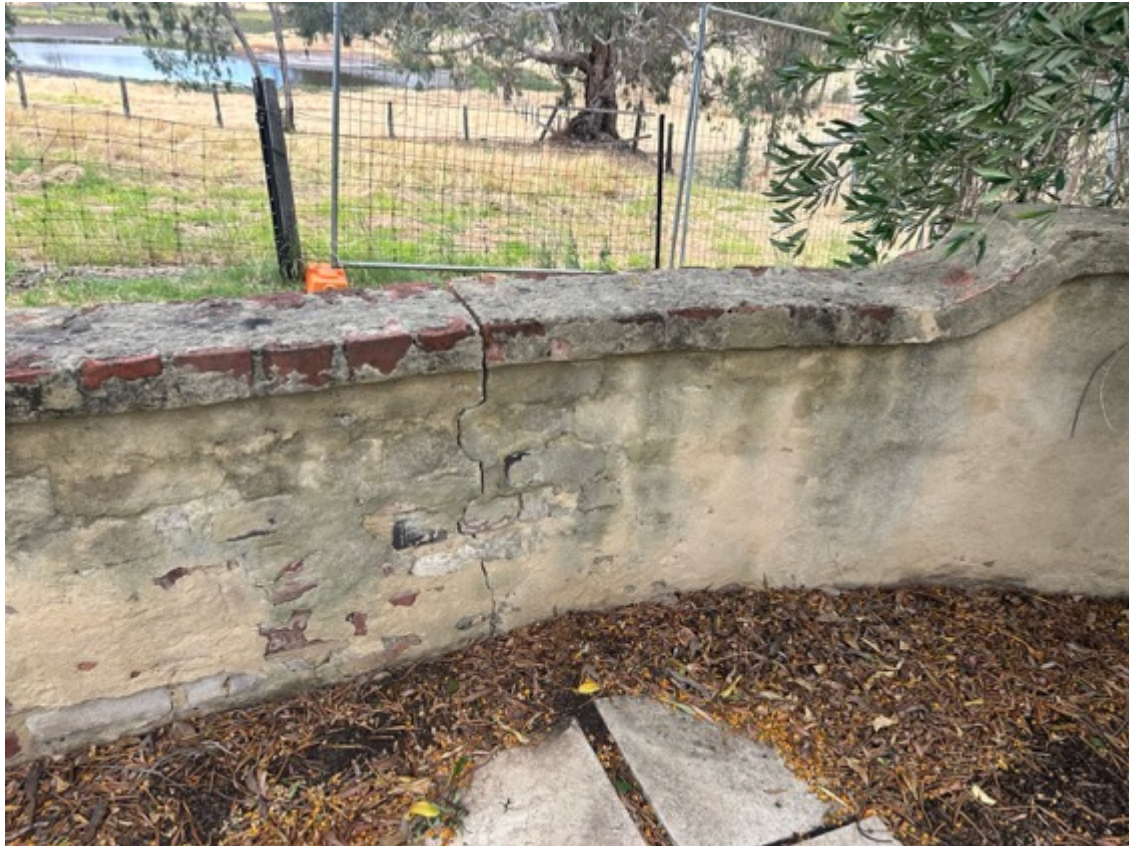
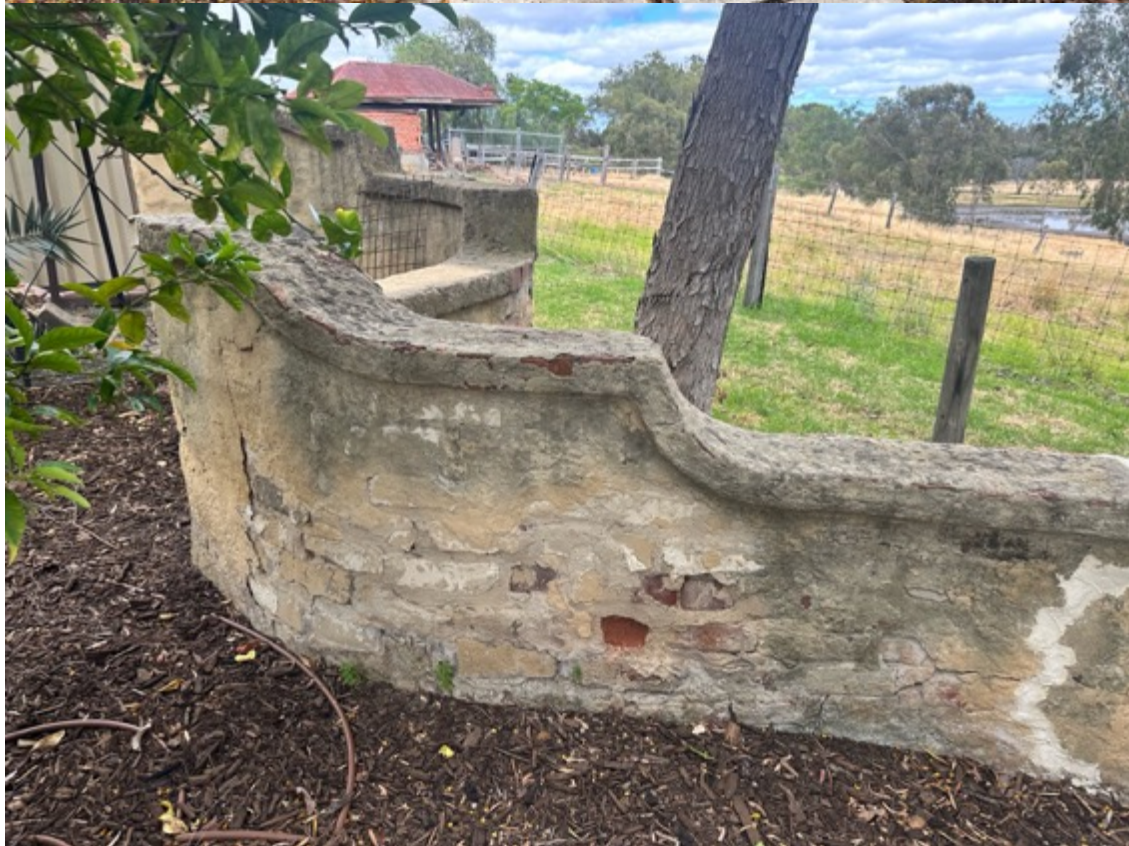
North rear boundary and rear east fencing

Many significant cracks up to 50mm wide requiring repair, refer photographs below:  
(Maintenance)

Termite damage to east gate post requires replacement. (Maintenance)

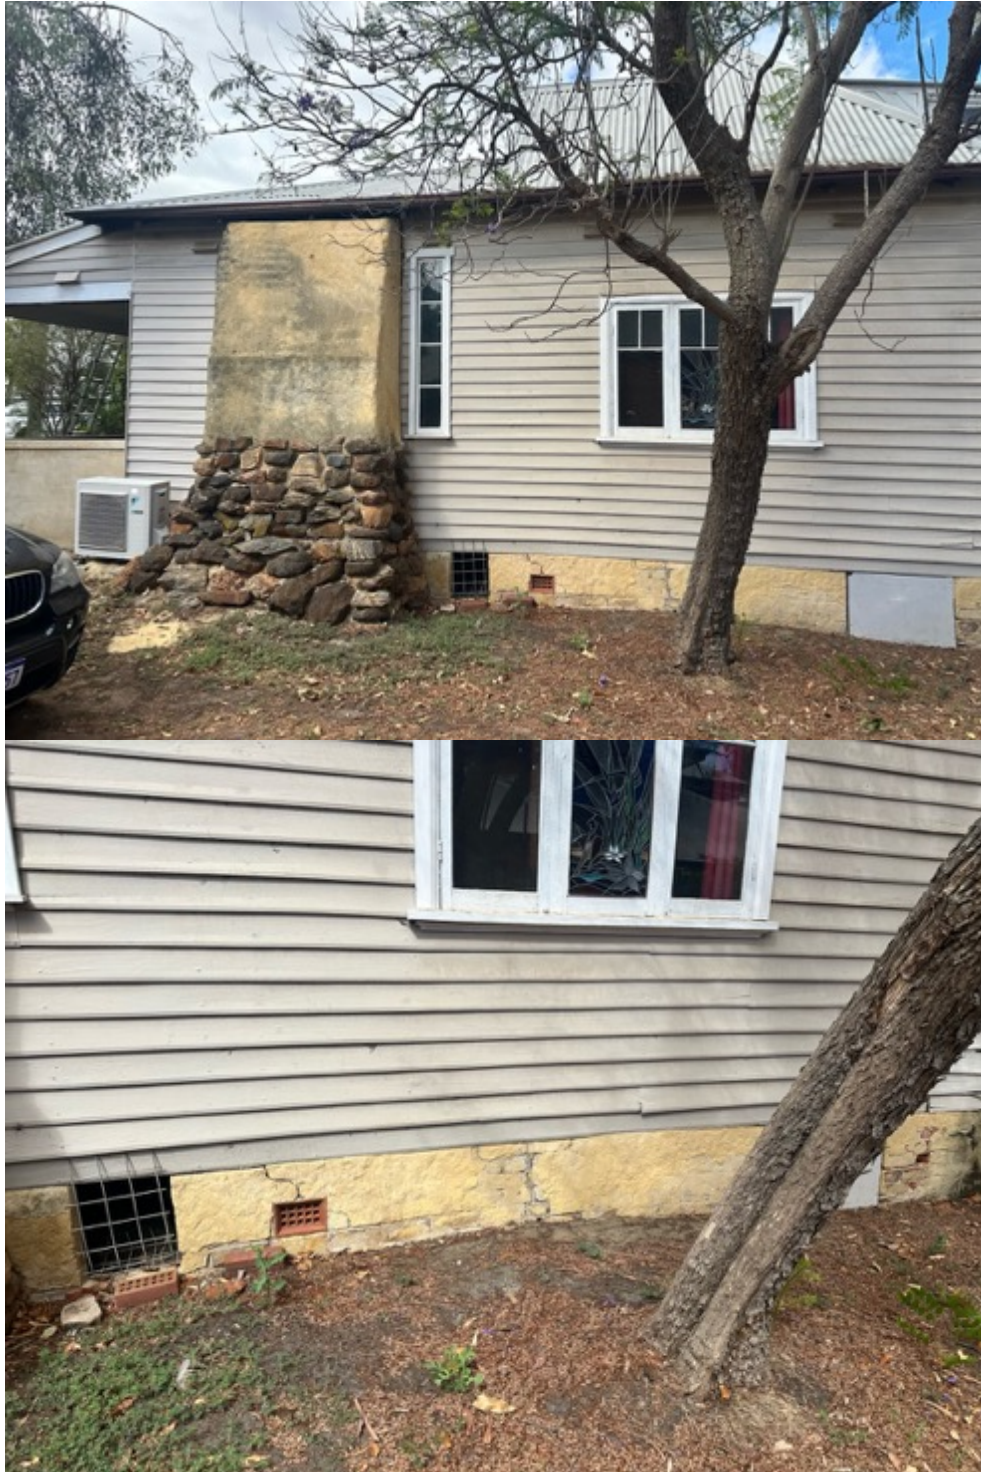
The east side Jacaranda tree has caused cracking of the east side brick footing and chimney wall requiring repair.

It is recommended that this tree be removed before repairing the brick footings. (Maintenance)

It is recommended to demolish / remove the east brick chimney which has separated from the house framing and is unstable. It is considered a currently a safety risk. **Safety risk**

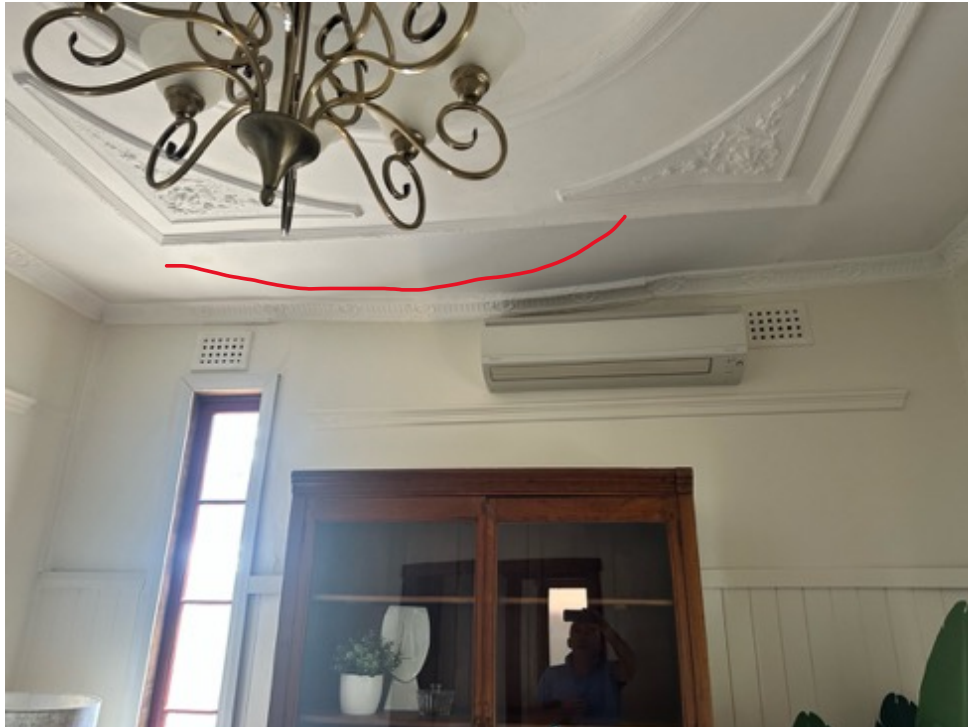
There is a large sag in the front east lounge room ceiling and decorative cornice on the east wall caused by subsidence cracking of the footings from the jacaranda tree, this is the location of the separated chimney.

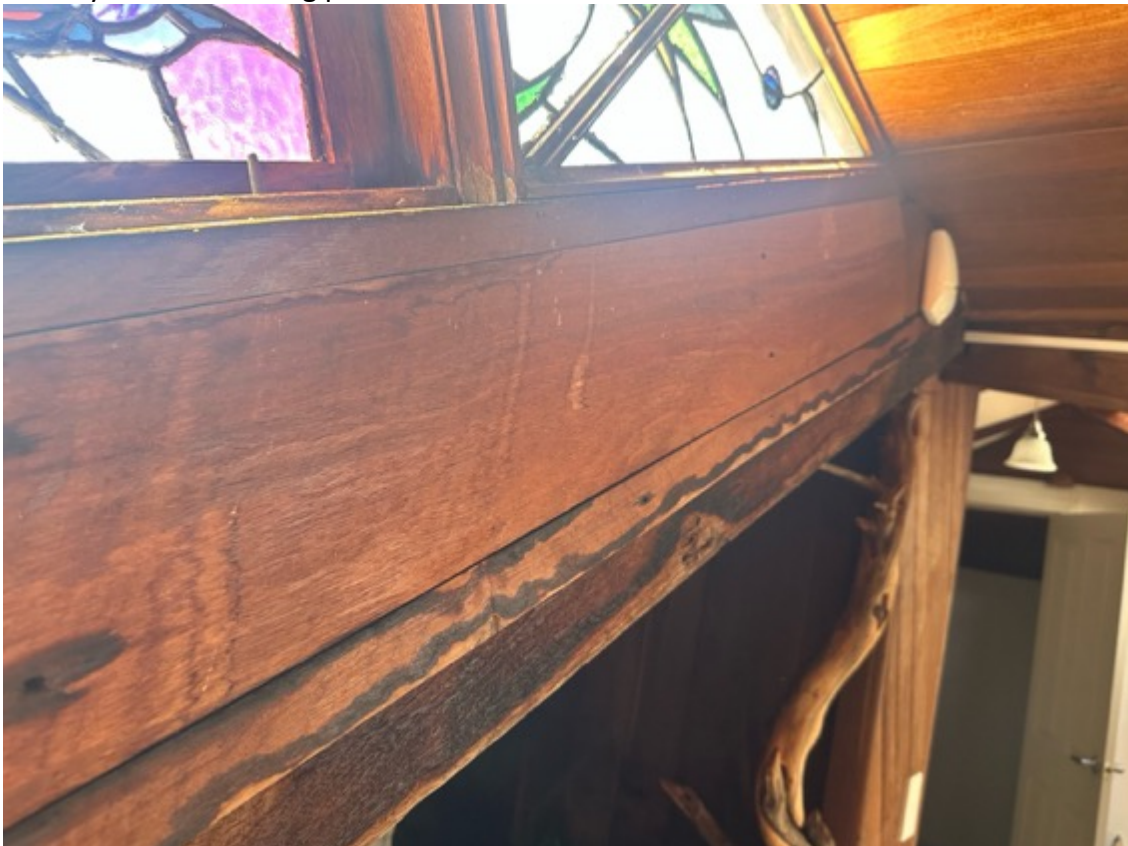
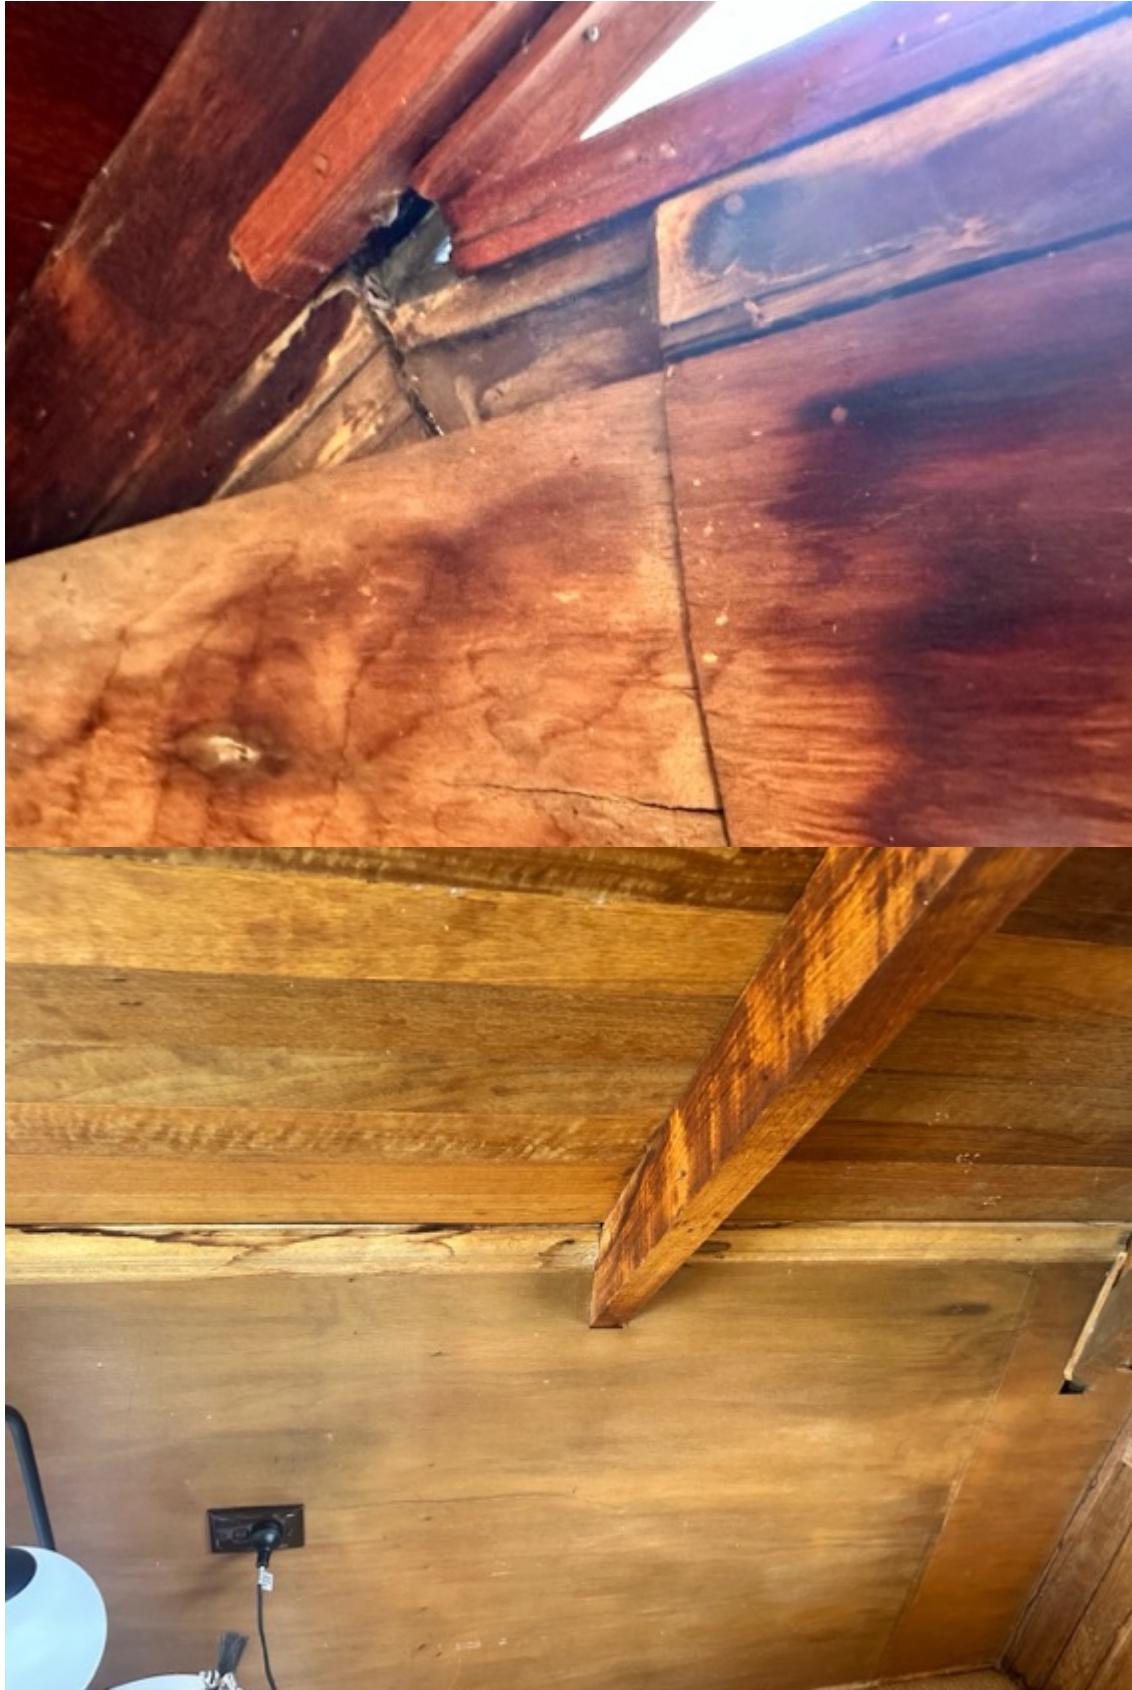
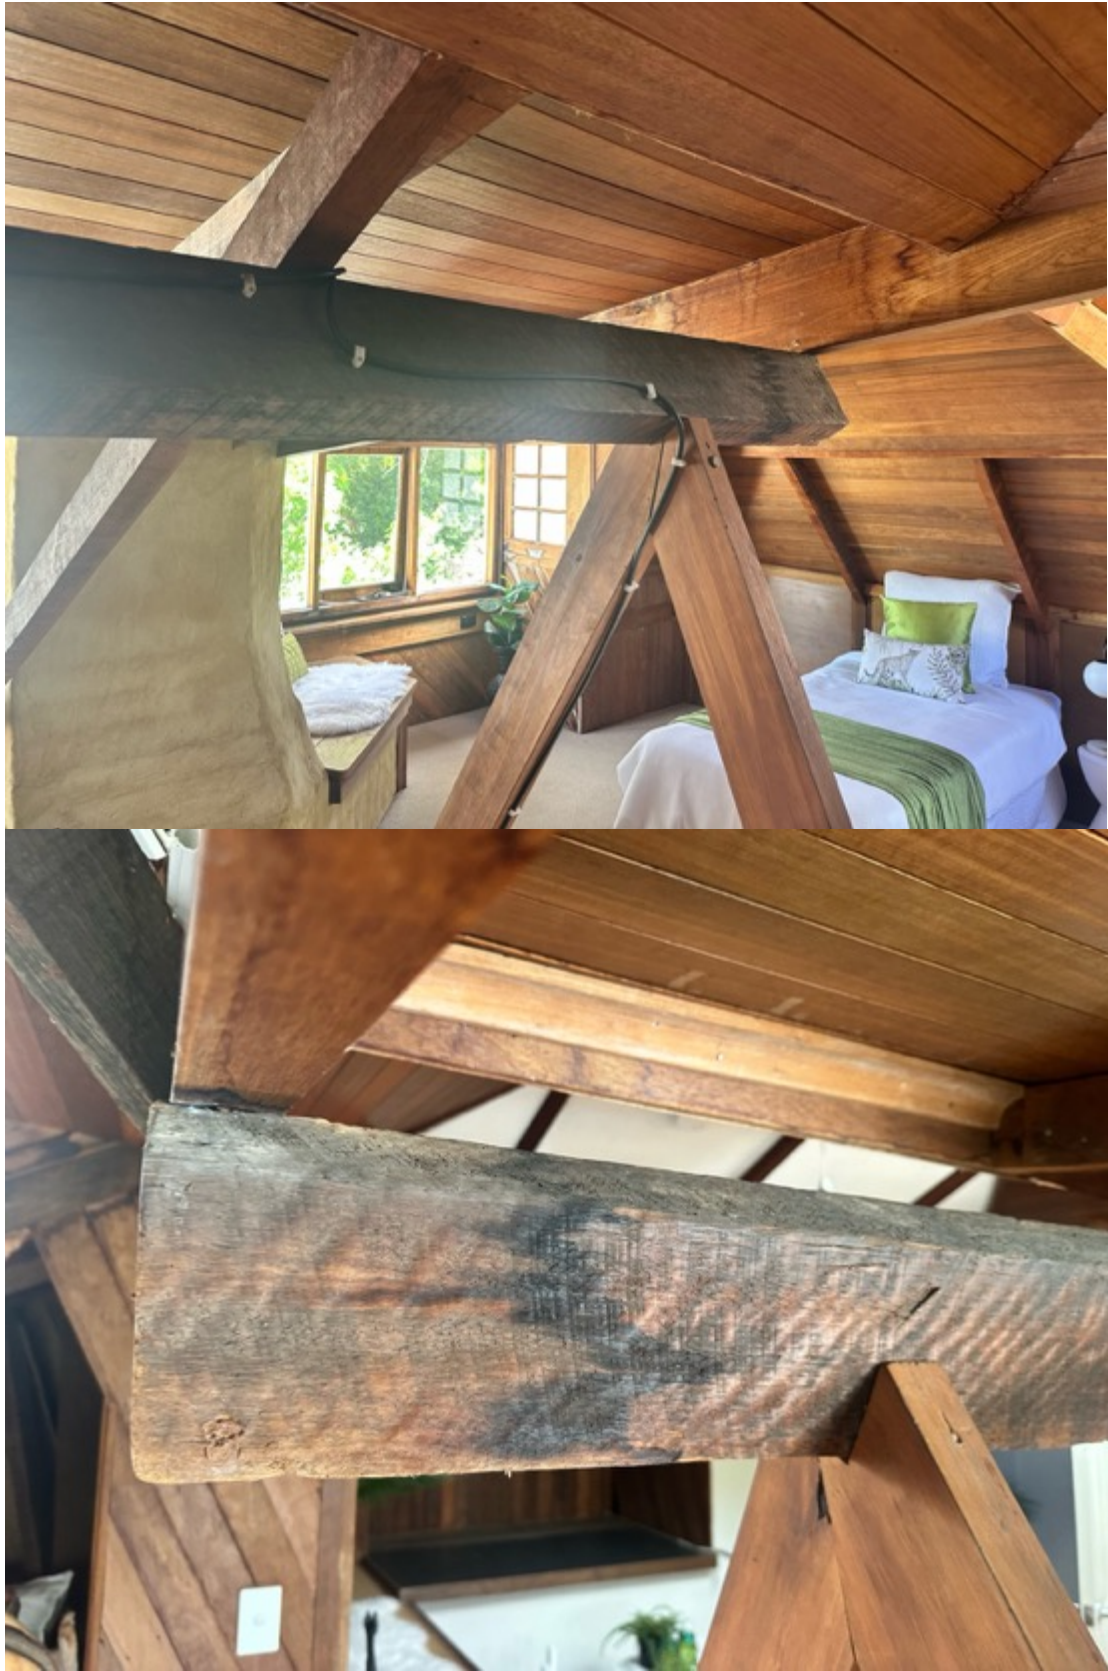
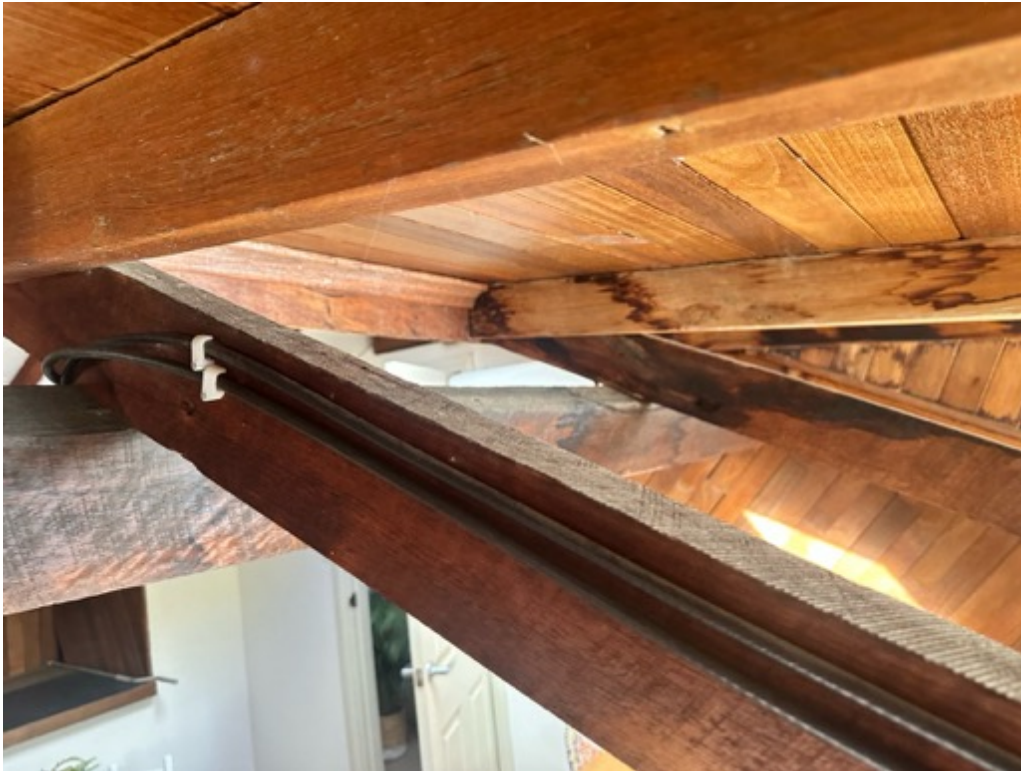
Stairs to the attic room do not conform with BCA requirements for a habitable room. The stair going measures 200mm and not the required 240mm, they are too steep.

The stair riser measures 185 mm and is compliant. The stair handrail is too short at the top and is also non-compliant with the BCA stair requirements

Water staining to attic windows and wall linings consistent with previous water ingress.

Swelling and weathering of window timbers and binding of windows.

window head undersized to both river facing windows appears to be 110 x 40 hardwood

leaking to northeast window and water staining

inadequate head height and under purlin at eye level is not part of the original home and unlikely to have building permit.

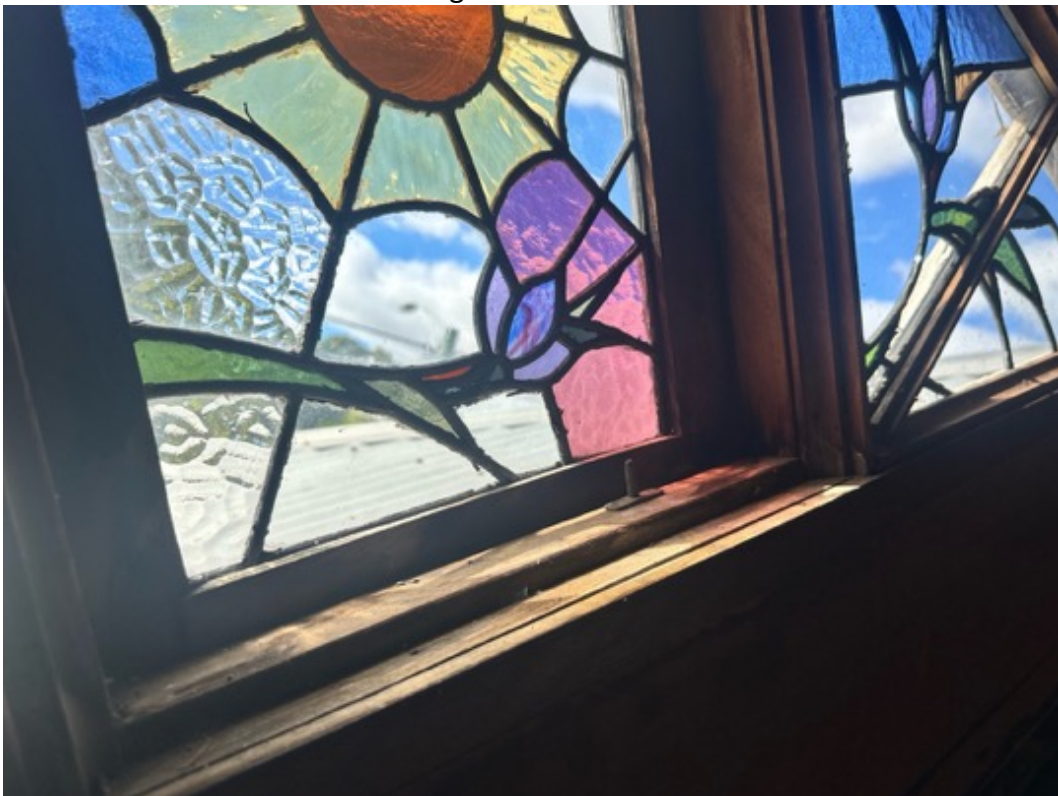
Weathering and leaking to the timber windows and binding , requiring repair refer photos of attic windows above (Maintenance)  
cracked fixed north one and leaking around window

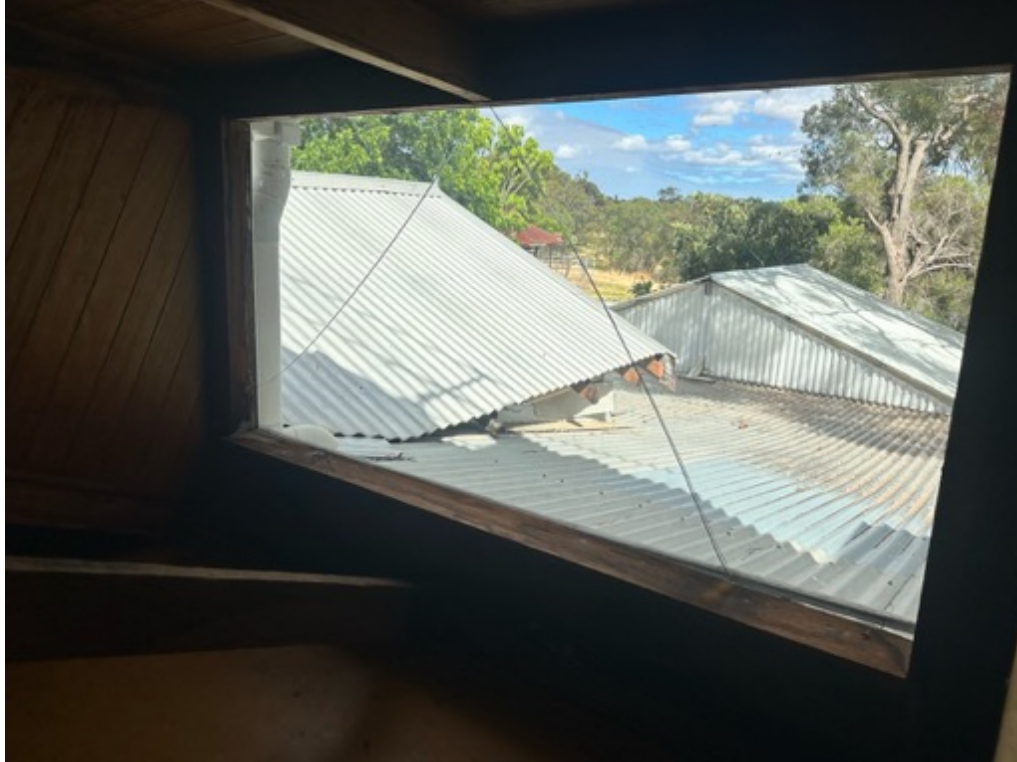
Cracked window in the attic requiring replacement.

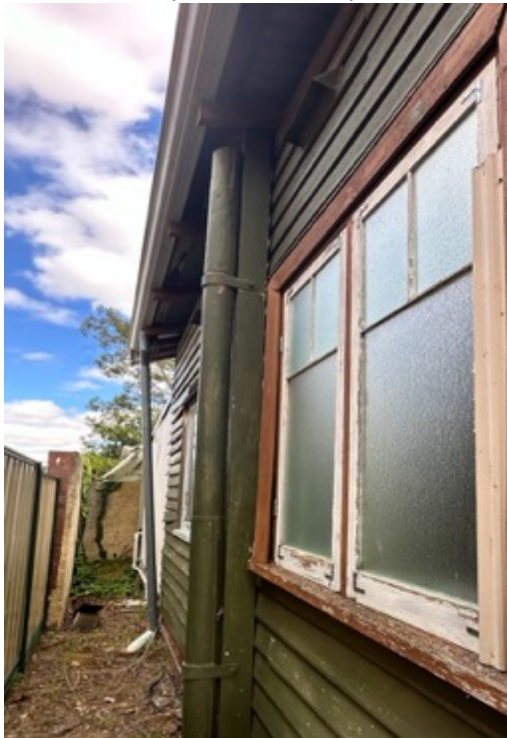
The sewer vent on the west side of the home does not extend through the roof with a cap as is normal. (Maintenance)
