Project: Transport Statement, Clay and Sand Extraction and  
Cartage, Walyunga Road, Walyunga.

Client: Brikmakers Pty Ltd.

Date: 16<sup>th</sup> May 2016

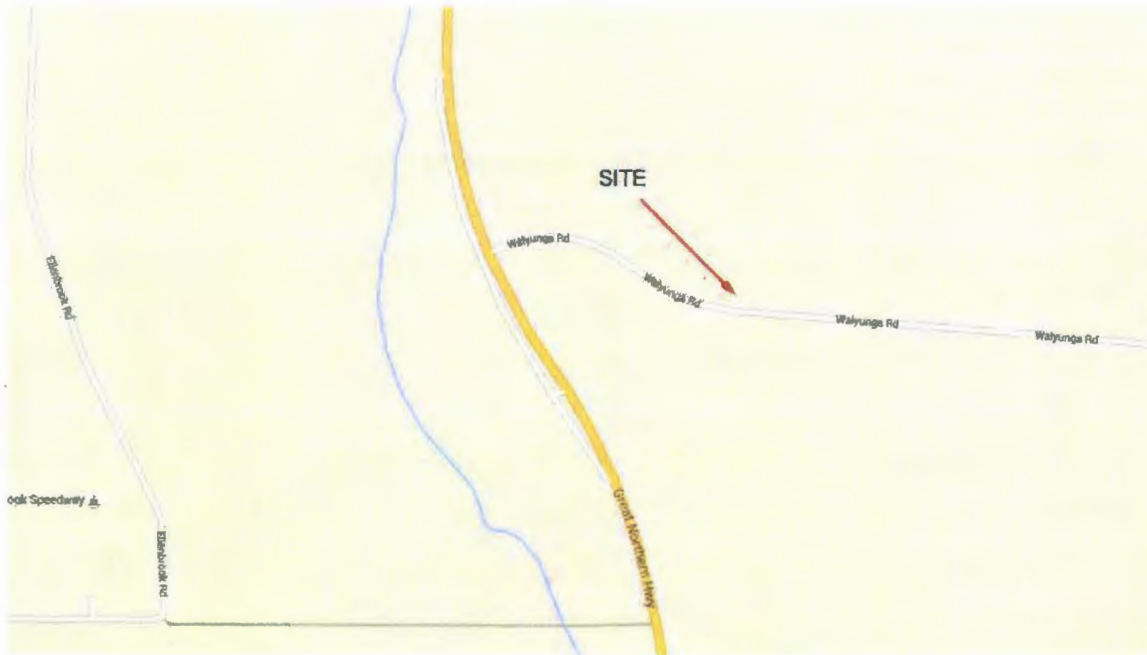
Figure 1 - Site Location

The site is located as shown on Figure 1 and is within the City of Swan.

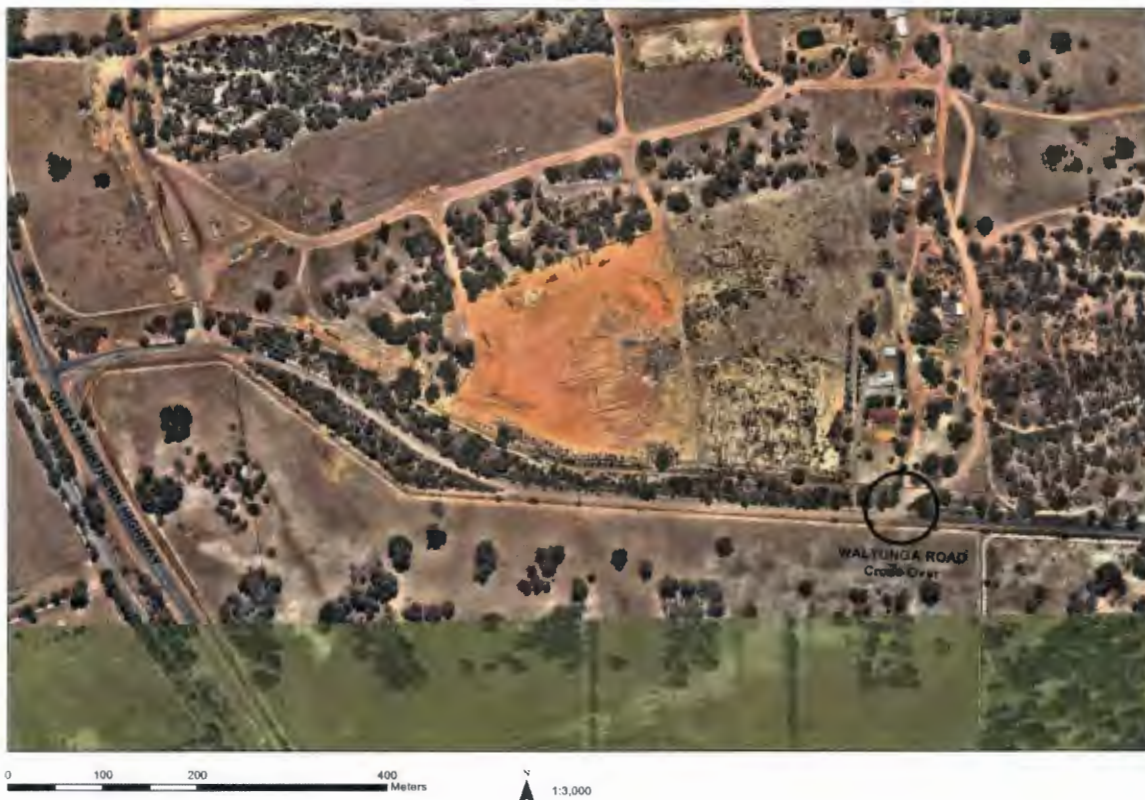
Figure 2 - Aerial Photograph

The existing site together with the surrounding area is shown on the aerial photograph, refer Figure 2.

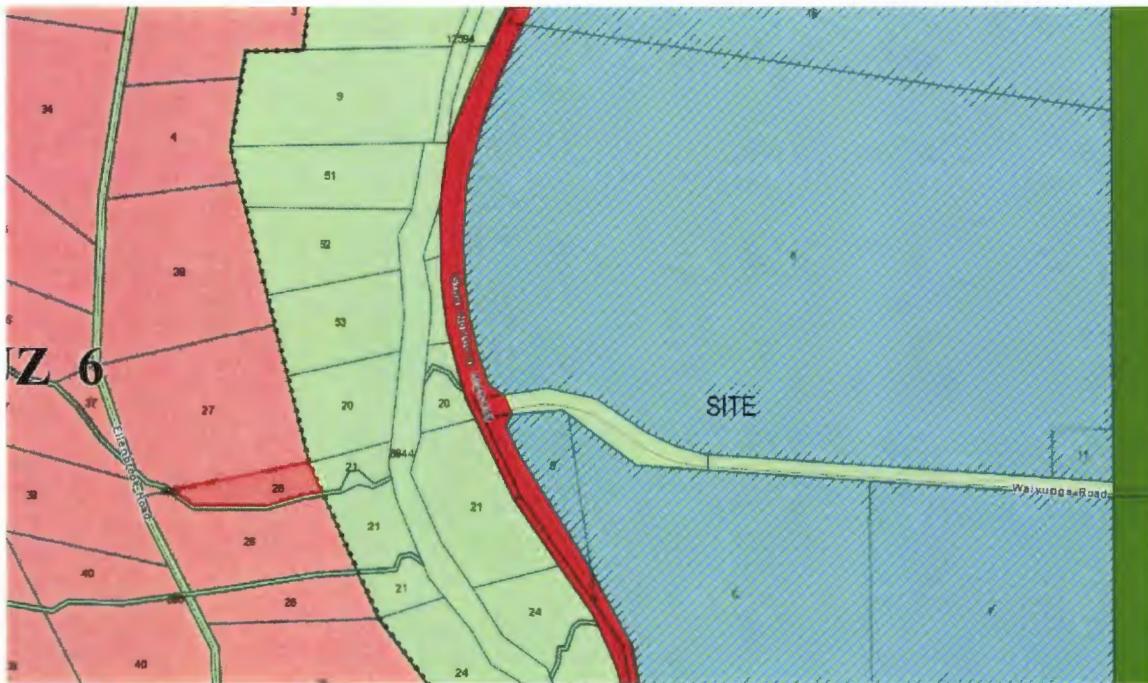
Figure 3 - Extract of City of Swan Town Planning Scheme

The site is zoned under the City of Swan Local Planning Scheme 17 (LPS No.17) for "Regional Reserve, Primary Regional Road". The site is currently being used for clay and sand extraction and it is proposed to develop the site further for ongoing extractive industry purposes.

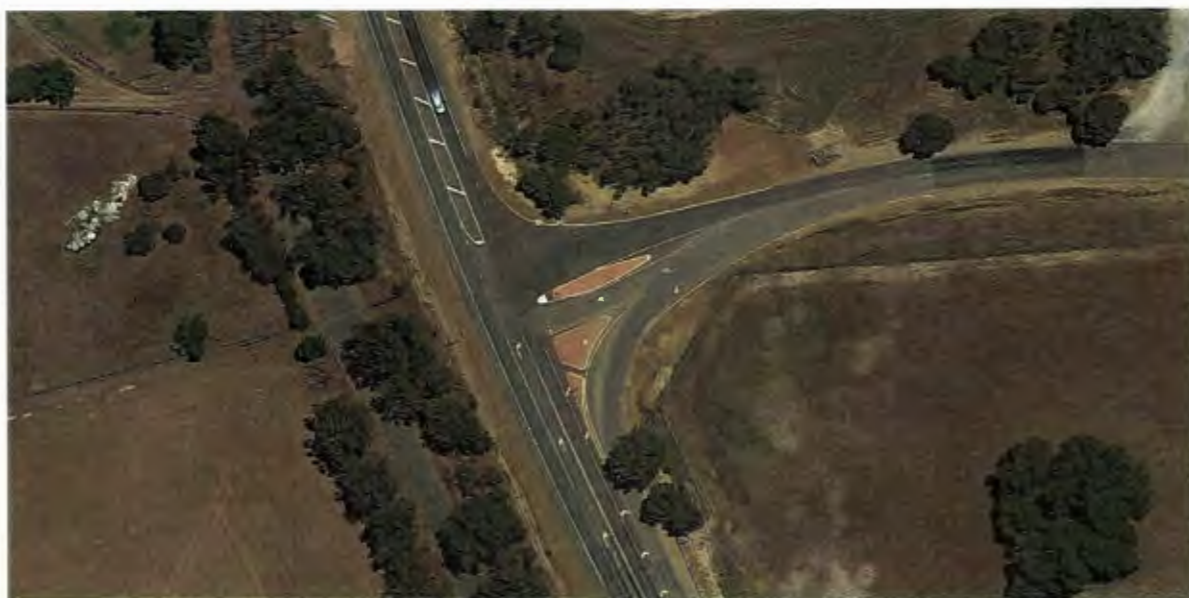
Figure 5 - Intersection of Walyunga Road and GNH

The intersection of Walyunga Road with GNH is configured as a standard "T" junction with a northbound right turn lane and a southbound left turn acceleration lane.

The intersection layout is shown on Figure 5.

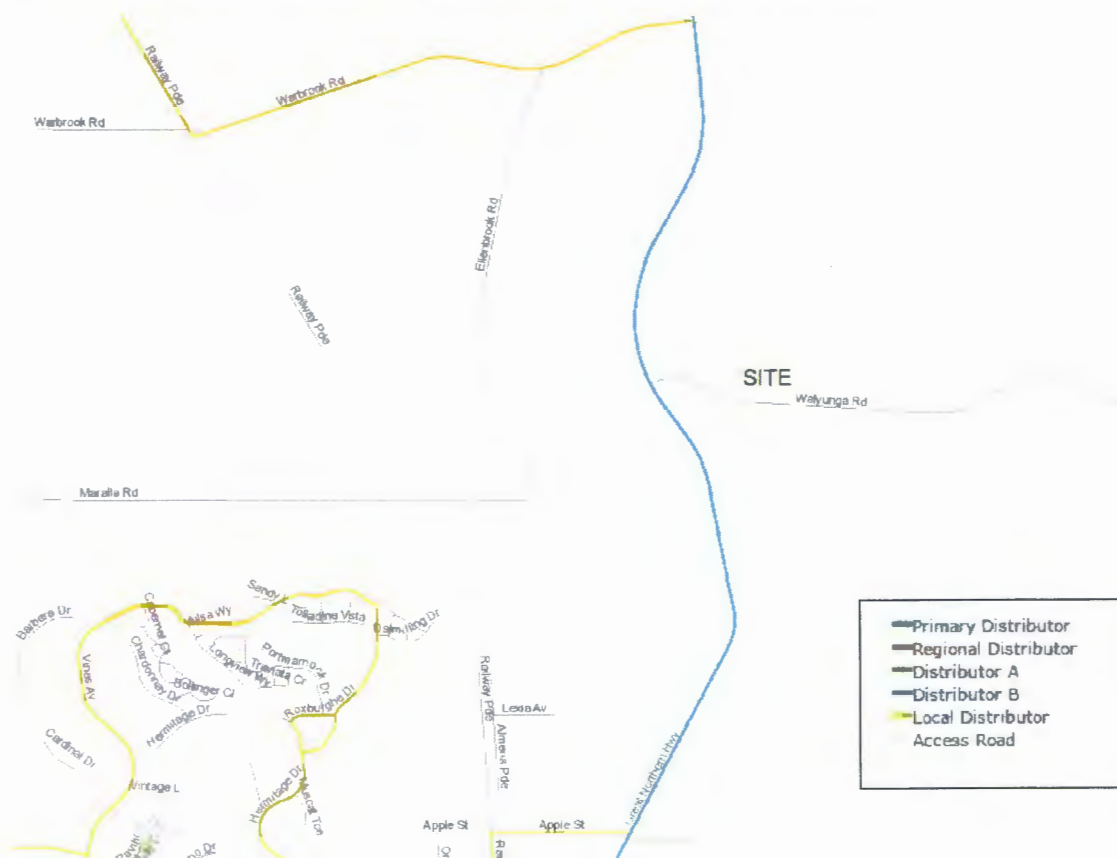
Figure 6 shows the Road Hierarchy for the road network adjacent to and around the site.

Primary Distributors provide for major regional and inter-regional traffic movement and carry large volumes of generally fast moving traffic. Some are strategic freight routes and all are National or State roads. They are managed by Main Roads WA. Indicative traffic volumes are above 15,000 vehicles per day with operating speeds typically between 60 and 110 km/h.

Access Roads provide access to abutting properties with amenity, safety and aesthetic aspects having priority over the vehicle movement role. These roads are bicycle and pedestrian friendly. They are managed by local government. Maximum desirable volume is in the order of 3,000 vehicles per day with typical operating speeds of 40 to 50 km/h.

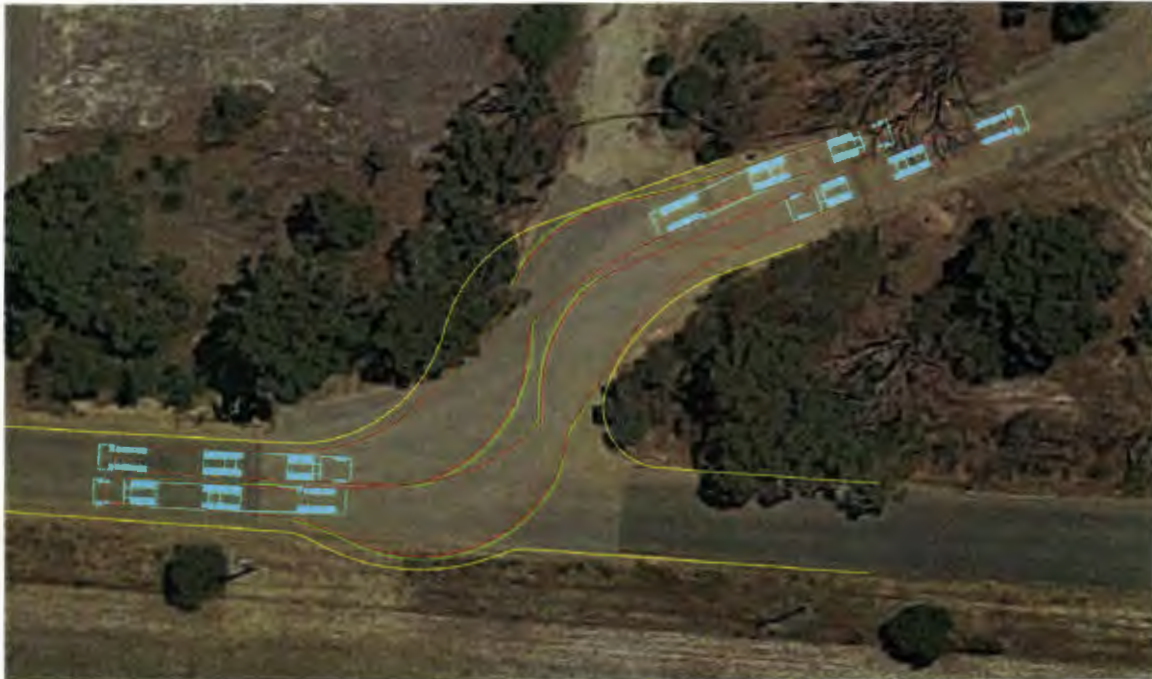
Figure 11 – Recommended Crossover Geometry

Access to and from the site will be via a crossover on Walyunga Road located approximately 900 metres east of Great Northern Highway. The existing crossover intersects at an acute angle as shown on Figure 11 and should be realigned generally as shown. As the cartage of clay has the potential to deposit detritus from truck chassis and wheels on the roadway and obscure pavement markings, all trucks will be brushed down prior to leaving the site to minimise the risk of loose material being deposited onto the roadway.

Similarly, sight distance requirements from the Walyunga Road crossover would require in the order of 240 metres ASD and 340 metres SISD. Fringing vegetation currently impacts on the available sight distance and sight triangles should be cleared as part of the recommended crossover upgrading works.

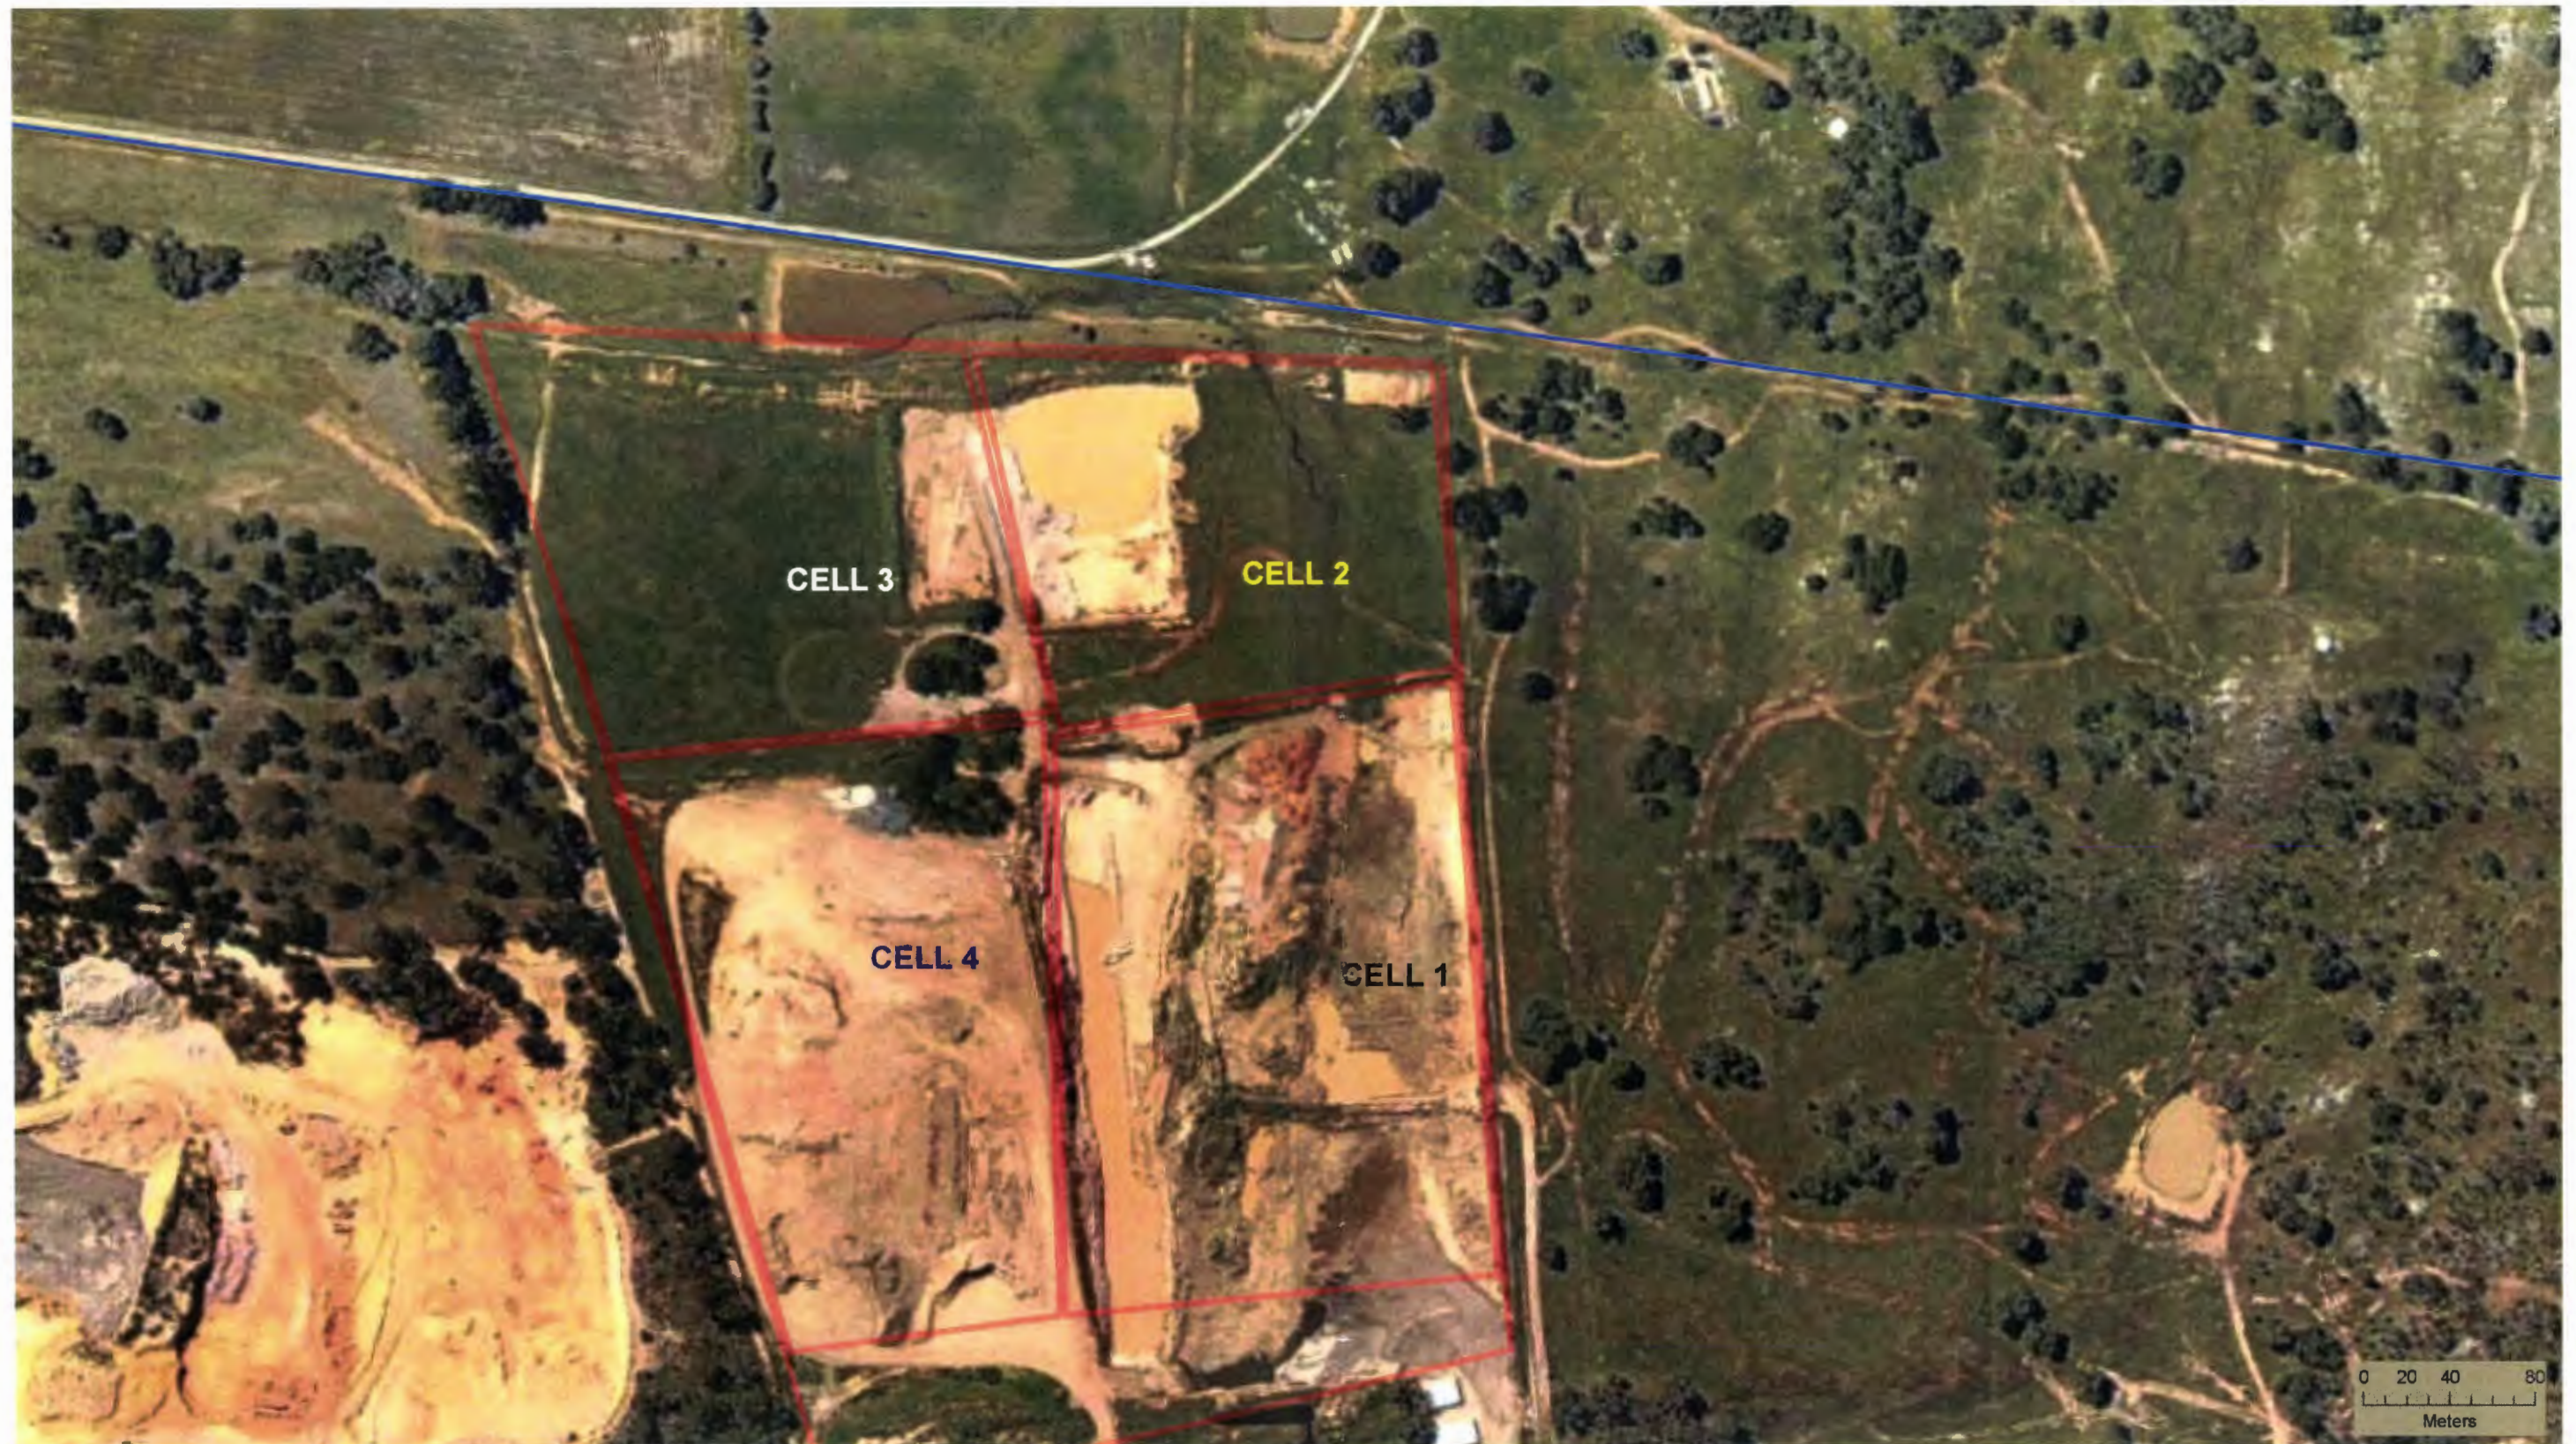
**FIGURE : Proposed Extraction Site Layout**

Project development proposals include the extraction of clay as indicated on Figure 2. MBS Environmental Pty Ltd has been commissioned by BGC to undertake testing for Potential Acid Forming (PAF) materials within their proposed extraction area on Lot 5 Walyunga Road.

Fieldwork was conducted on 11 September 2007 and included the drilling of a total of six holes using an air core drill rig. This was incapable of penetrating into fresh rock, so only the weathered overburden was tested. The positions of these holes are shown in Figure 2. Due to weather conditions and conditions of the land surface at the time of the survey no further holes could be tested.
