# **Extractive Industries Licence Application Dust Management Plan**

LOT 5, ON PLAN 7892 WALYUNGA ROAD

CITY OF SWAN

**Client:** BRIKMAKERS  
**Project:** Lot 5 Walyunga Road  
**Title:** EIL Application: Dust Management Plan  
**Reference:** **004\_4\_EIL\_EXTENSION\_DUST**  
**Status:** Draft

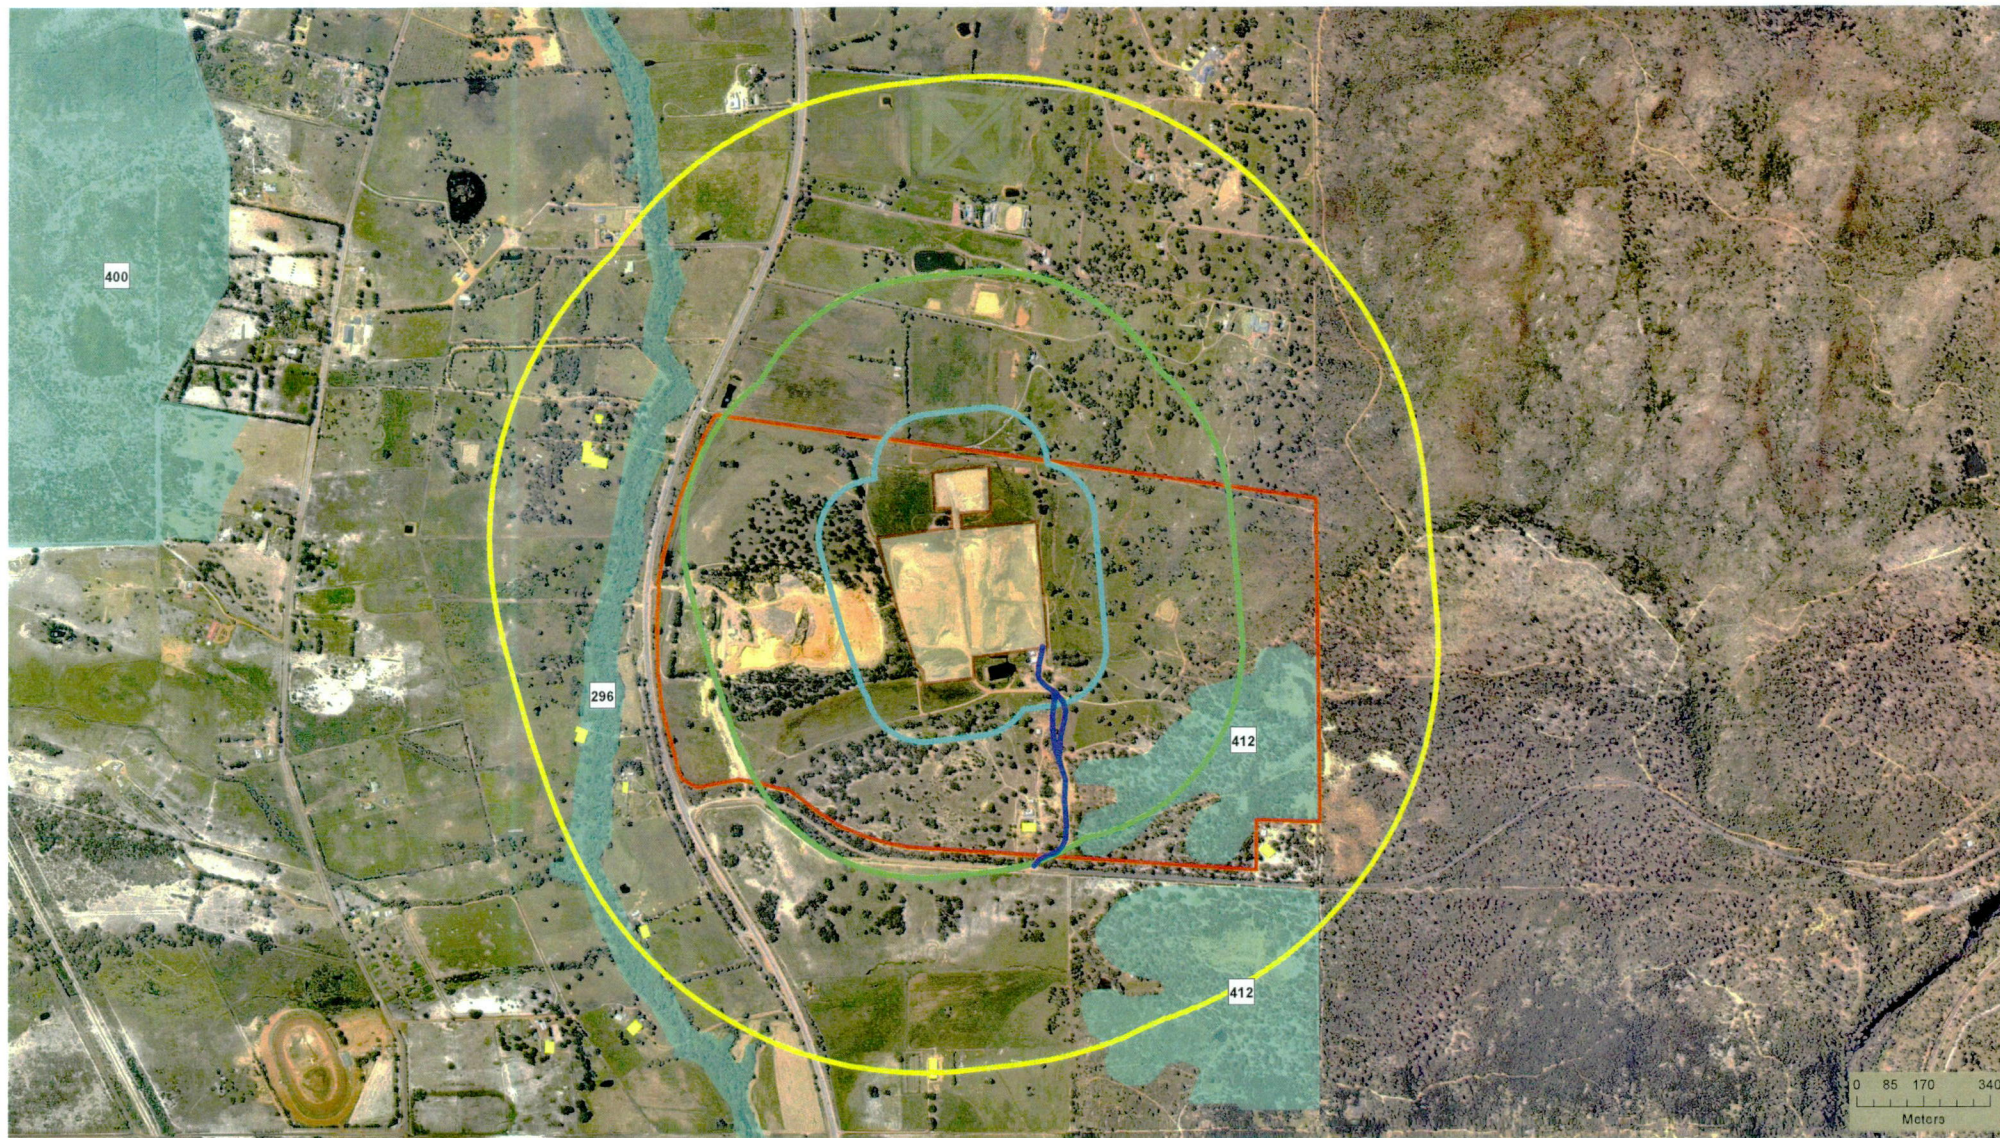
## **Figure 1 – Site Location and buffer**

FIGURE : Site Location and Buffer zone

There are six residential dwellings located within 1km of the proposed activities. The closest dwelling is located approximately 450m from the Site however this property is owned by the land owner.

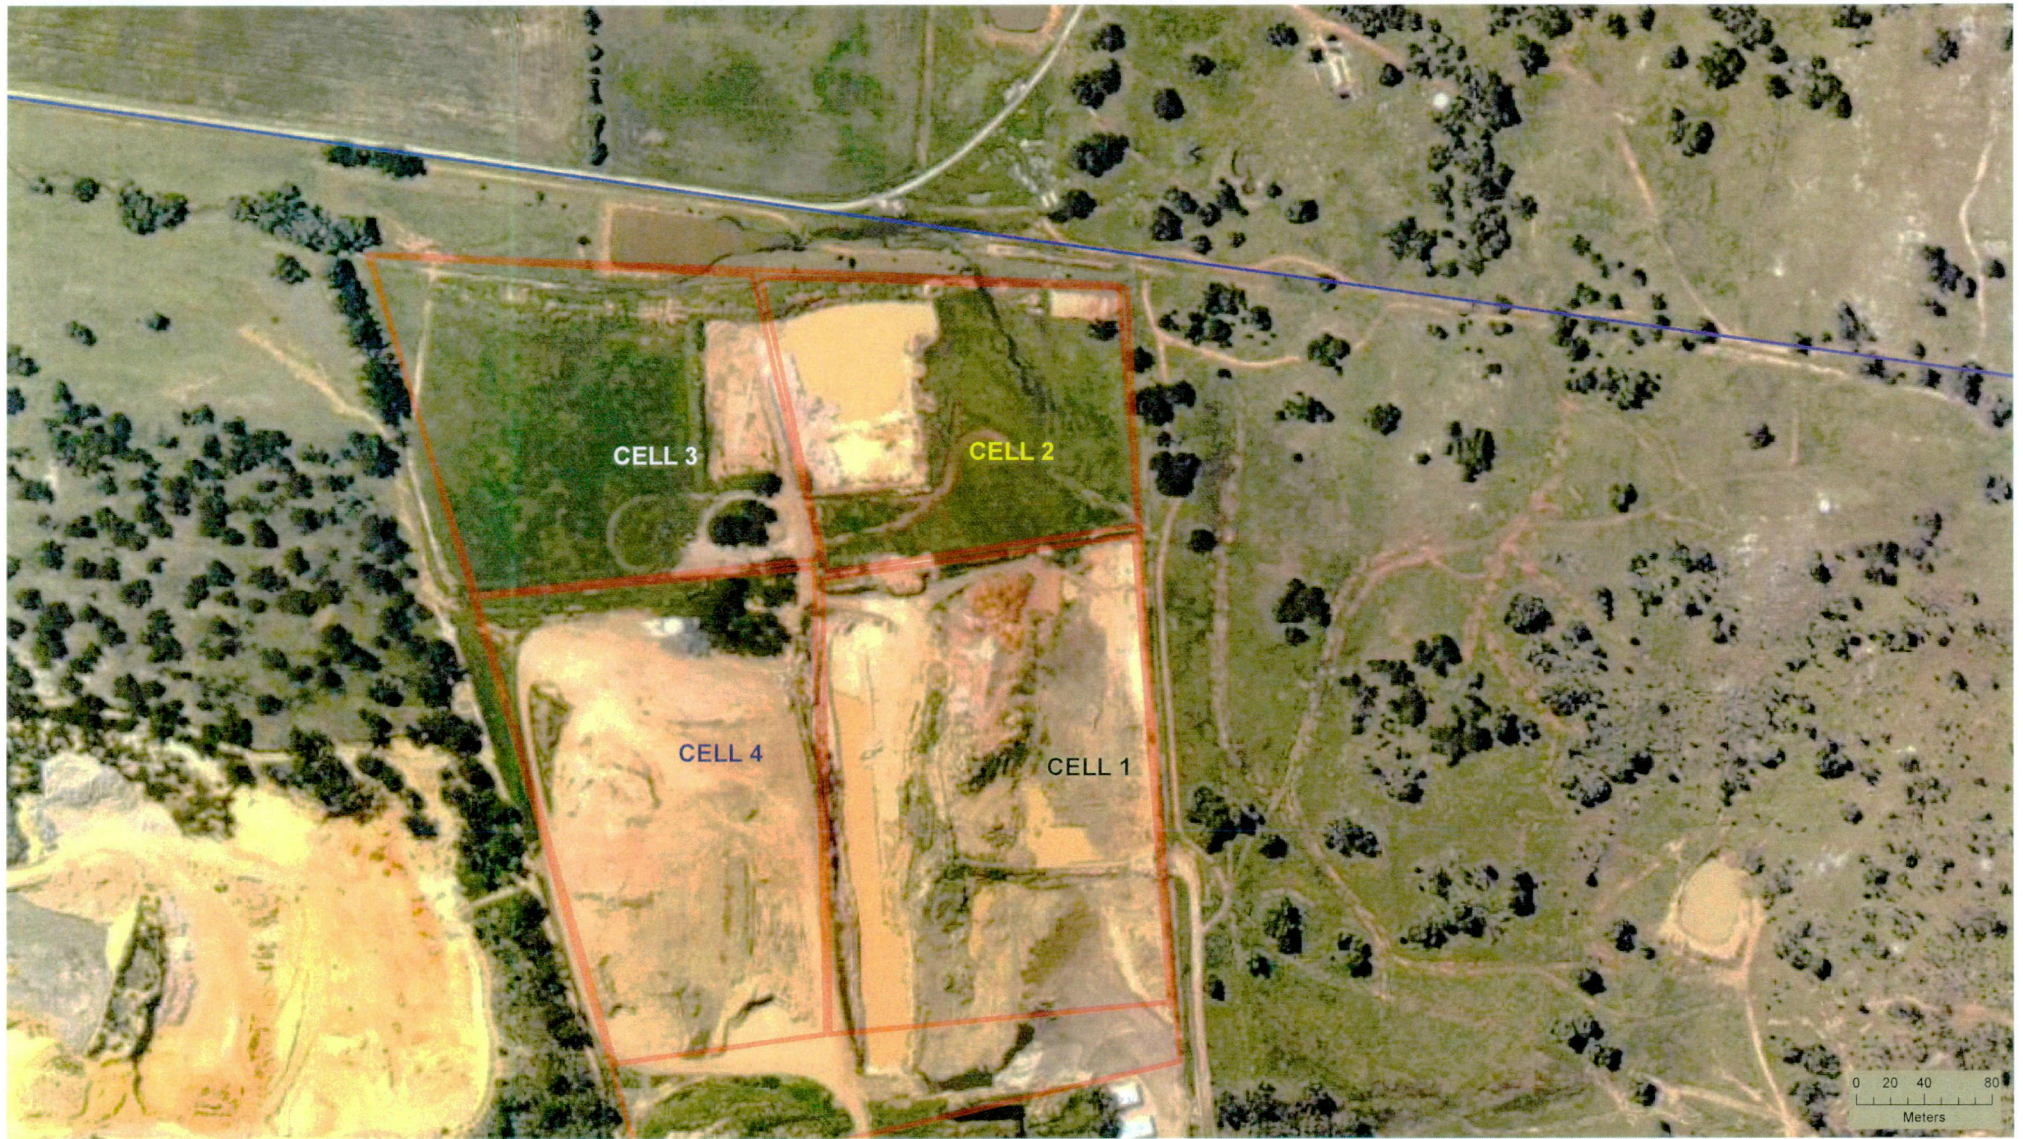
## **Figure 2 – Extraction Site Layout**

FIGURE : Proposed Extraction Site Layout
