# BUILDING REPORT

88 Terrace Road Guildford

# Building Report

**Property** : 88 Terrace Road Guildford  
**Inspection Date** : 20 th December 2025  
**Occupied** : Vacant  
**Weather Conditions** : Fine  
**Inspector** : Brian Connor Building Practitioner 100541 Mobile 0401866 640

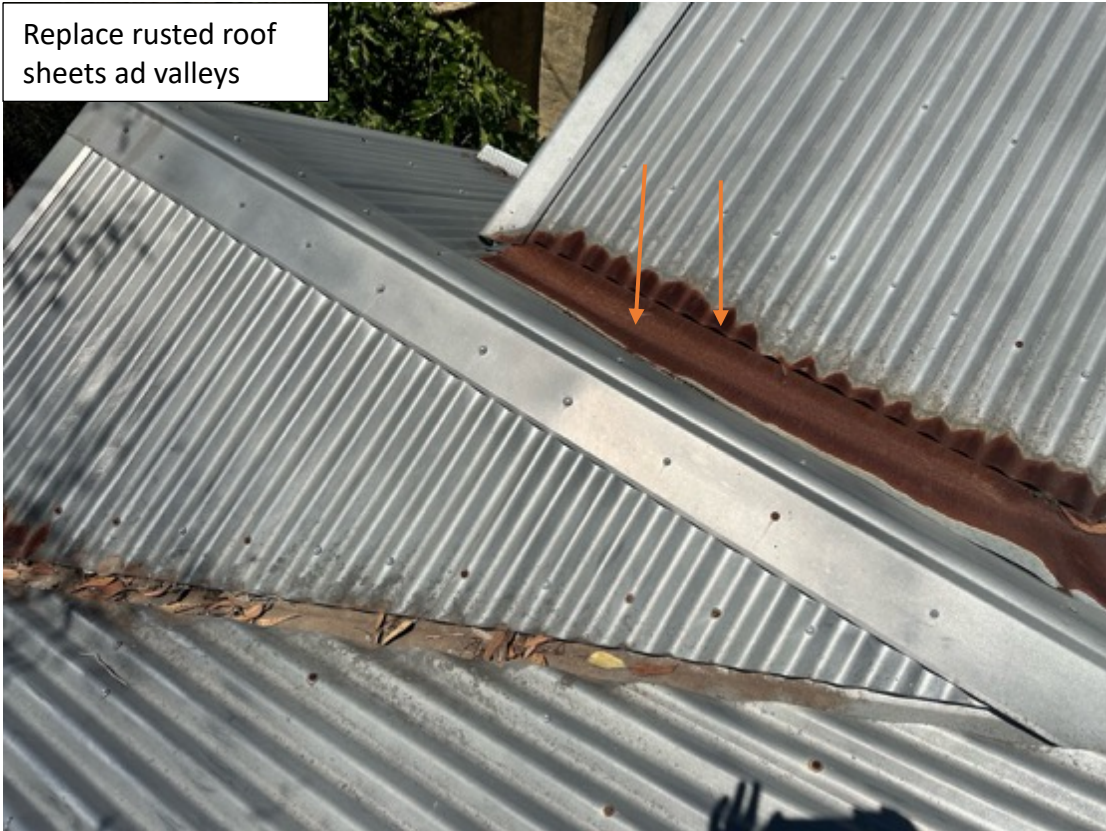
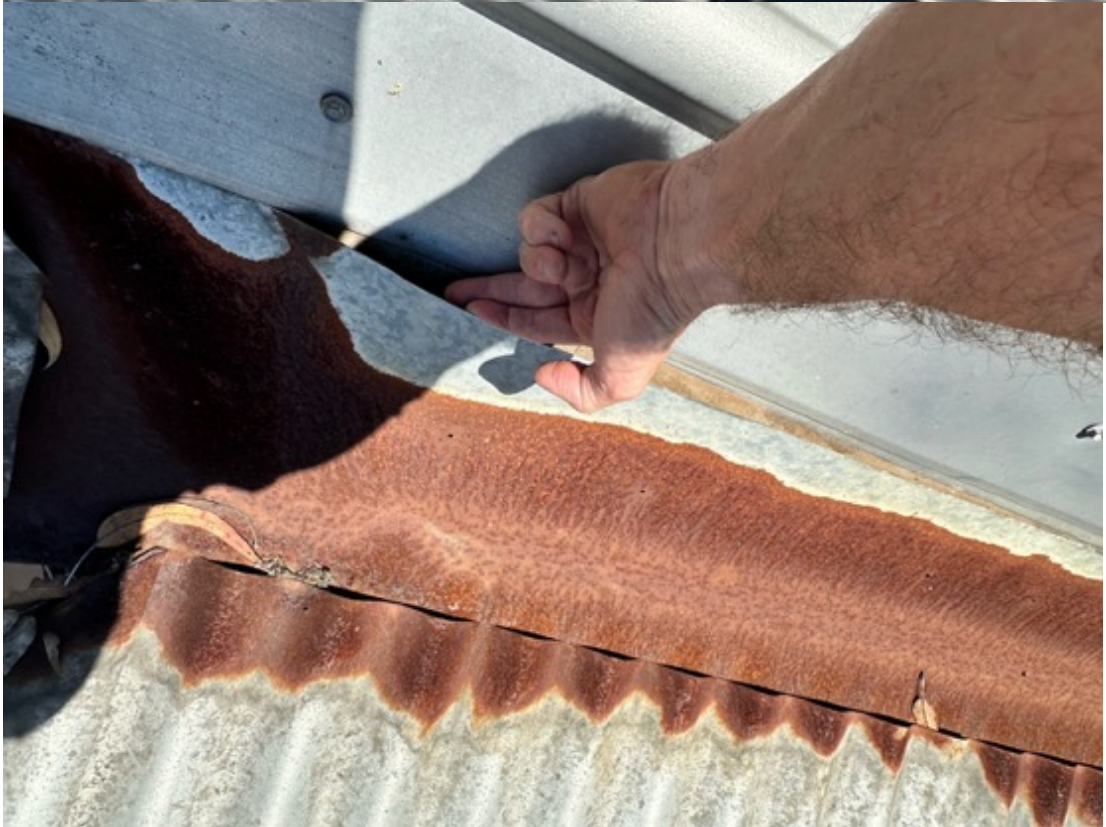
The valley and ends of roof sheets are rusted over the front entry and should be replaced.  
(Maintenance)

Replace rusted roof  
sheets ad valleys

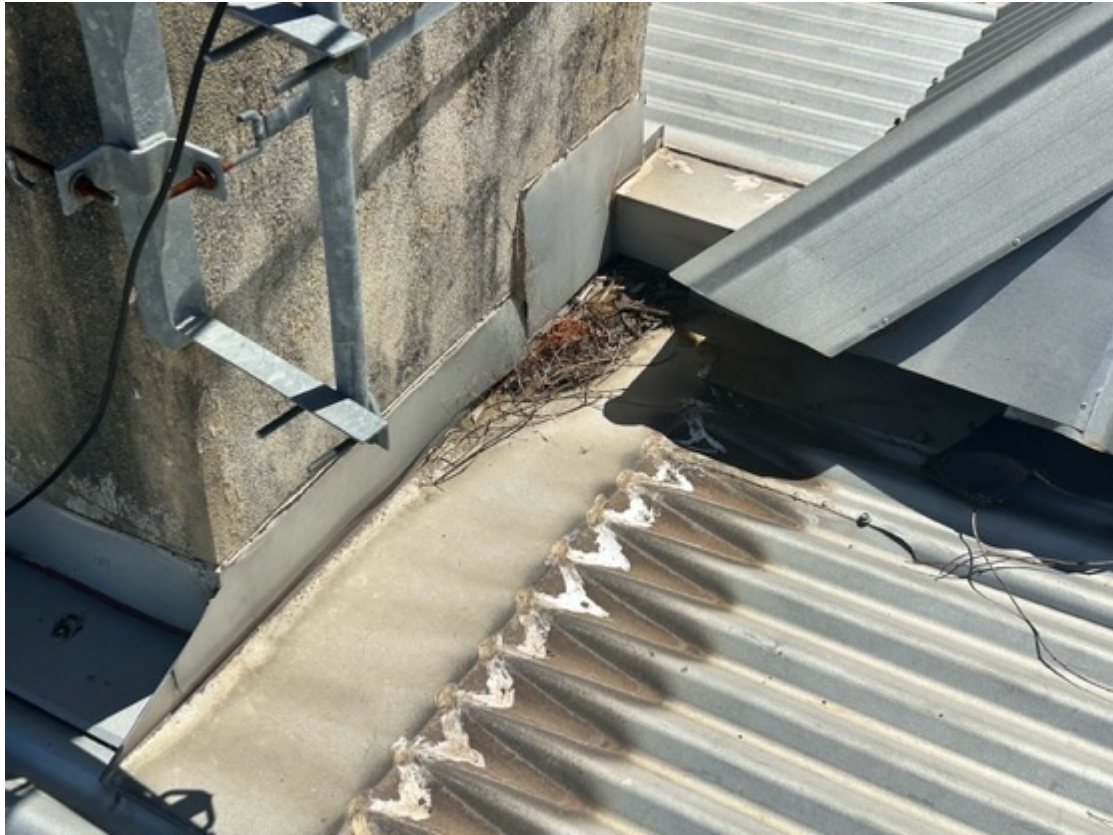
There is a shallow valley gutter to the attic roof and water entry in heavy rains is possible (insufficient fall on the valley gutter) (Maintenance)

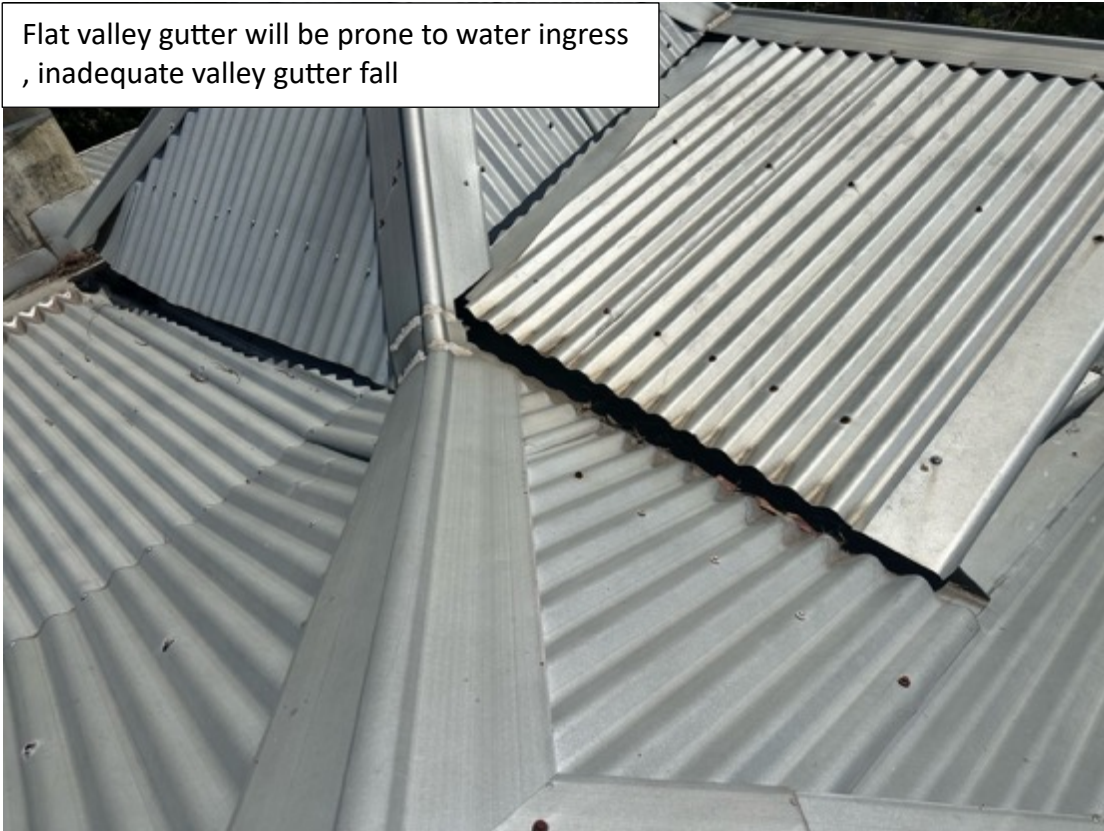
Flat valley gutter will be prone to water ingress , inadequate valley gutter fall

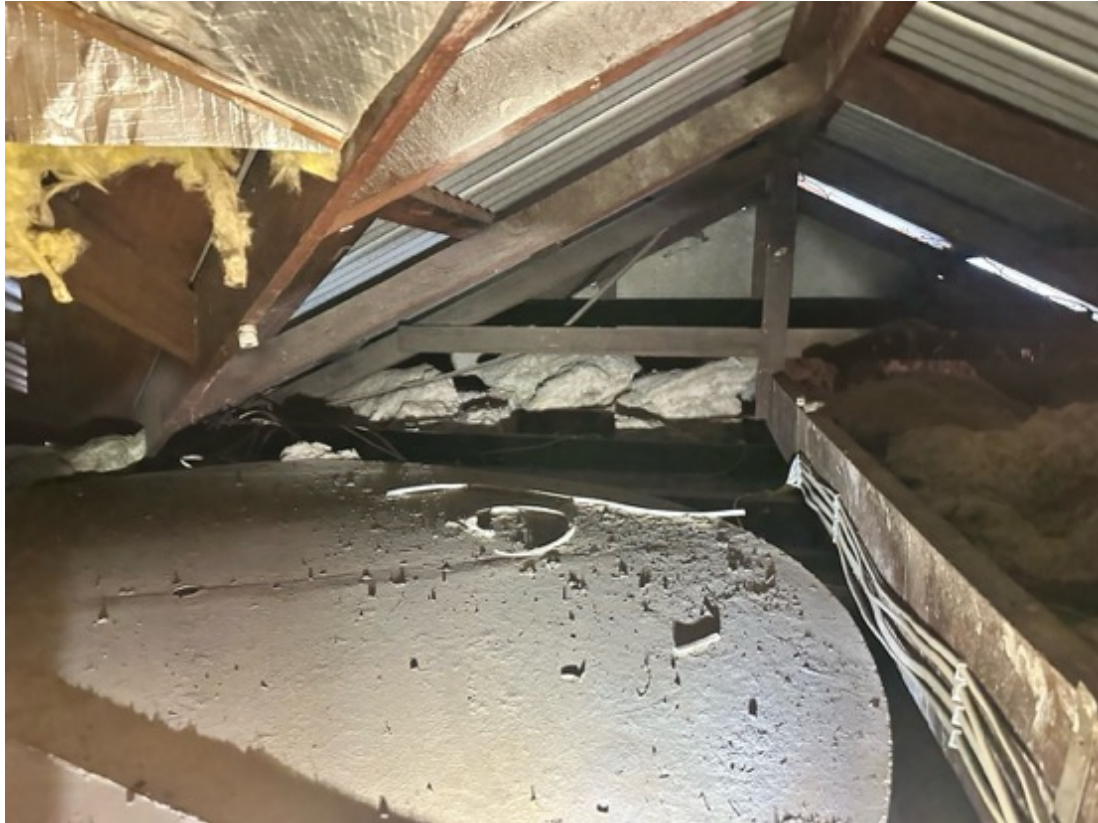
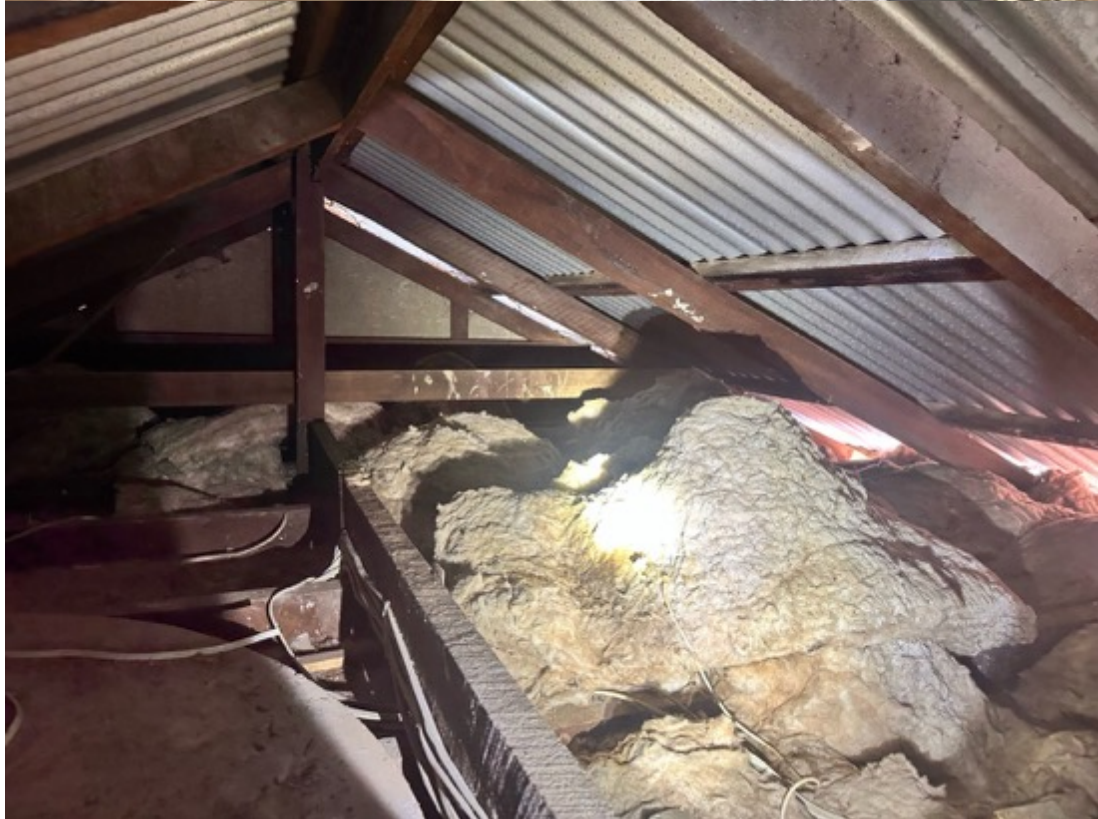
The main roof framing does not meet current Australian standards but has no signs of failure.

Ties down straps and under purlin to rafter and under purlin to props connection straps are not installed to the Attic extension as required by AS 1684.2 , this is required when any structure is renovated or upgraded. **This is a structural defect.**

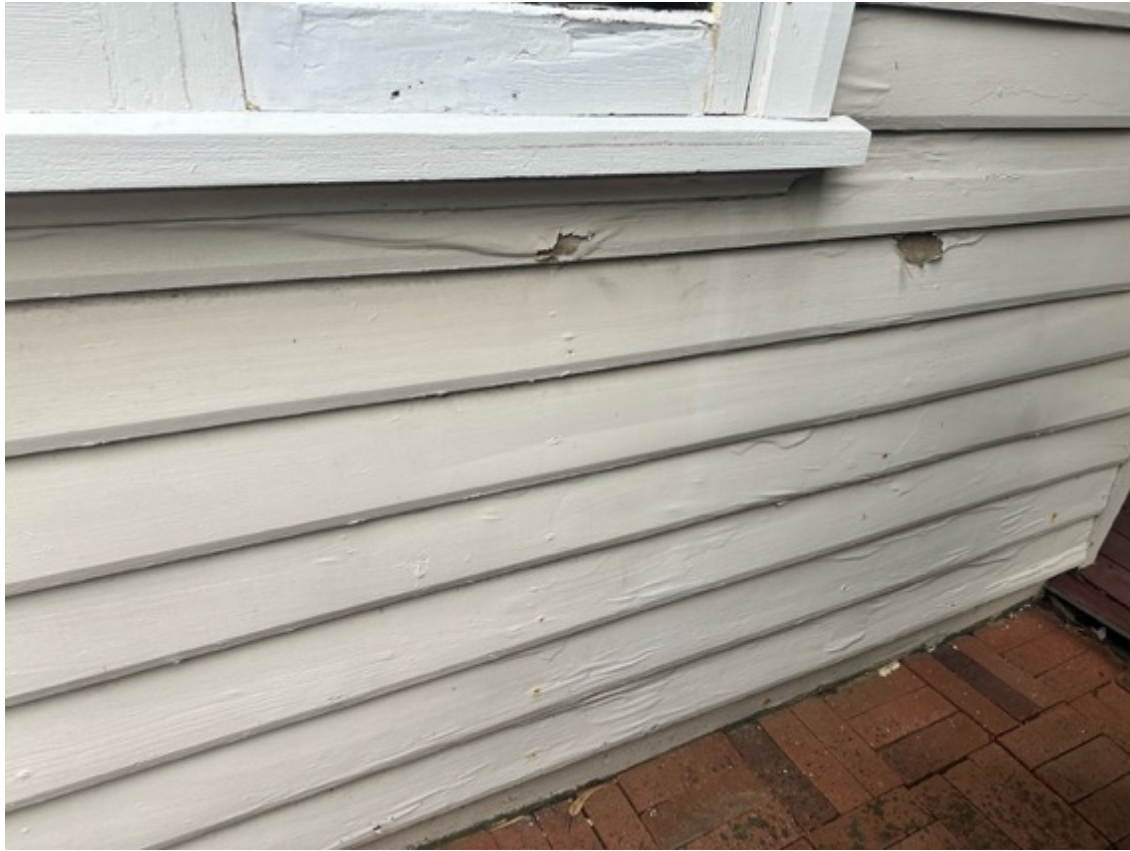
## East elevation

Chimney stone cladding huge gaps and cracks 30 mm to stone and brickwork cracked and leaning greater than 100 mm chimney unstable not safe and needs to be demolished.

Jacaranda roots gave cracked the footing and vase brickwork tree needs to be removed and wall rebuilt.

Rotted weatherboards requiring replacement.

fascia rotted requires replacement.

Gutters rusted require replacement.

Down pipe requires replacement.

Windows weathered requiring repair

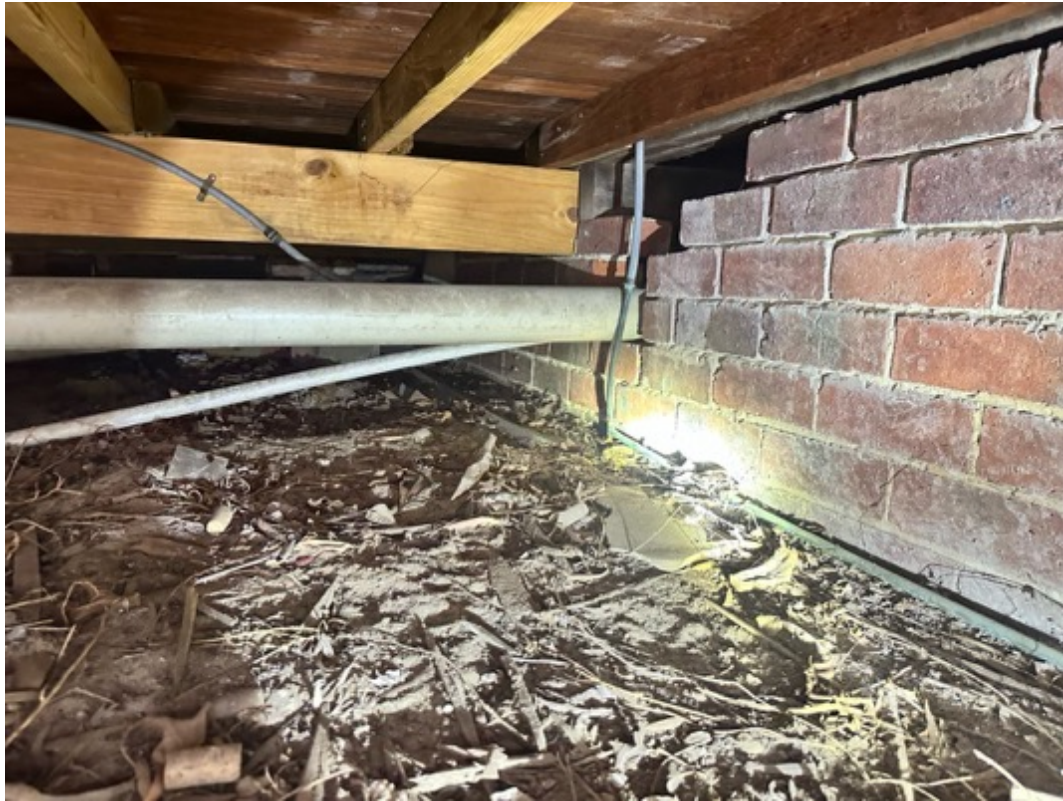
East elevation access Living room

Collapsed central brick support to Living room. **Not structurally sound.**

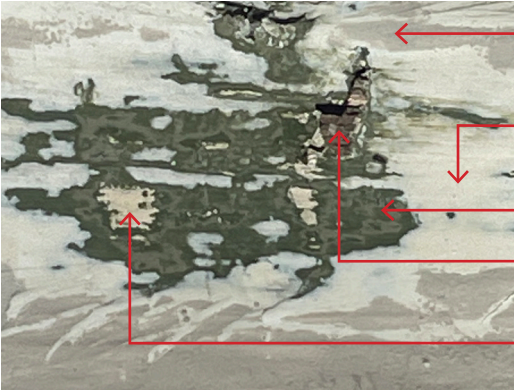
Figure 1. External weatherboard wall to east (side) elevation (Dar Studio, February 2026).

- 5th Layer (Current Top Layer)  
Colour: Cream (Magnolia/ Warm White - closest match to AS colour)
- 4th Layer  
Colour: White
- 3rd Layer  
Colour: Olive Green
- 1st Layer  
Timber Substrate
- 2nd Layer (assumed original)  
Colour: Cream

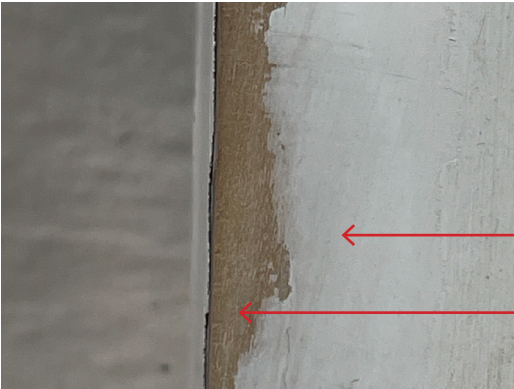
Figure 2. Triple casement window frame to east (side) elevation (Dar Studio, February 2026).

- 2nd Layer  
Colour: White
- 1st Layer  
Timber Substrate

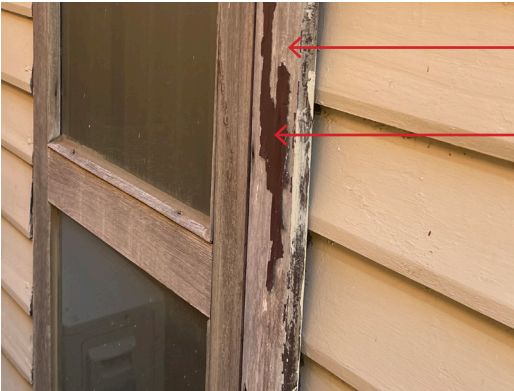
Figure 3. Single window frame to west (side) elevation (Dar Studio, February 2026).

- 2nd Layer (Current Top Layer)  
Colour: White
- 1st Layer  
Colour: Dark Brown (Timber Substrate Underneath)
