Proposed Development at  
No.88 Terrace Road, Guildford  
**Heritage Impact Statement**

Prepared for Lyn O'Brien  
May 2026 | Job No: L26-002

This Heritage Impact Statement (HIS) has been prepared to form part of a Development Application to the City of Swan for proposed development at 88 Terrace Road, Guildford. The proposal involves a selection of repair works including like-for-like replacement of roof and rainwater goods, like-for-like repairs to weatherboard cladding, repainting, and replacement of skylight window and non-original front door. Other works include removal of dangerous and intrusive elements such as non-operational chimney, non-original brick dwarf wall from the front verandah and non-original brick boundary wall, and removal of select trees. New works include construction of a new vehicular garage to the rear of the lot, and new timber picket front to the street front. No works are proposed to the interior of the existing Inter-War residence.

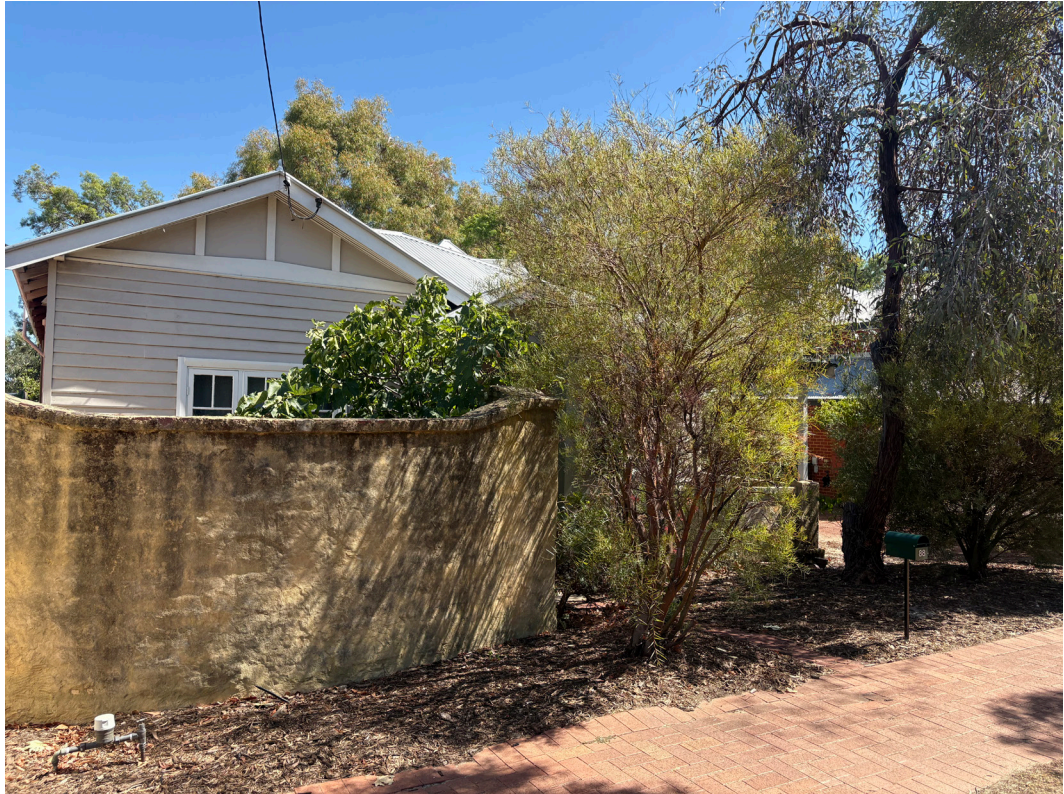
Figure 10. Front view of residence, showing non-original brick front wall (proposed for removal) and sparse landscaping (DAR Studio, February 2026).

| Heritage Value | |
|---|---|
| <b>Positive Impact</b> - The proposal includes the removal of the non-original brick wall to the front, side (north-east), and rear (north), and replacement with timber post fence. | The replacement fencing aligns with Guildford-Mandoon Heritage Area Policy (Part A) and character of the area. It improves permeability, and enables the residence to provide an improved the contribution to the streetscape. |

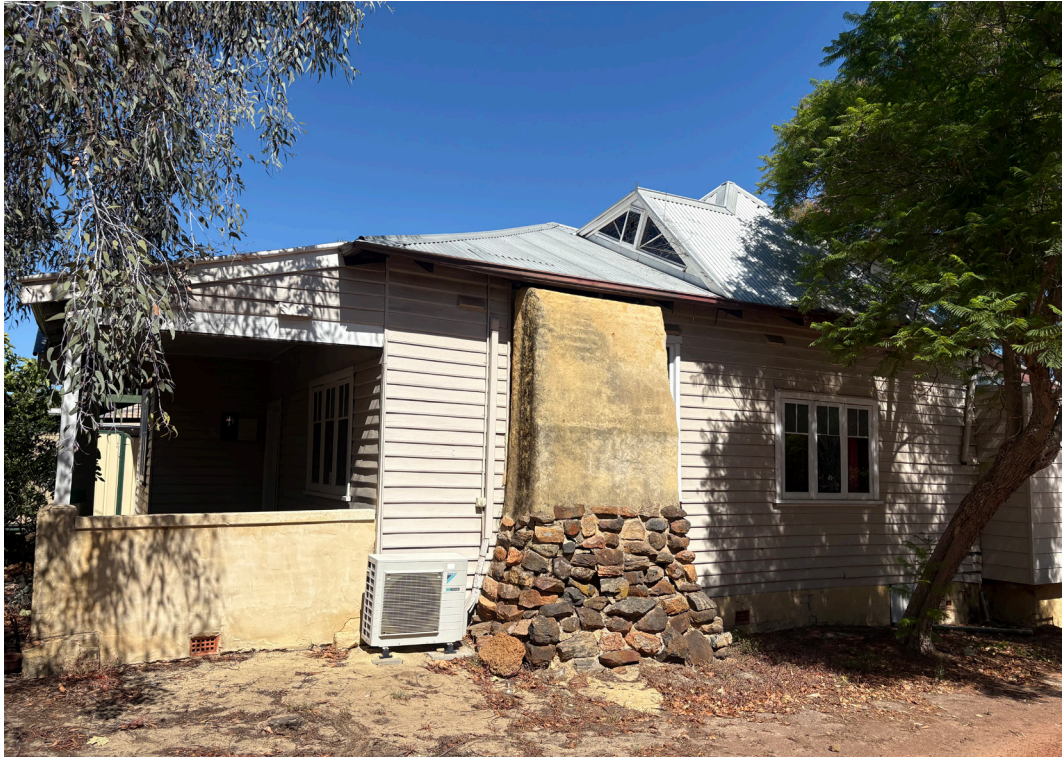
Figure 12. Side (north-east) elevation of residence, showing complex roof form, front verandah (dwarf wall proposed for removal), chimney (proposed for removal), and skylight above (proposed replacement) (DAR Studio, February 2026).

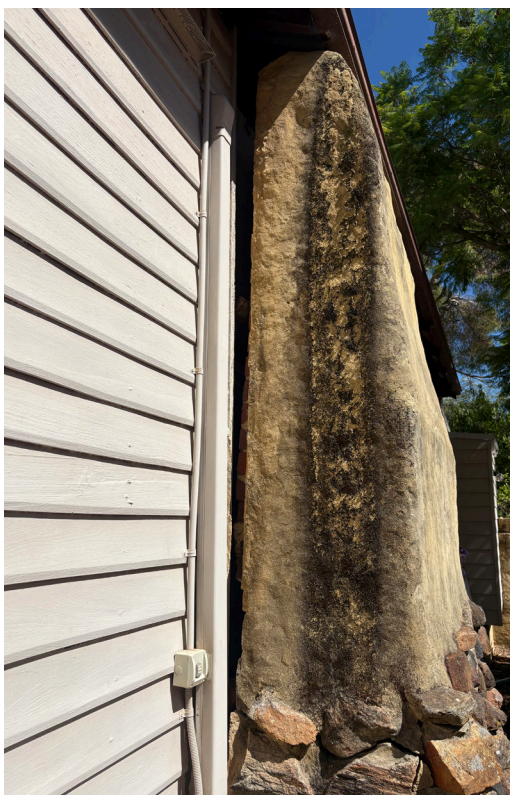
Figure 13. Detail of chimney detached from the house (DAR Studio, February 2026).

The residence incorporates a rendered brick chimney located to its eastern side. The chimney has detached from the building with a lean greater than 100mm, and is unstable and unsafe. Evidence suggests that the chimney is original to the building, however its integrity is low having been significantly altered, and is no longer operational. The chimney has been removed above the roof level, and internally the mantelpiece and hearth has been entirely removed, with the original opening no longer evident, having been covered with painted timber panels.

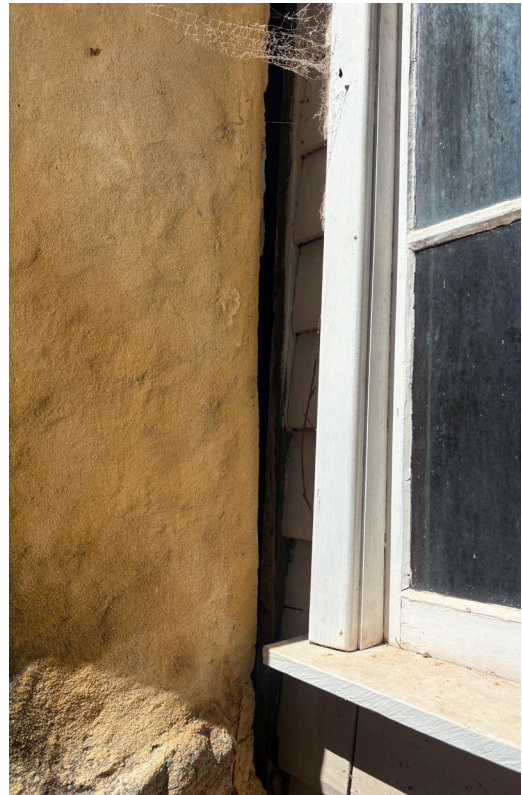
Figure 14. Detail of chimney detached from the house (DAR Studio, February 2026).

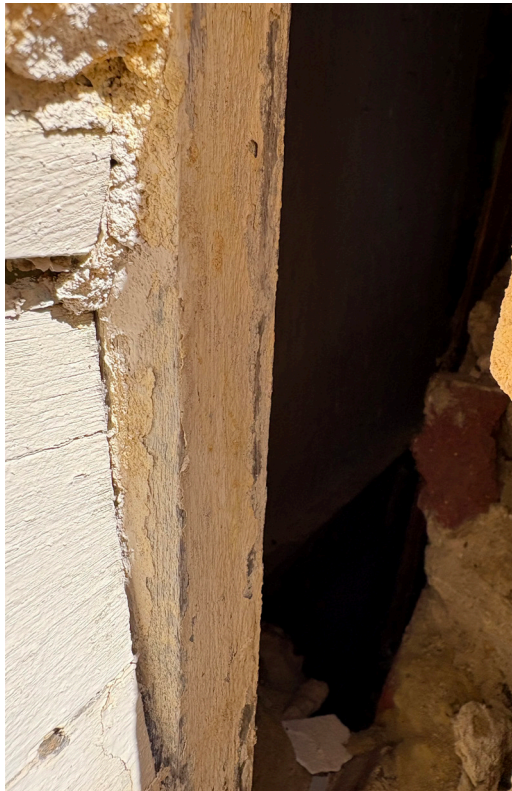
Figure 15. Significant detachment of chimney (DAR Studio, February 2026).

| Heritage Value | |
|---|---|
| <p><b>Minor Impact</b> - The proposal includes the removal of the existing chimney. The chimney has detached from the building with a lean greater than 100mm, and is unstable and unsafe. It is no longer operational, and has been removed above the roof level, and internally the mantelpiece and hearth has been entirely removed, with the original opening no longer evident, having been covered with painted timber panels.</p> <p>As the chimney has some aesthetic and historic value, being an original element of the house and visible from the public realm, its removal will have some minor heritage impact.</p> | <p>Considering that the chimney has no functional purpose, as the internal fireplace and fabric above roof level has been removed, and it has detached from the building causing safety concern, removal of the remaining fabric is considered acceptable.</p> <p>Its removal will improve the overall condition and long-term conservation of the building.</p> |

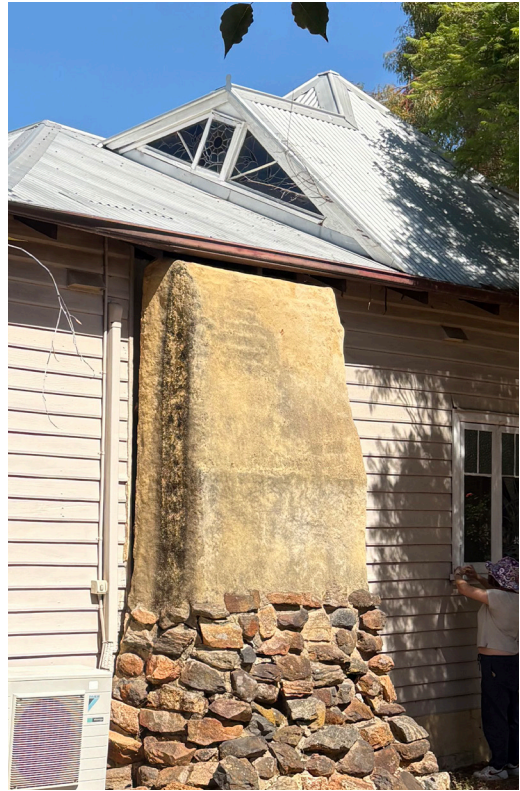
Figure 16. Detail showing chimney removed above roof line (DAR Studio, February 2026).

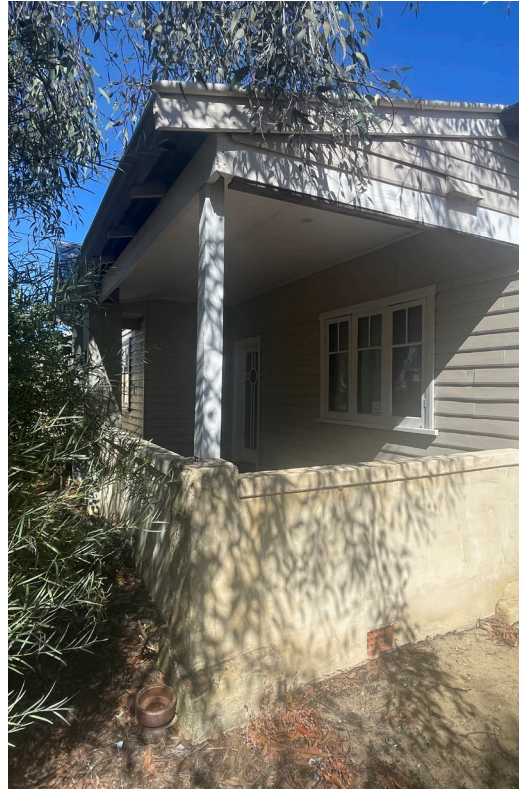
Figure 18. Front verandah showing non-original brick dwarf wall proposed for removal (DAR Studio, February 2026).

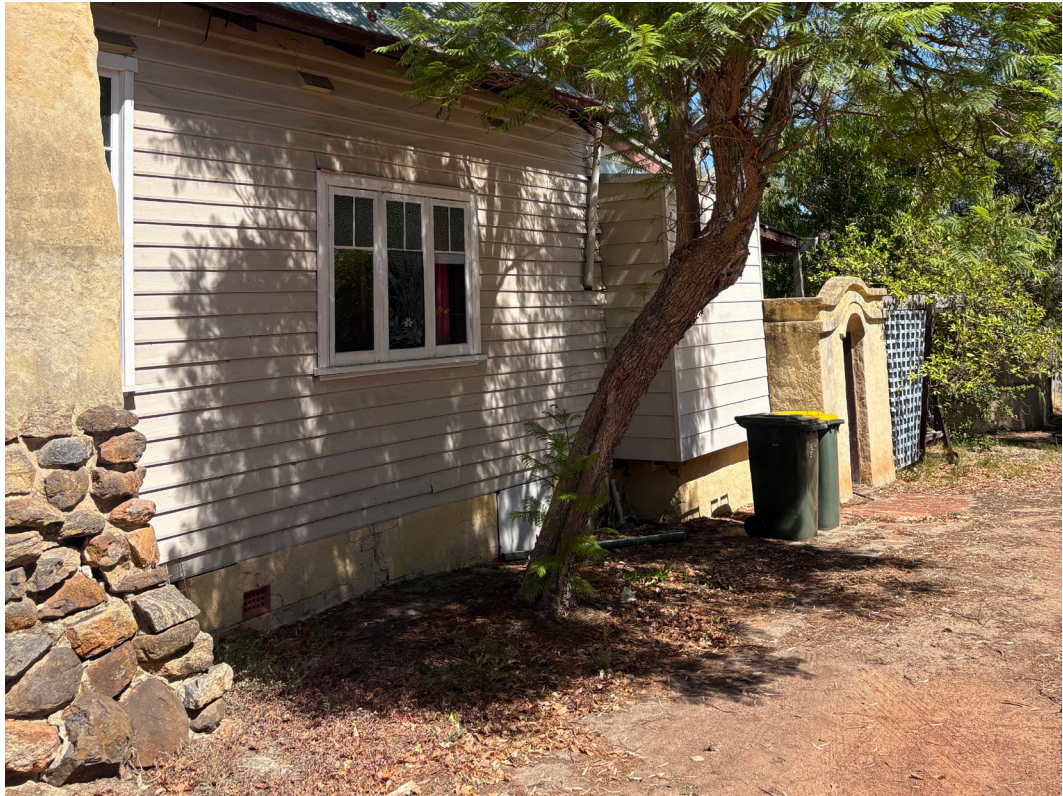
Figure 19. Side (north-east) elevation of residence, showing proximity of Jacaranda tree, causing damage to residence. Damaged weatherboard cladding proposed for replacement. Note disconnected downpipe (DAR Studio, February 2026).

The original section of the residence is clad with horizontal weatherboards, with fibre cement boards used in the later (rear) addition. The original weatherboards are in varying condition, with areas to the front (south), and either side (west and east) noted as being in poor condition owing to water damage, and require replacement. Gaps and holes are noted in some weatherboards which require fixing.

A Jacaranda Tree is located to the east of the building, approximately 9m in height, and 4-5m canopy spread. Roots of the tree have caused issues with the residence, including cracking to the brick footings and adjacent chimney, causing the wall to subside and interior ceiling to sag. Some large trees are sited to the rear of the lot boundary, of which two (Red Flowering Gum and one Rottneest tea tree) are recommended for removal by an arborist, owing to poor health and structure.

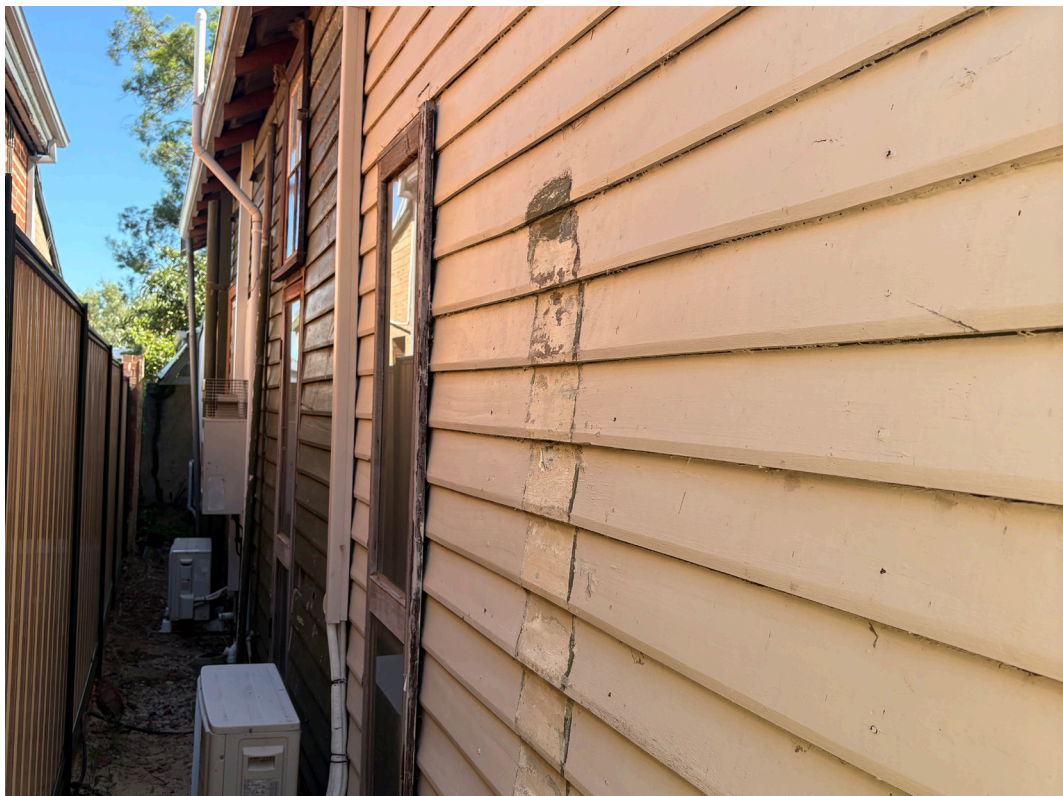
Figure 20. Side (south-west) elevation showing mis-matched and damaged cladding proposed for repair and replacement (DAR Studio, February 2026).
